Department of Civil Engineering
Indian Institute of Technology Madras (IITM)
Chennai – 600 036

February 5, 2021

Subject: Report on visual inspection of CKAT, Vytilla on Jan 19, 2021 and prior inputs

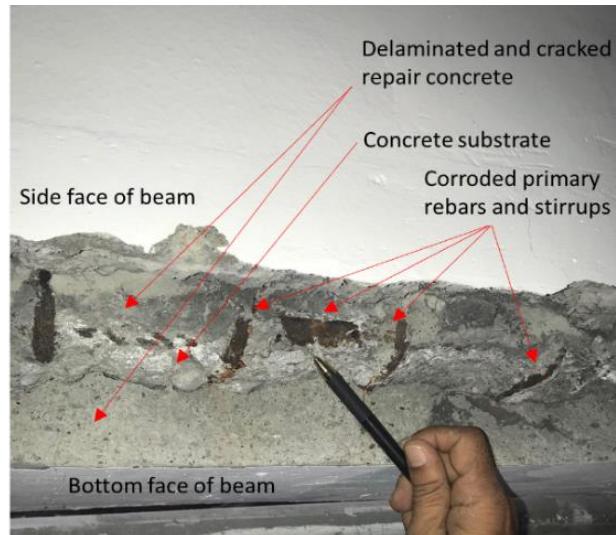
In the presence of the RWA authorities, walk-through inspections of Towers B and C were conducted. Severe corrosion-induced cracking of structural elements, associated patch repairs (repeated patch repairs at same locations, as informed by tenants), signs of leakages etc. were observed. As a particular case and to confirm the corrosion condition, the cracked/delaminated location of one of the long beams in the basement was autopsied (i.e., delaminated cover concrete was removed using a hammer and chisel). This region was found to be an already repaired region and significant steel rust/corrosion products were observed (see Figure 1).

This cracking and delamination might have occurred because the prior repair could not arrest the corrosion of the primary reinforcement and stirrups. This is due to the possible presence of sufficient chlorides in the concrete in contact with the steel. As informed and observed, it seemed that the repair was done by covering the substrate concrete and steel using repair concrete (without any undercutting and electrochemical treatments). The lack of coarse aggregates in this repair concrete indicated that this was possibly microconcrete. Such patch repairs with microconcrete and without undercutting and electrochemical treatments cannot

Figure 1 Ongoing corrosion in the repaired beam in the basement

control corrosion due to (i) the residual chloride effect and (ii) the halo effect. The residual chloride effect is due to the possible chlorides in the substrate concrete and the inadequately cleaned steel surface/rust present and the halo effect is due to the difference in the chemistry between the repair and substrate concretes. The microconcrete was about 2-inch thick, which seemed more than required cover thickness for such members. Also, non-metallic mesh for confinement was observed at the side faces (it seemed that mesh was not present at the bottom face), questioning the effectiveness of mesh in confining the concrete.

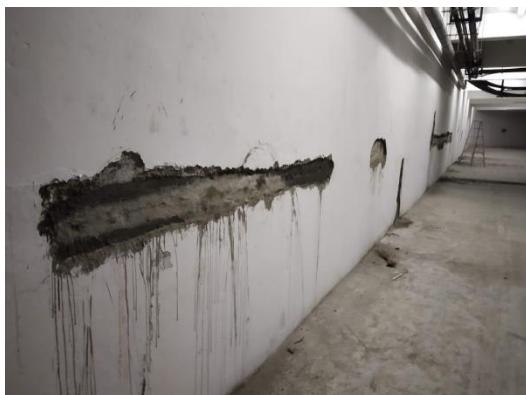
Figure 2. Leaking of basement wall
(performance of recent repair must be checked
during the upcoming monsoon)

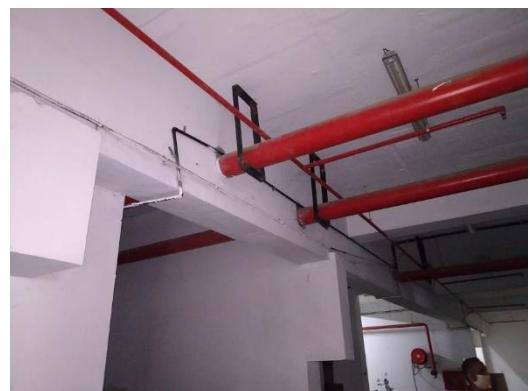
Figure 3. Fire pipes passing through the beams
(the consequences must be checked by a
structural consultant)

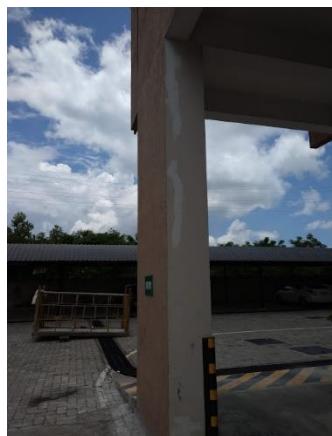
Figure 4. Patch repair of cracks in columns

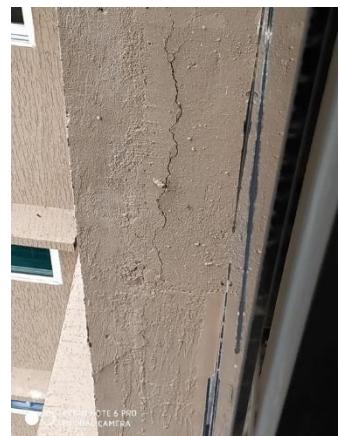
Figure 5. Cracks on patch repaired columns
(indicate inadequate repair practice)

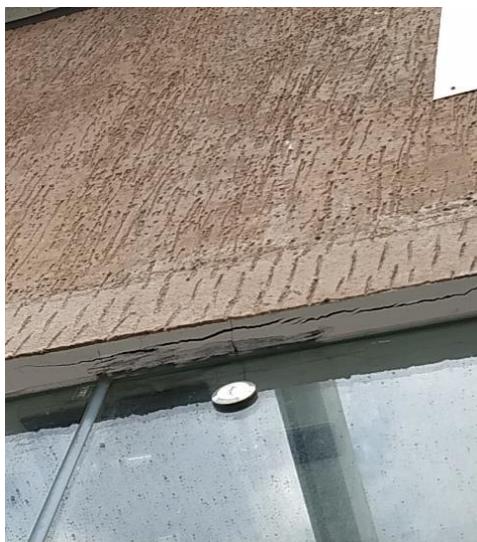
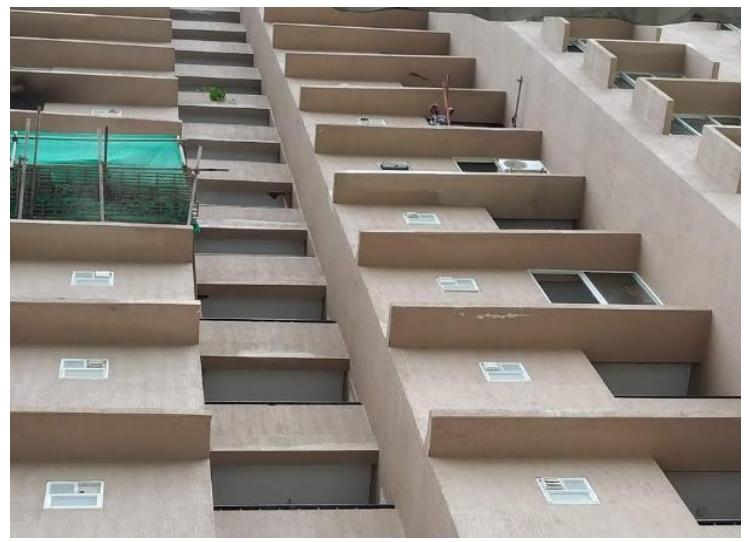
Figure 6. Repaired beams, columns, sunshades, etc. at many floors (see the changes in texture and colour) exhibiting additional cracks - indicating inadequate repair practice
