**A Review on the Report by Bureau Veritas on**  
Investigation of distress in basement floor and terrace level overhead tanks of  
Army Welfare Housing Organisation “Chanderkunj Army Towers”  
at Silver Sand Island, Vytilla, Kochi, Kerala (November 2020)

**Review of the report by Bureau Veritas (dated Dec 3, 2020) for  
Chander Kunj Apartments, Silver Sand Island, Vytilla, Kochi**

**Results of the chloride tests conducted at IIT Madras**

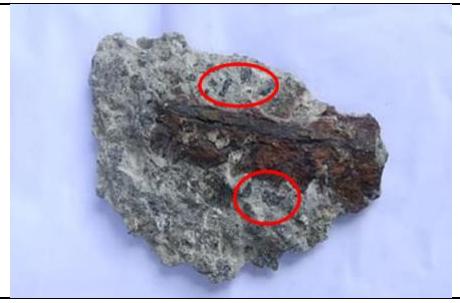
</td> <td data-bbox="1144 1664 1367 1978">4.94</td> </tr> </tbody> </table>	Location	Chloride content reported (kg/cm <sup>3</sup> )	Retaining wall - Basement floor	0.045 0.04 0.028 0.096	Tower-B basement floor	1.12 1.12	Tower-C basement floor	0.34 0.26	Parking area	0.37 0.04	Tower A - stilt floor	0.4 0.045	Water tank	0.045 0.045 0.079	Photo of the sample collected	Acid soluble chloride content (kg/m <sup>3</sup> of concrete)
