# **REPORT ON VISUAL INSPECTION OF CHANDERKUNJU ARMY TOWER AT SILVER SAND ISLAND, COCHIN**

**CHANDERKUNJU ARMY TOWER**

**SEPTEMBER 2020**

**Subject: Report on Site visit to Chander Kunj Army Towers at Silver Sand Island,  
Vytilla, Kochi**

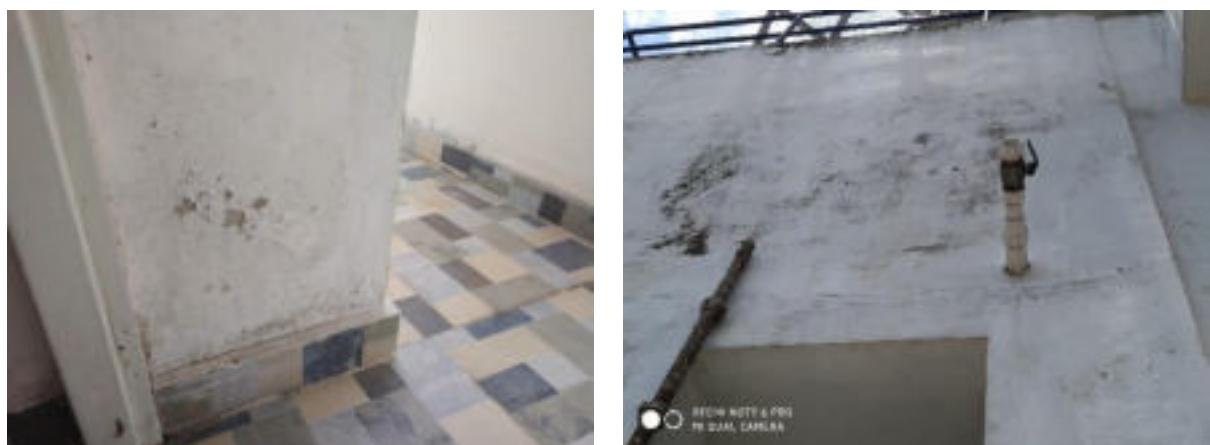
Figure 3. Dampness in the walls and water tank walls

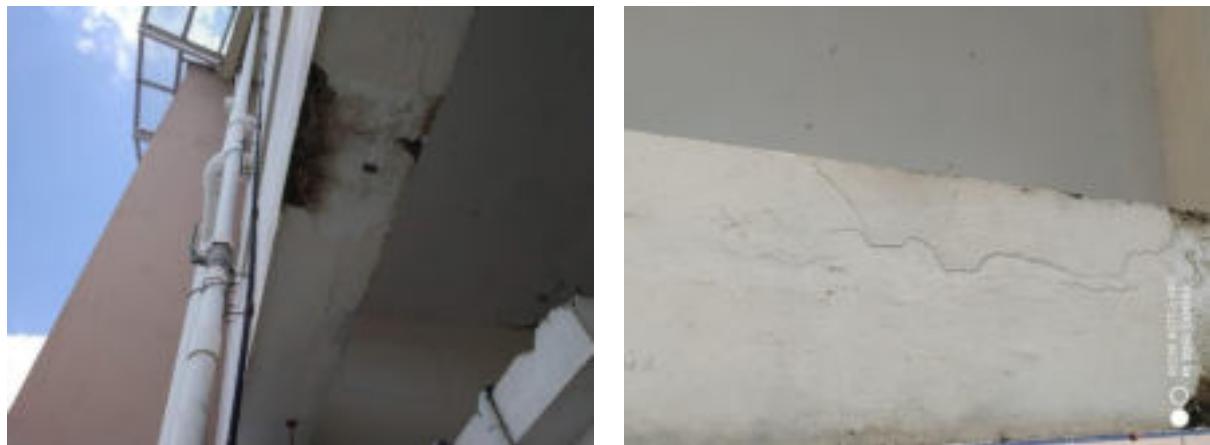
Figure 4. Cracks on the beams due to corrosion

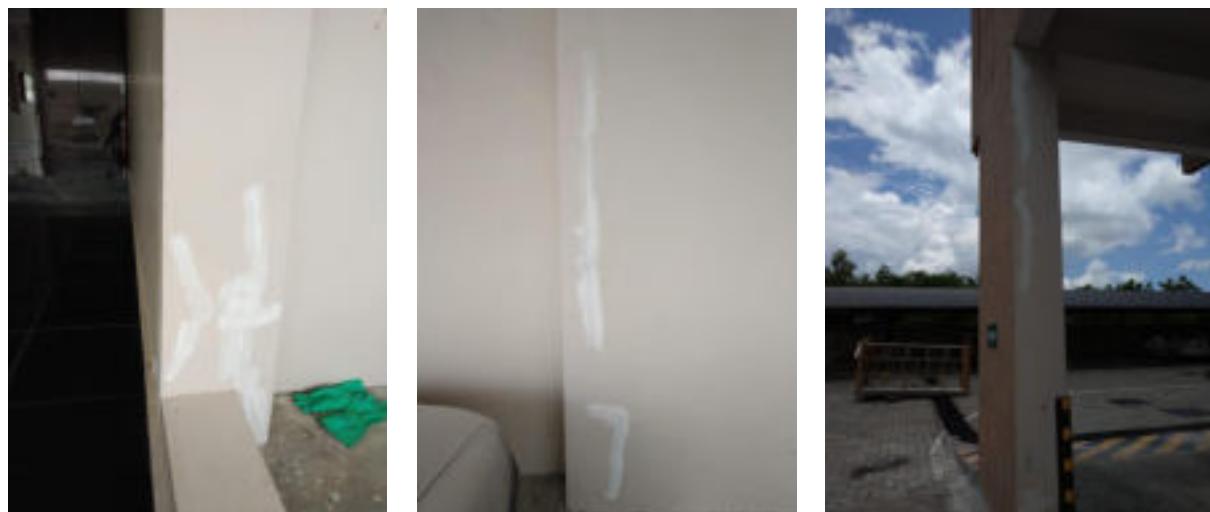
Figure 5. Improper repair of cracks in columns with filler material

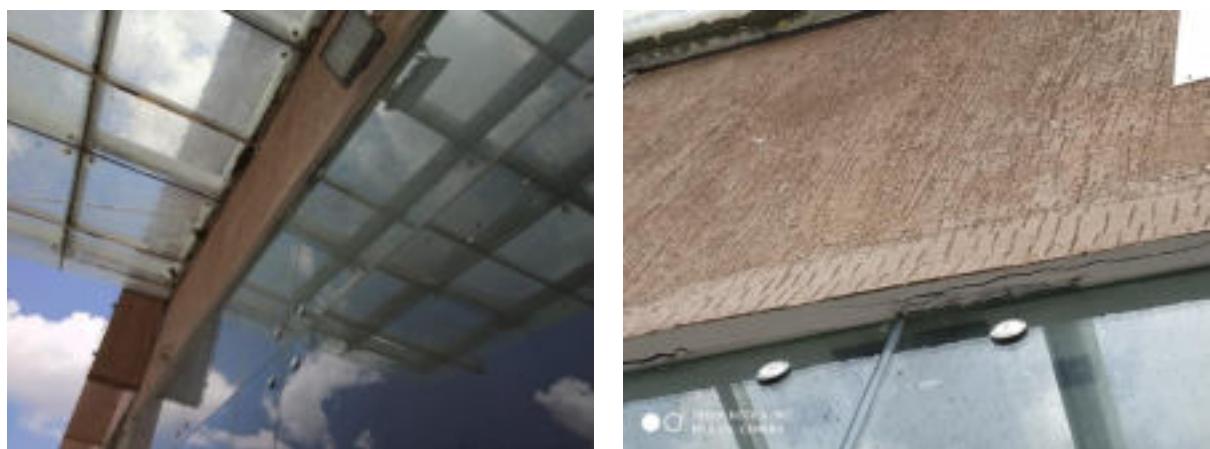
Figure 6. Reoccurrence of cracks in the already repaired beams

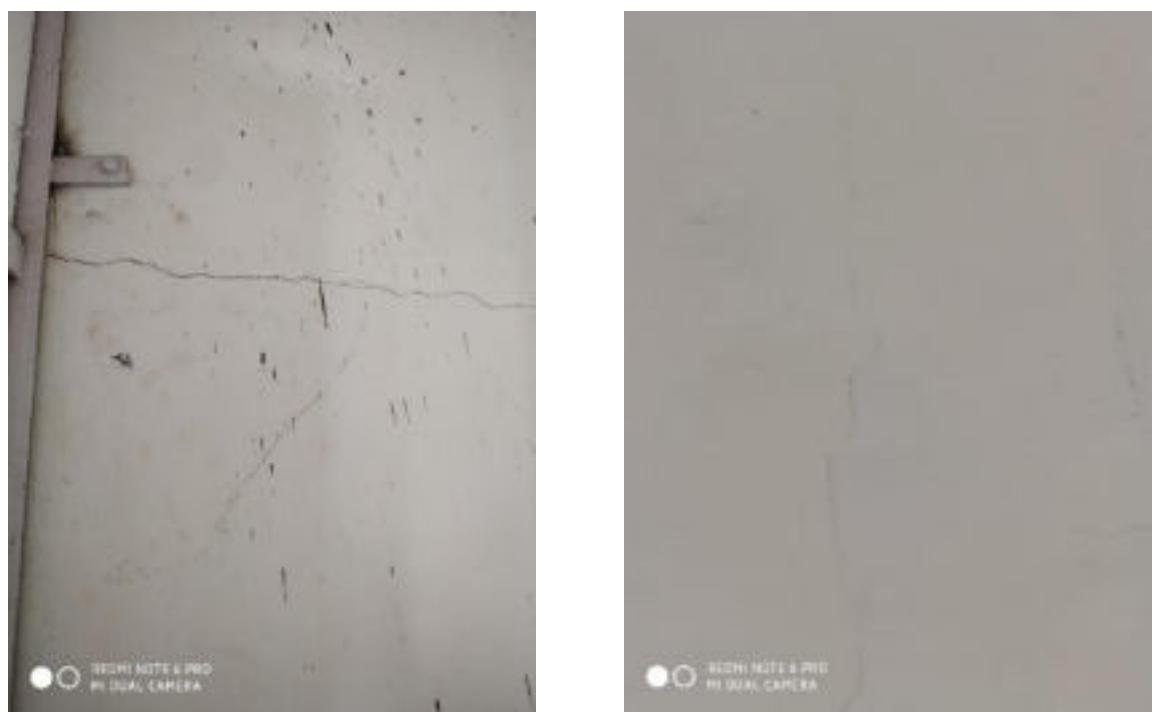
Figure 8. Cracks in structural elements

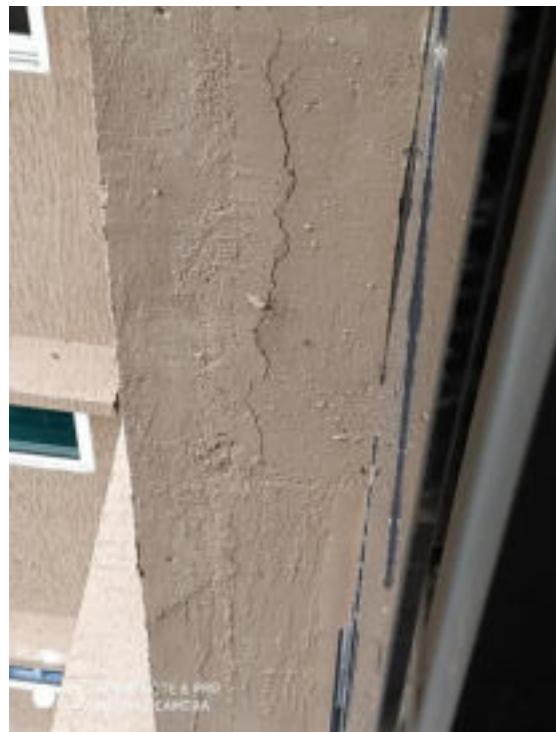
Figure 11. Cracks in columns due to corrosion of reinforcement

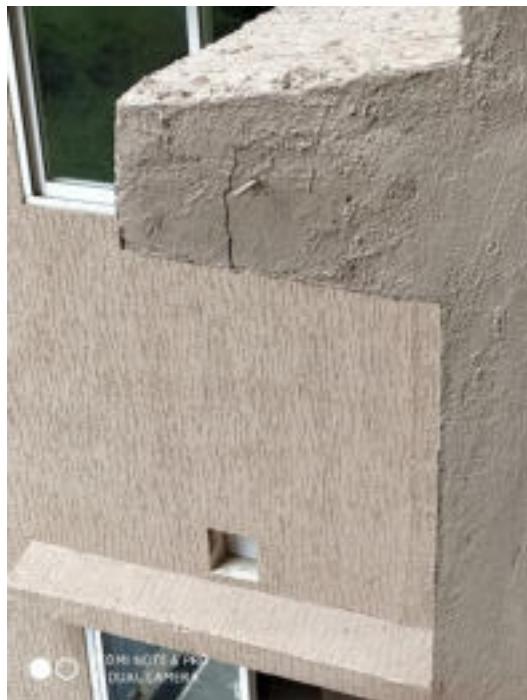
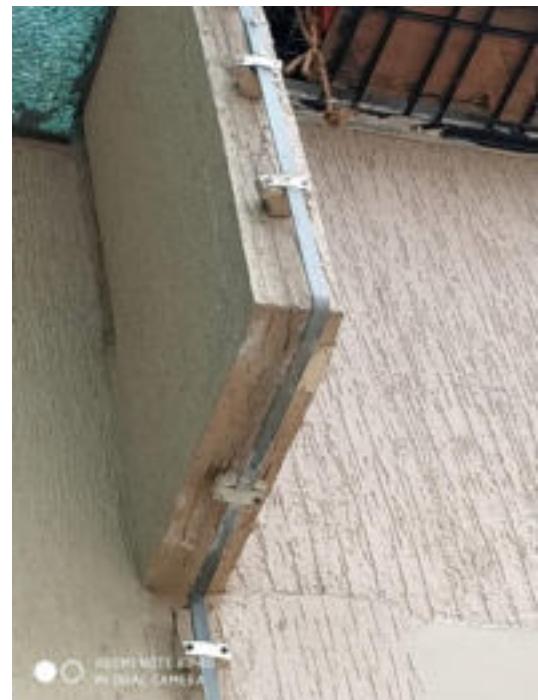
Figure 12. Cracks in shade

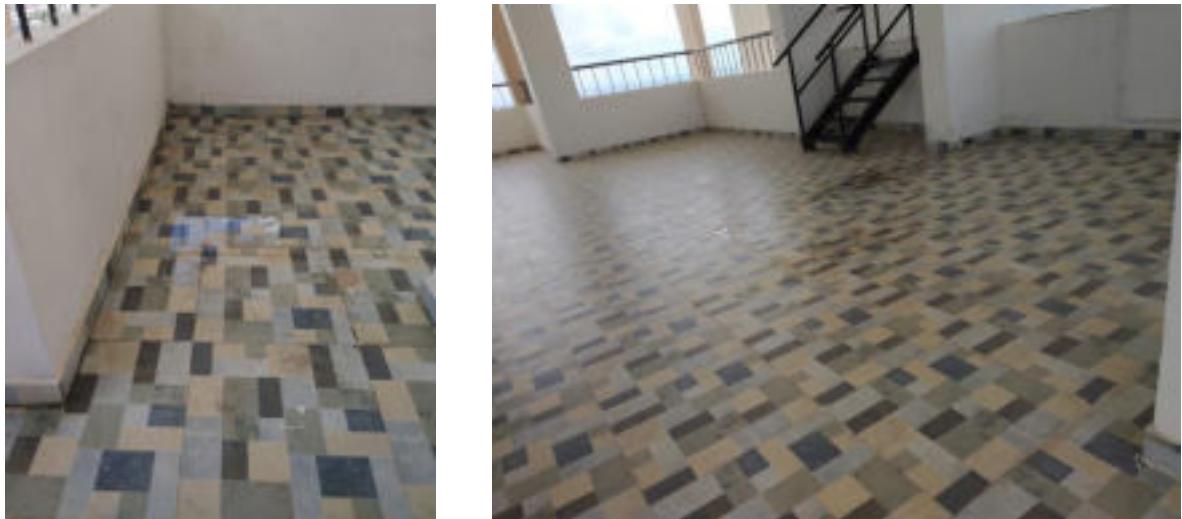
Figure 13. Water is getting stagnated in the floor
