**Structural Condition of Chander Kunj Army Towers (CKAT) at**

**Silver Sand Island, Vytilla, Kochi**

**(IITM Report-4)**

**Prof. Radhakrishna G. Pillai**

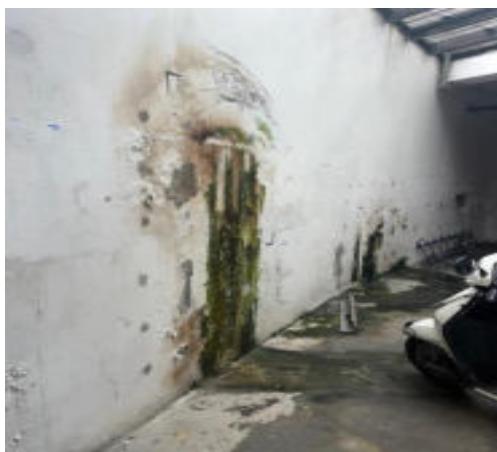
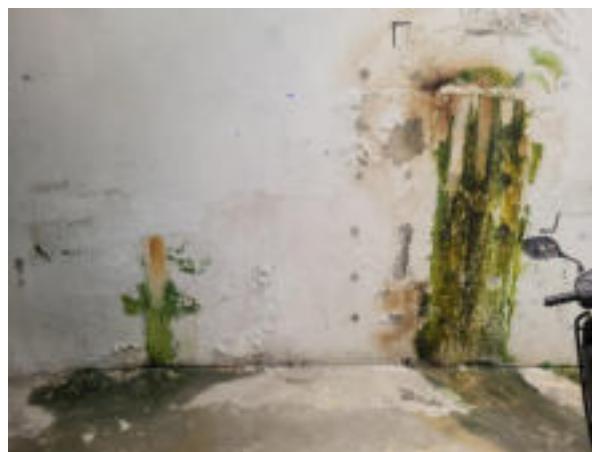
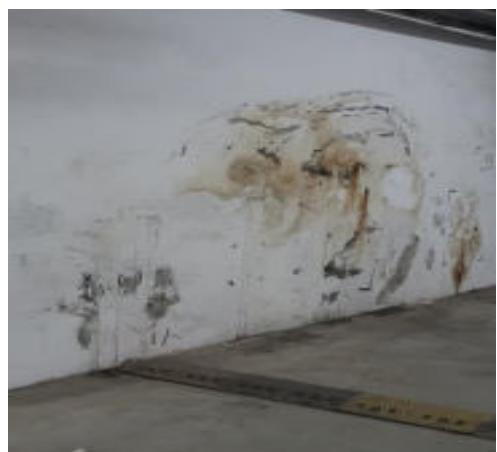
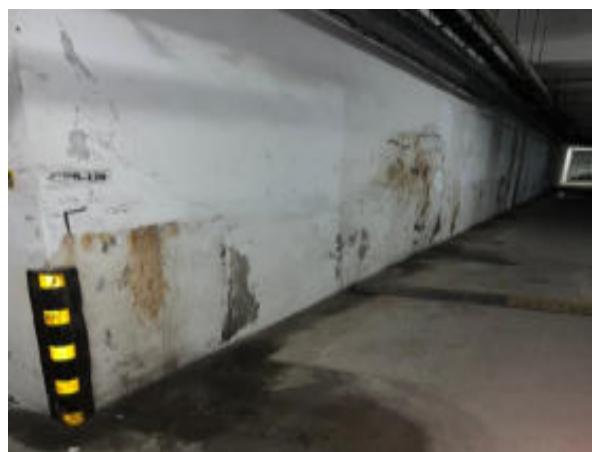
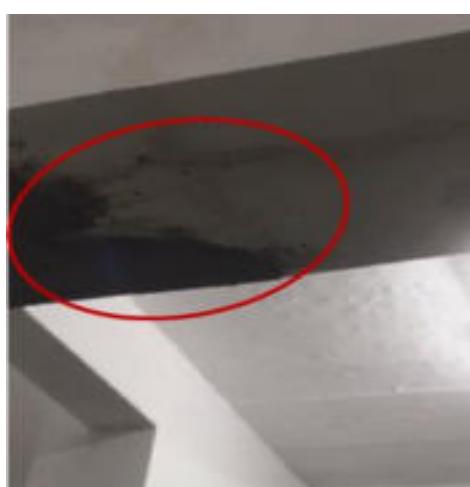
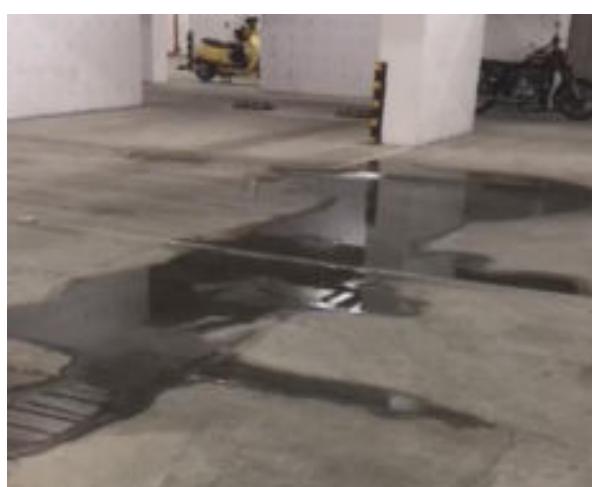
- 3.1 Basements were identified as one of the most critical parts of the buildings. Severe leakage of water through the peripheral retaining walls occurs due to high water table, especially during the rainy season. Despite multiple repairs by grouting on the negative side of the retaining wall, leakages were found to reappear in the same locations (See Figure 2). Dampness, peeled-off paint, spalled concrete and exposed corroded rebars on the roof slabs in the basement were visible (See Figure 3). Seepage and stagnation of water in the basement caused by inadequate waterproofing at the construction joints and improper slope for rainwater drainage were also observed.

(a) Flaked paint, corrosion stains and algae growth on retaining walls and water leakage

(b) Flaked paint, corrosion stains and algae growth on retaining walls and water leakage

(c) Flaked paint and corrosion stains on retaining walls

(d) Flaked paint and corrosion stains on retaining walls and water leakage

(e) Water dripping from beam and dampness on beam during rain

(f) Water leakage during rain

**Figure 2 Water leakage and consequent corrosion visible in the basement**

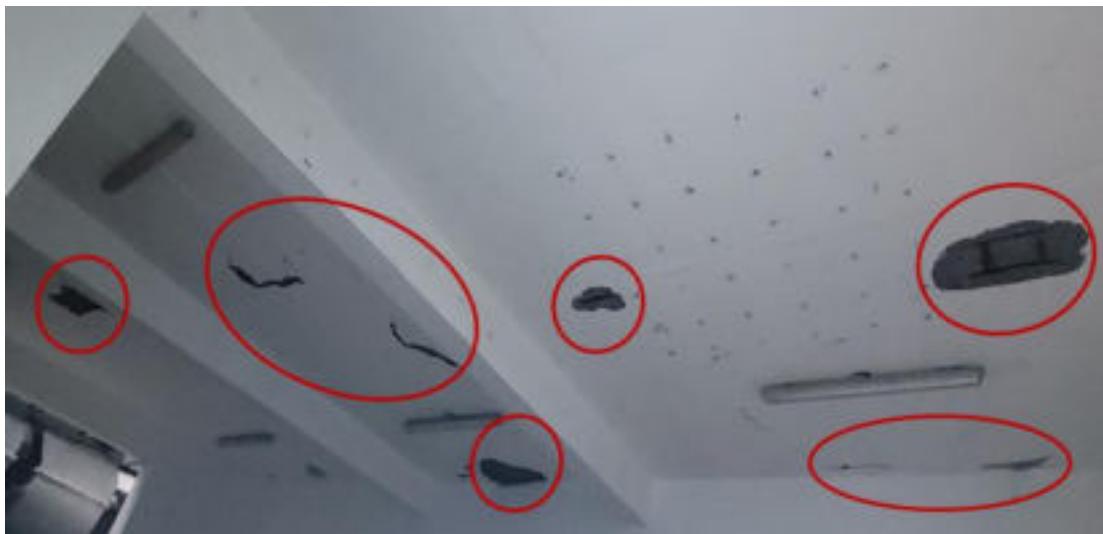
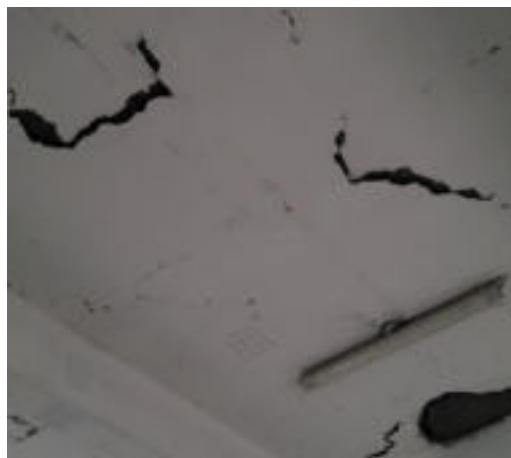
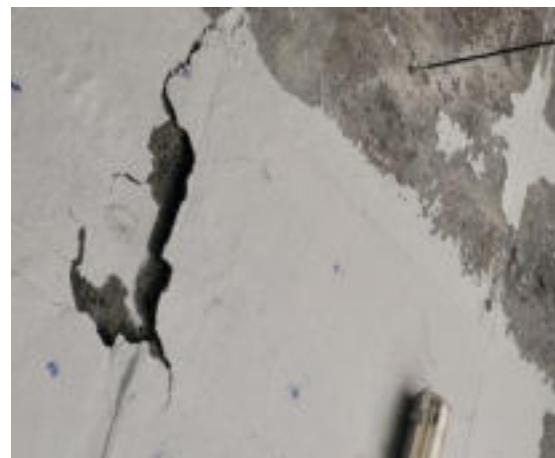
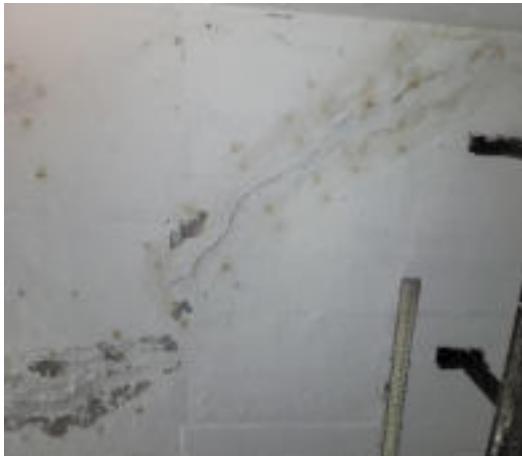
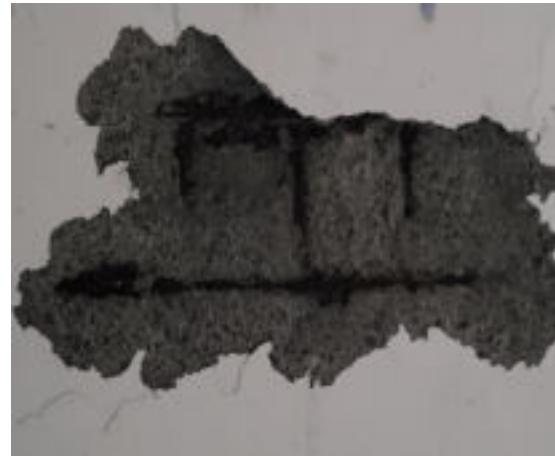
(a) Cracked, spalled and exposed corroded rebars at various locations

(b) Cracked and delaminated concrete

(c) Peeled-off paint, cracked and delaminated concrete

(d) Flaked paint, dampness, corrosion stains and cracks

(e) Spalled concrete and exposed corroded rebars

**Figure 3 Visual distresses on the roof slabs in the basement**

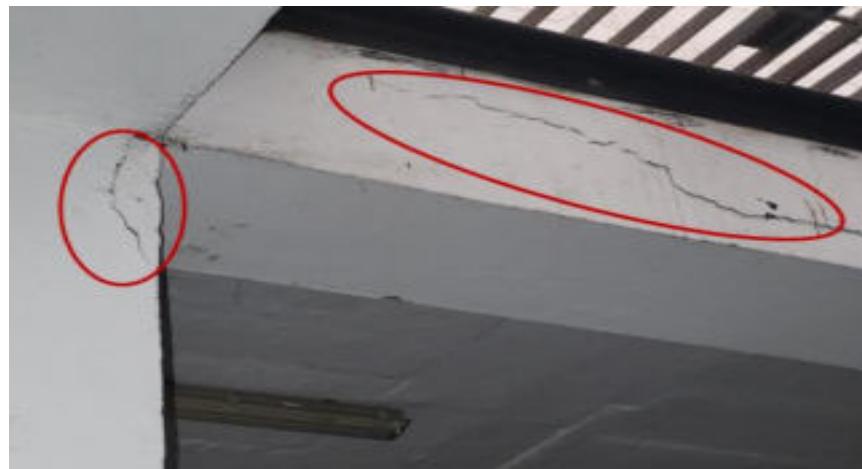
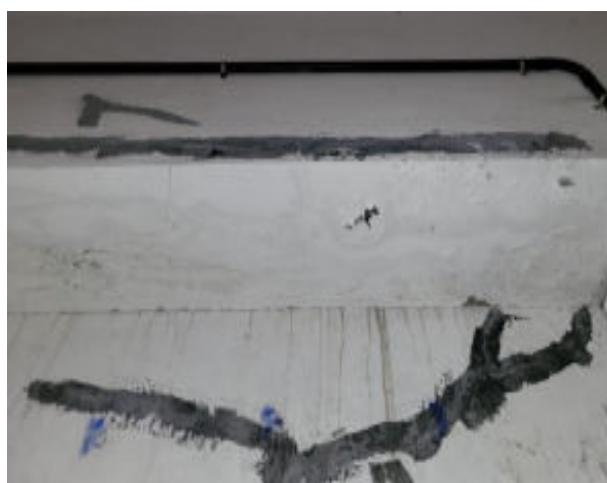
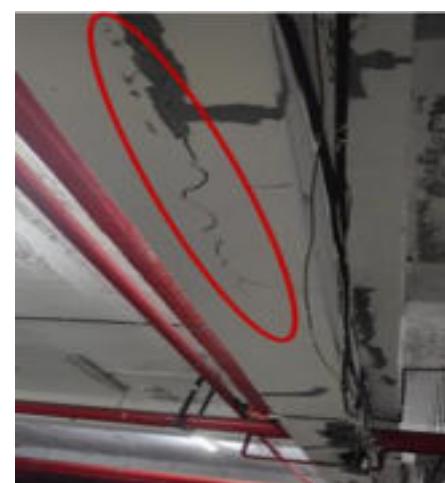
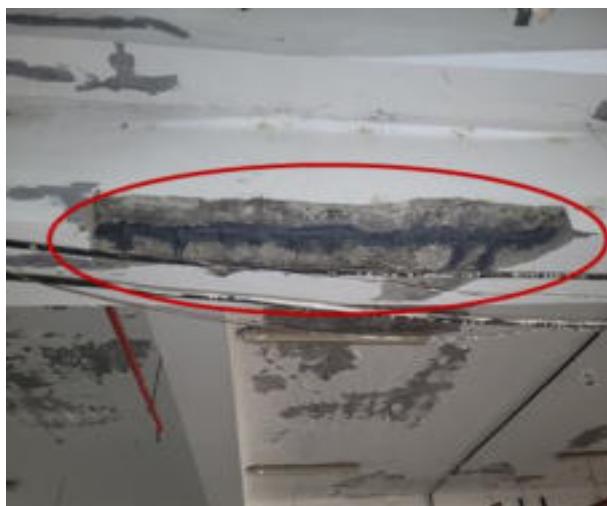
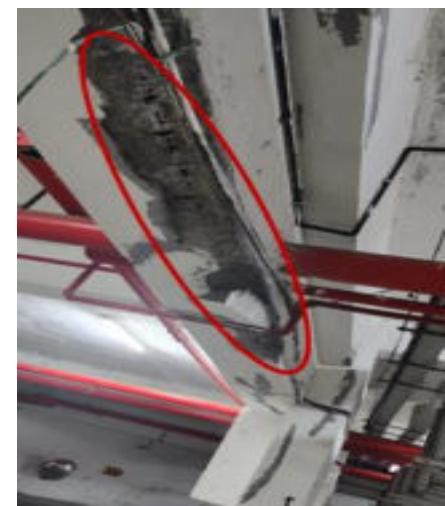
- 3.2 Columns, shear walls, and beams in the basement were found to be severely corroded causing extensive cracking and spalling of concrete (see Figure 4 and Figure 5). Most of the corbels have also suffered significant damage and it was found that multiple patch repairs were done, see Figure 6. In several long-span and deep beams, metal pipes (red-painted; for fire-fighting system) pass through the bottom portions of beams, the consequences of which must be checked by a structural consultant (see Figure 7).

(a) Cracks in the beam-column joint and side face of a beam

(b) Cosmetic repair of cracks

(c) Cracks reappeared in patch-repaired region in beam

(d) Spalled concrete and cement paste applied over rebar to cover up corrosion of rebar

(e) Spalled concrete in beam and patch repairs

**Figure 4 Visual distresses and patch repairs done in the basement**

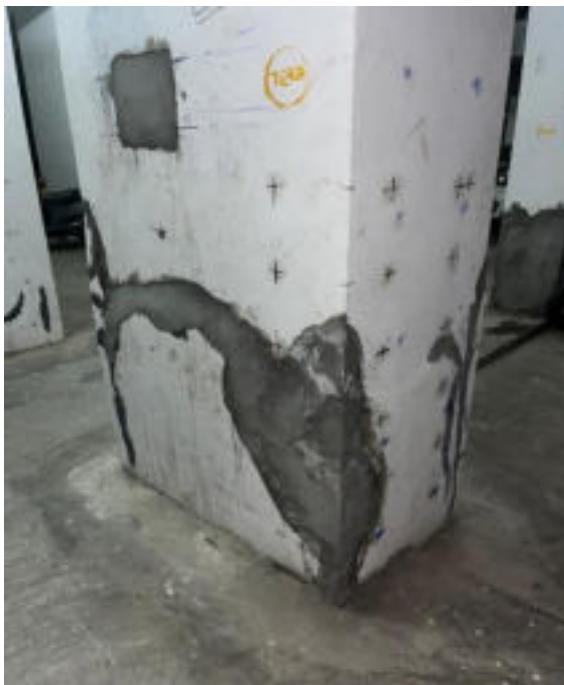
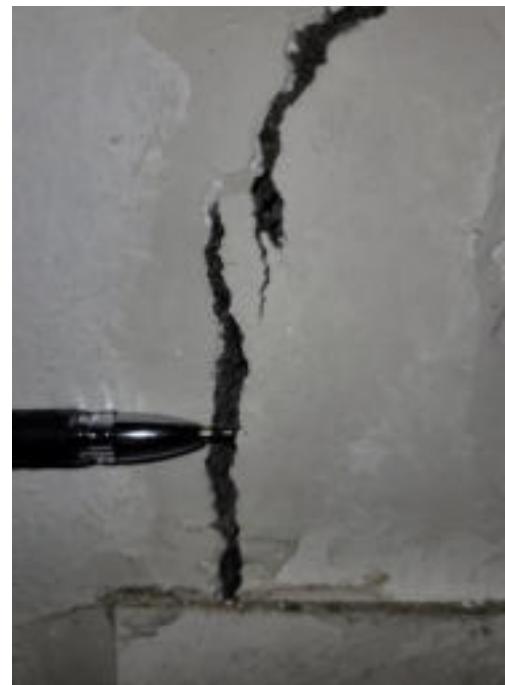
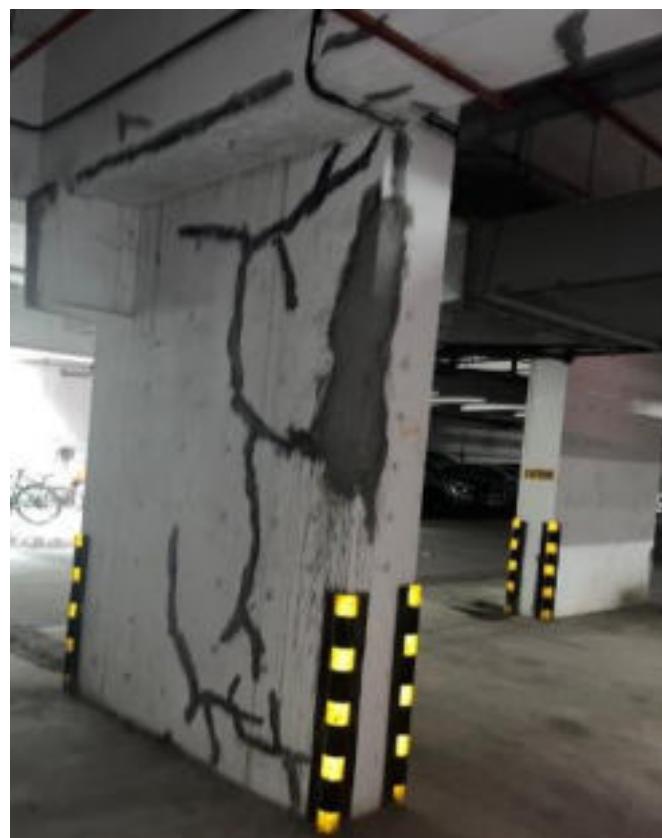
(a) Cosmetic repair of spalled region

(b) Wide crack

(c) Cosmetic repair of cracks and spalled region

**Figure 5 Wide cracks and patch repairs done in shear walls in the basement**

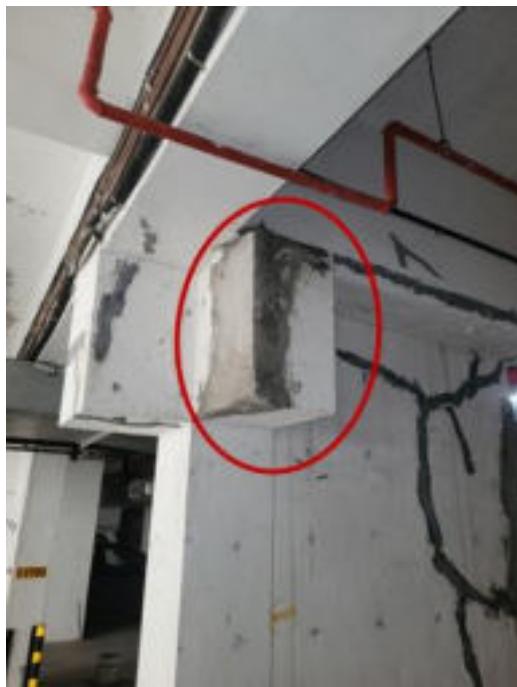
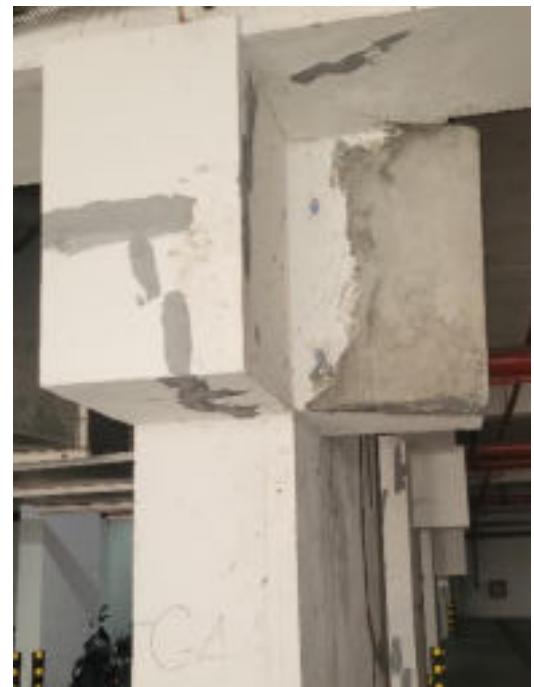
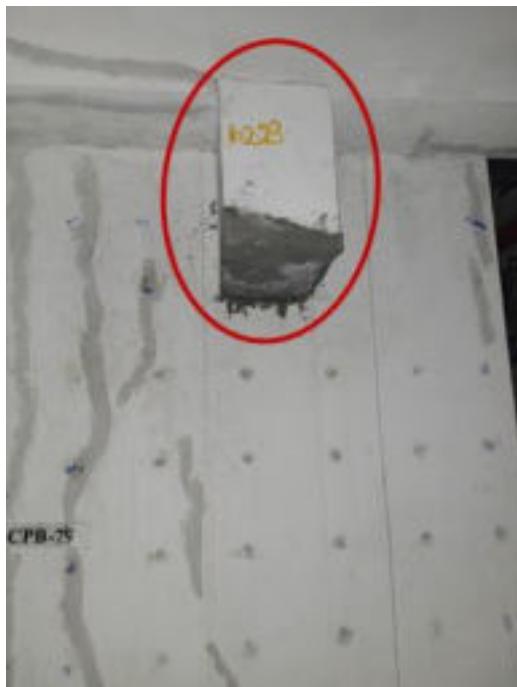
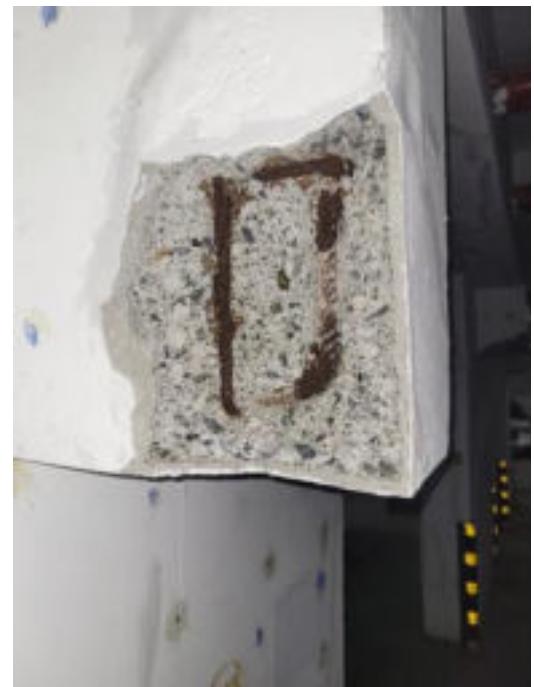
(g) Cosmetic repair of spalled region and cracks

(h) Cosmetic repair of spalled region and cracks

(i) Cosmetic repair of spalled region in corbel and cracks in shear wall and beam

(j) Spalled concrete and exposed corroded rebars

**Figure 6 Patch repairs and exposed corroded rebars in corbels in the basement**

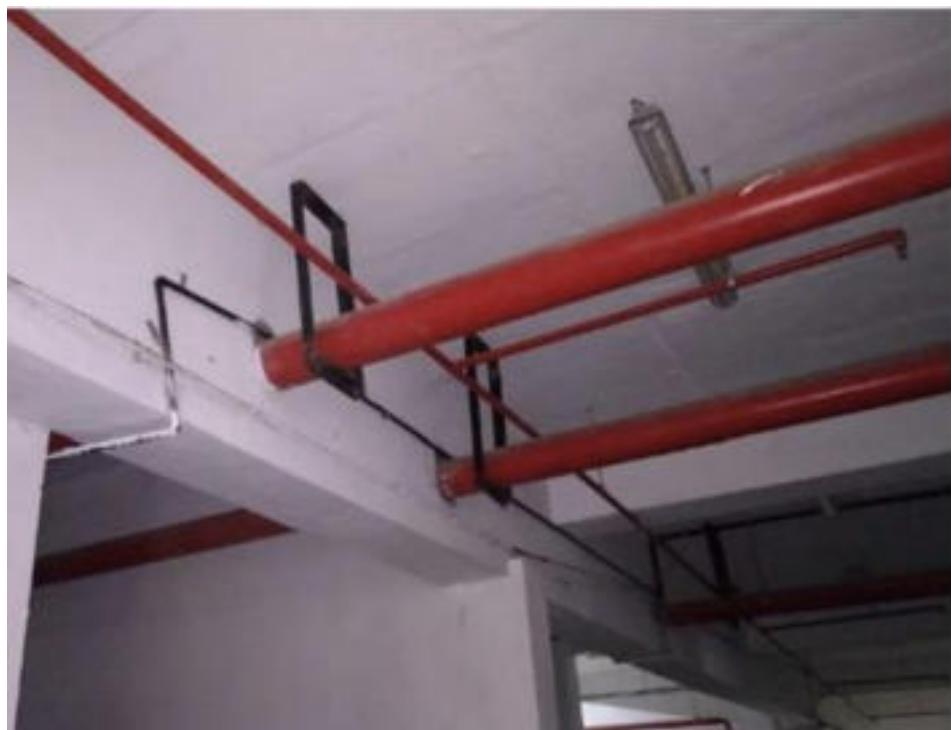
**Figure 7 Fire-fighting system pipes passing through the beams**

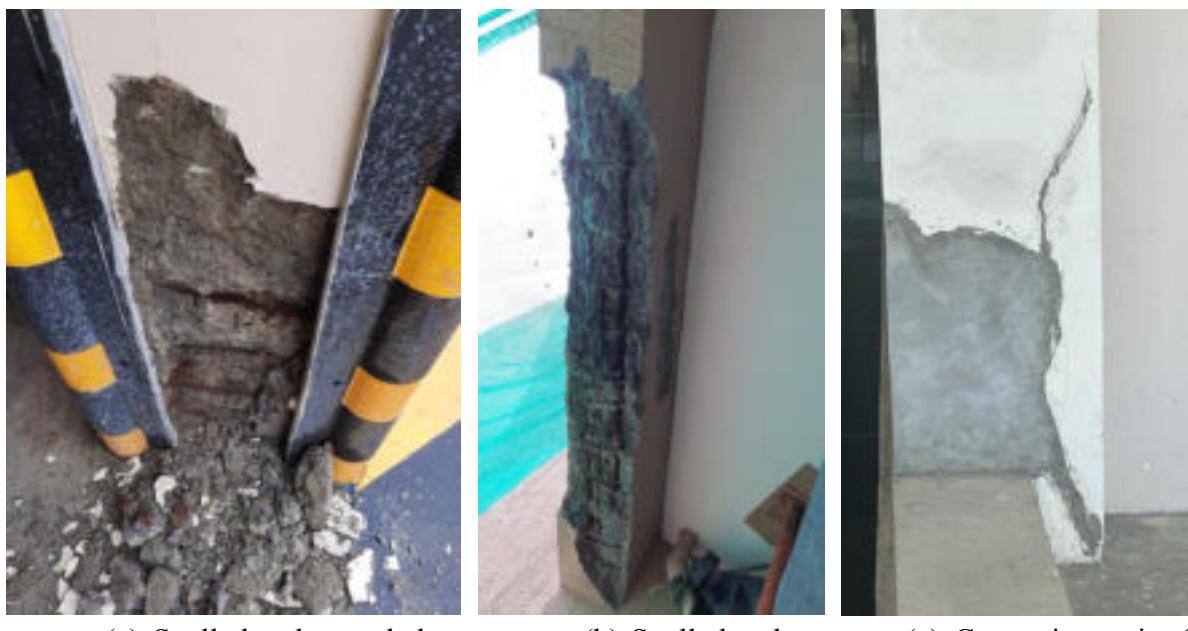
- 3.3 Columns, shear walls, and beams in the intermediate floors of the building have significantly deteriorated due to steel corrosion, see Figure 8, Figure 9 and Figure 10. Multiple patch repairs at various locations on the elements were also observed during the multiple visual inspections since 2020.

(a) Spalled and corroded rebars

(b) Spalled and exposed corroded rebars

(c) Cosmetic repair of spalled region

**Figure 8 Visual distresses and patch repairs in columns located in various floors**

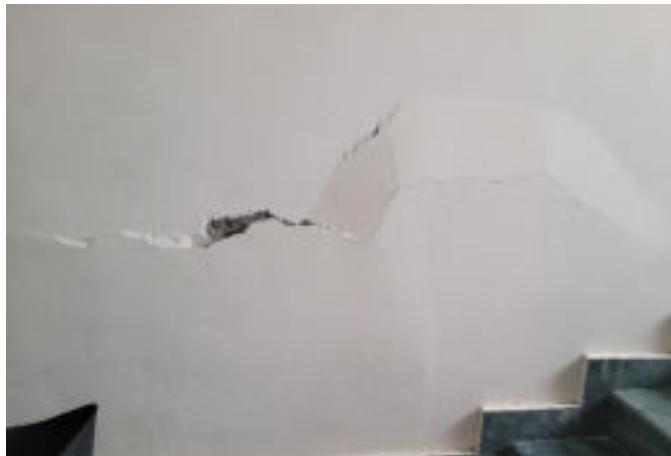
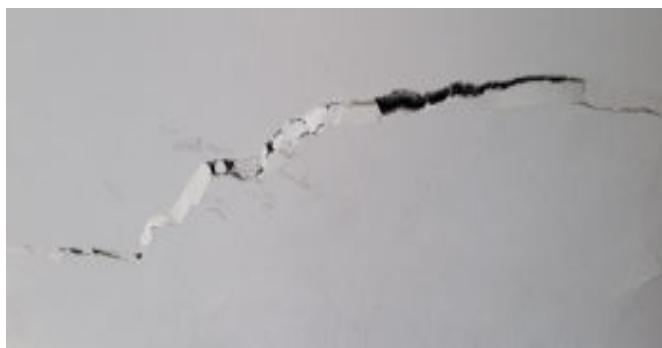
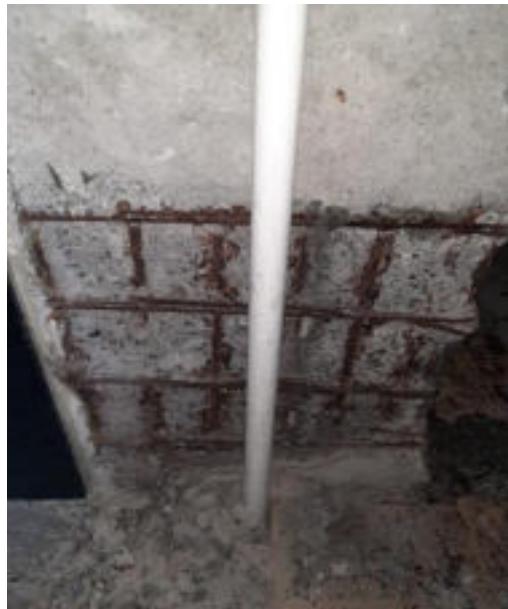
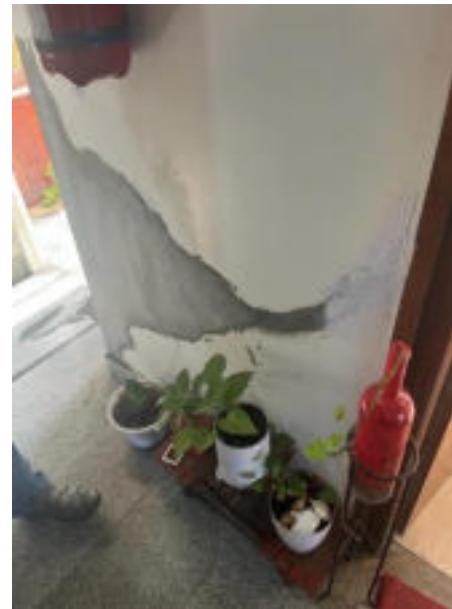
(a) Cracked, delaminated and spalled concrete

(b) Cracked, spalled concrete with cosmetic repair

(c) Cracked and delaminated concrete

(d) Wide longitudinal crack in concrete

(e) Spalled and severely corroded rebars

(f) Cosmetic repair of spalled region

**Figure 9 Visual distresses and patch-repairs in shear walls located in various floors**

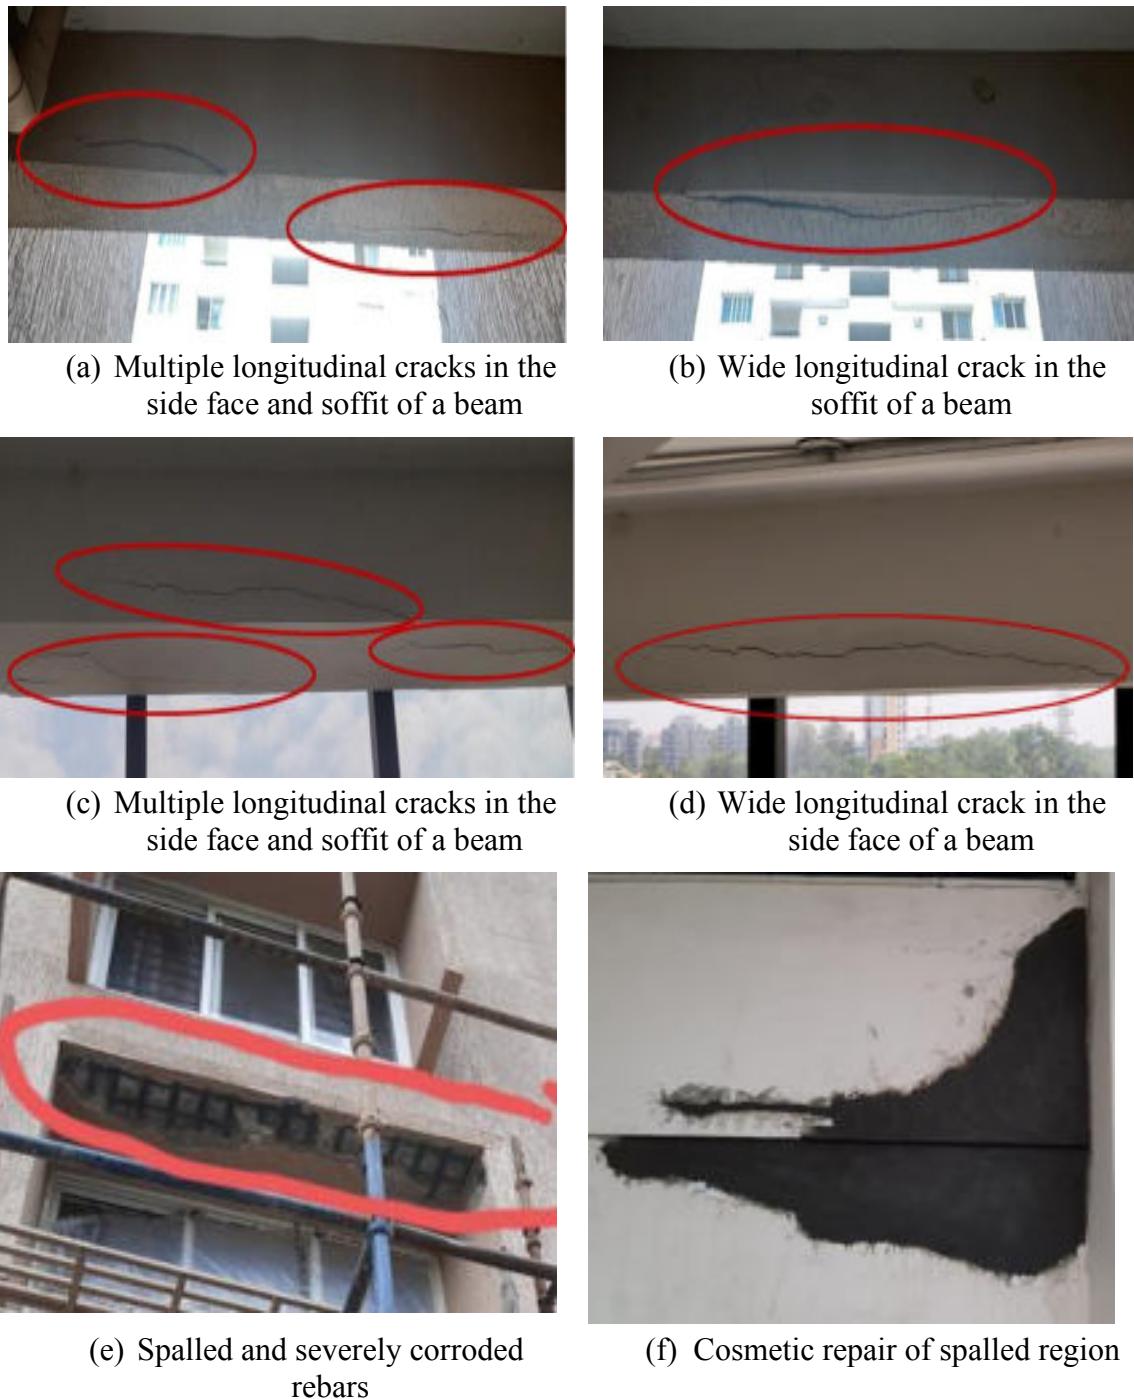
**Figure 10 Visual distresses and patch repair in beams located in various floors**

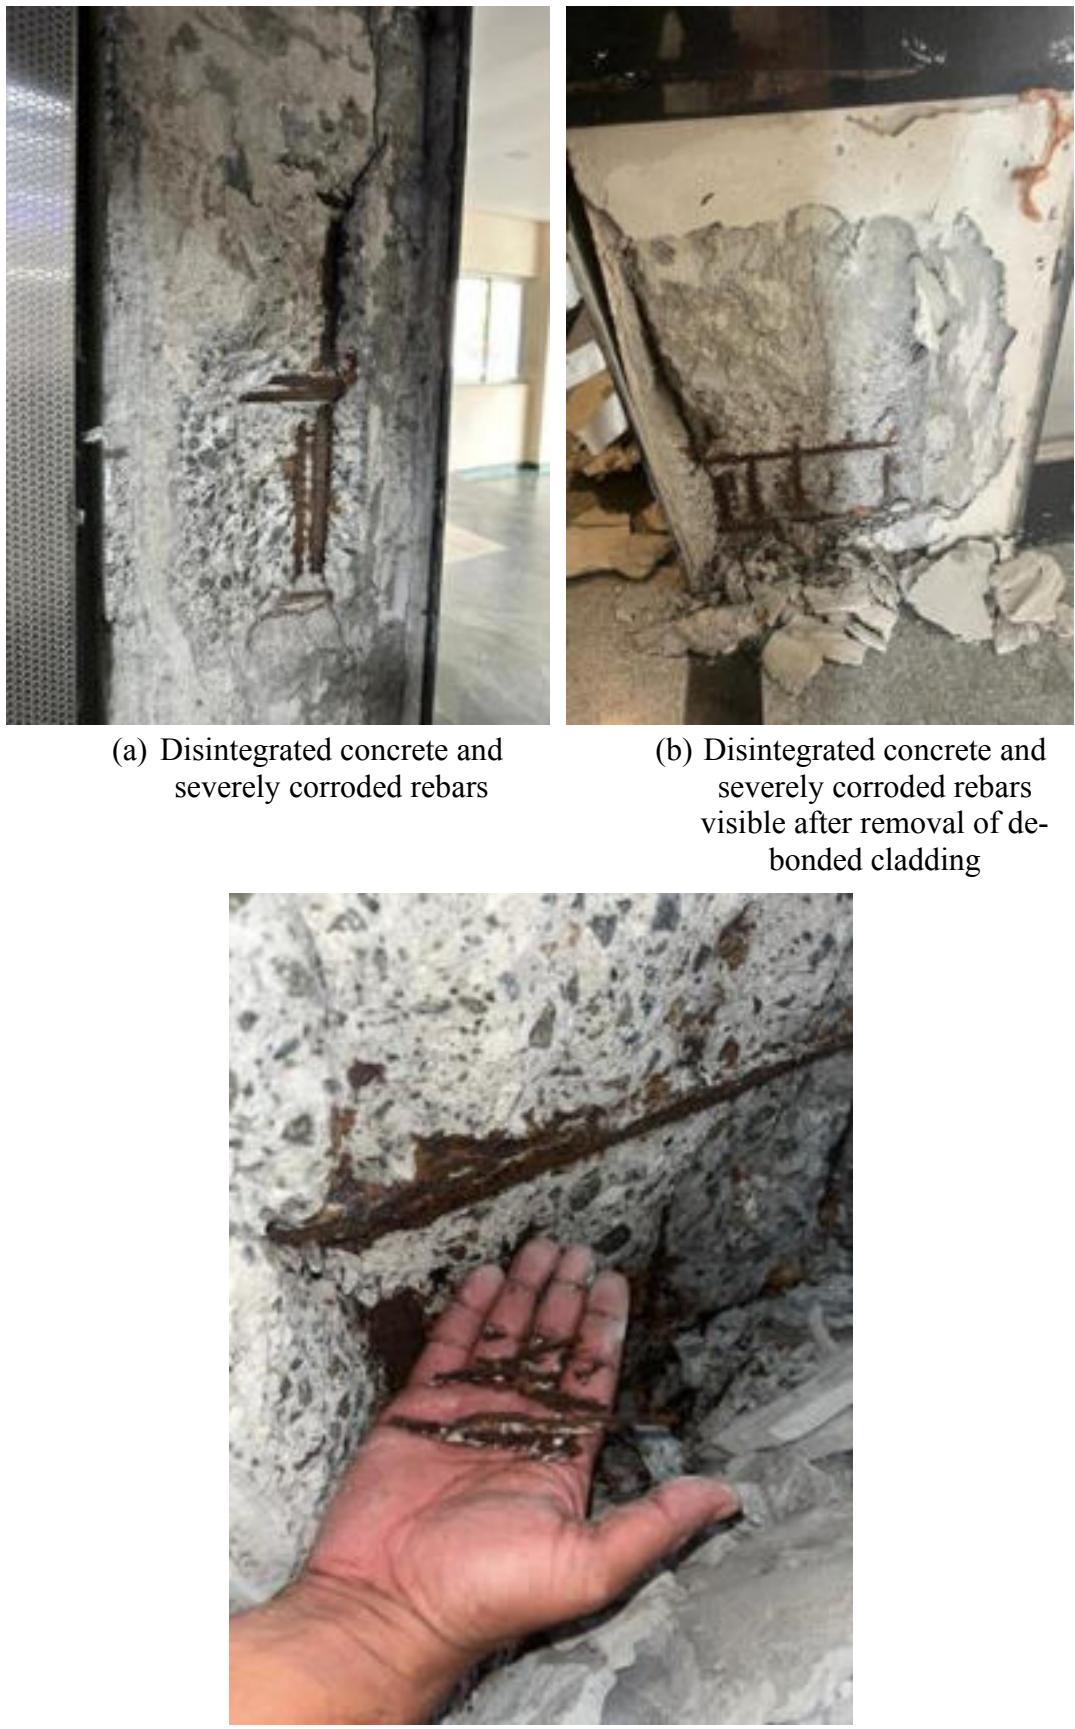
(c) Severely corroded rebars with significant cross-section loss

**Figure 11 Distresses in shear walls near the elevators**

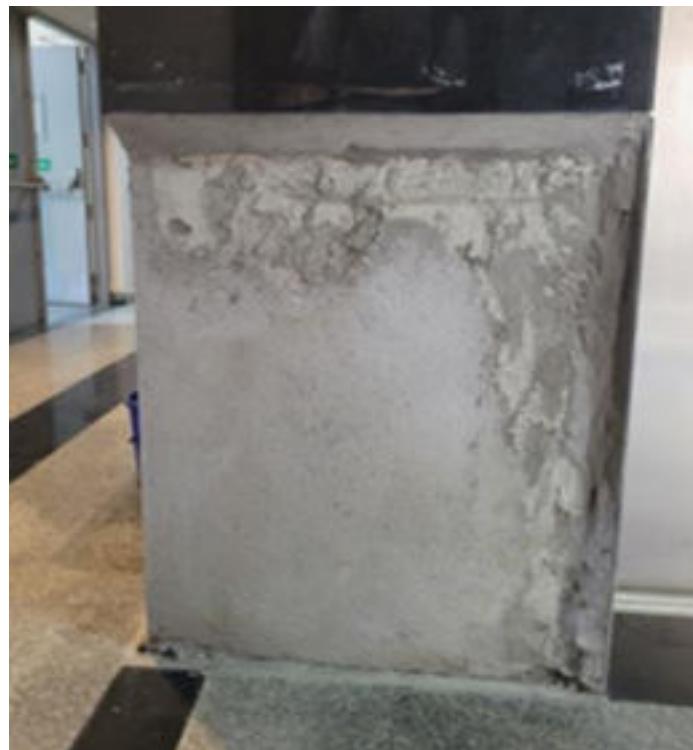
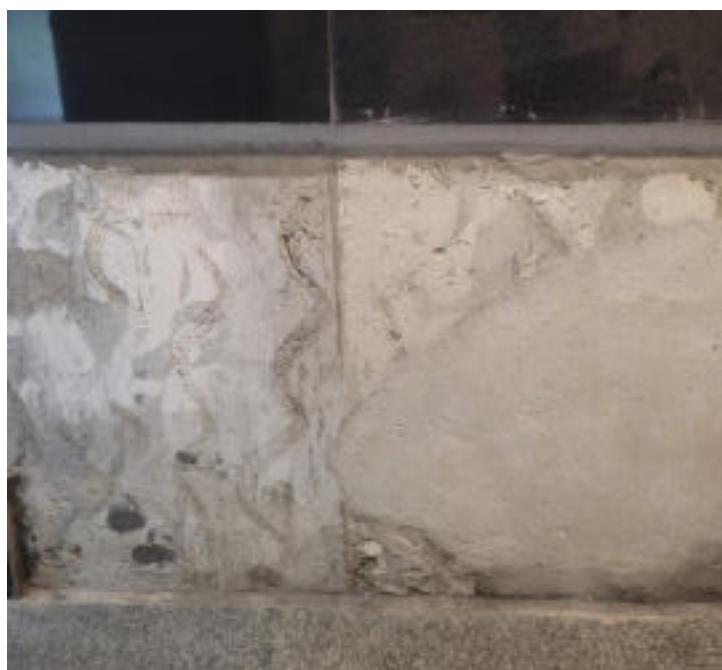
- 3.4 De-bonding of heavy granite panels/wall claddings on the shear walls near the lifts/elevators was observed in all the floors. This is a severe falling hazard and a serious safety concern. This poses high risk to the users, as all the occupants would wait and/or pass below these granite panels. As shown in Figure 13 & Figure 14, it is surprising to see that numerous of these heavy granite panels are affixed with duct-tape, which is not adequate to safely carry their weight and hold them in place, if fully de-bonded. Figure 11 Severely corroded rebars, loose concrete and inadequate filling of mortar between the cladding and the walls were seen upon removal of the claddings (See Figure 11). It was found that the damaged regions in the shear walls were inappropriately patch repaired at multiple locations near the elevators (See Figure 12).

(a) Cosmetic repair of spalled region of the shear wall near elevator

(b) Cosmetic repair of spalled region

**Figure 12 Inappropriate patch repair of damaged region in shear walls near the elevators (this should not have been done this way)**

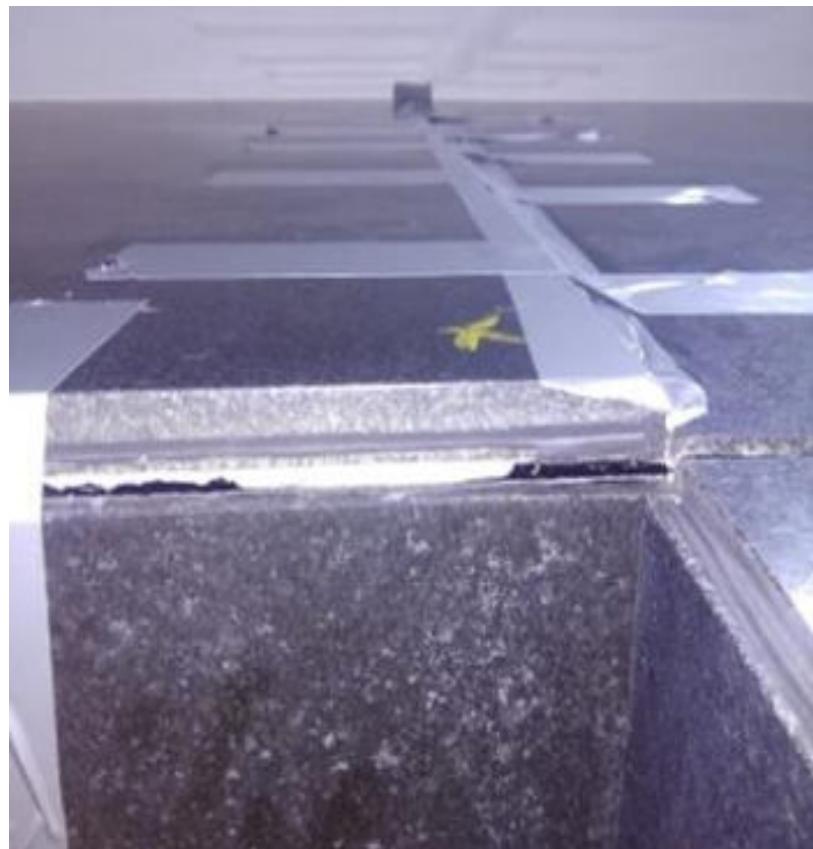
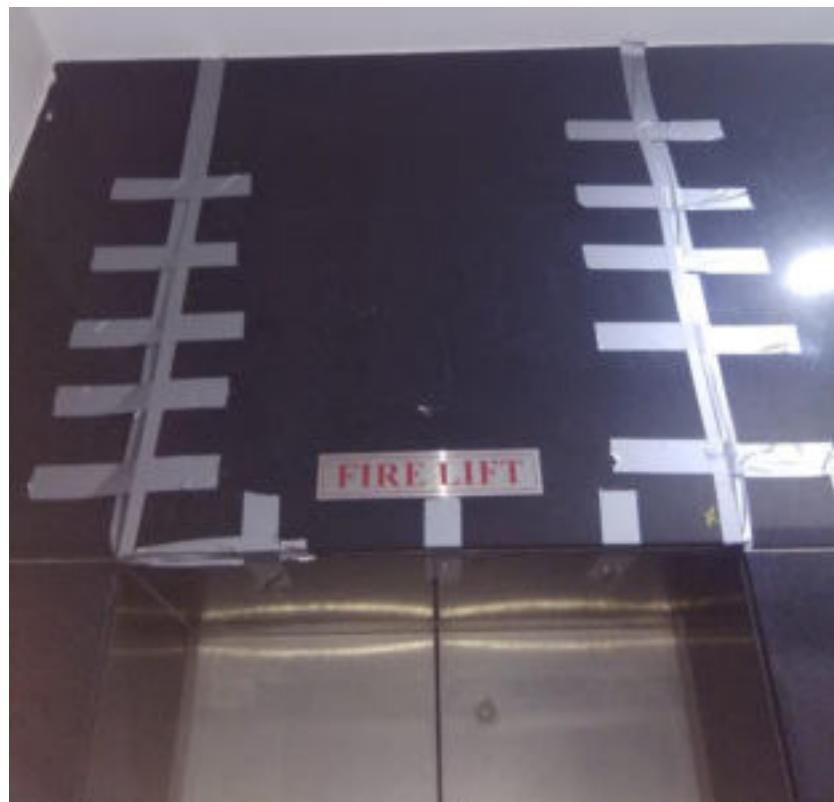
(c) De-bonded granite cladding hanging dangerously above lift door (looking upward)

(d) De-bonded granite cladding inadequately held using tape

**Figure 13 De-bonded claddings of shear walls near the elevators temporarily fixed using duct-tape (severe falling hazard)**

- (a) **Immediate removal of all the partially de-bonded vertical granite panels above the elevator doors and all loose concrete from the staircase elements.** These are severe falling hazards and a serious threat to the lives of the users, even during the proposed evacuation.
- (b) **Immediate evacuation of all the residents from Towers B and C.**
- (c) **Immediate removal of all the remaining partially de-bonded vertical granite panels around the elevators.**

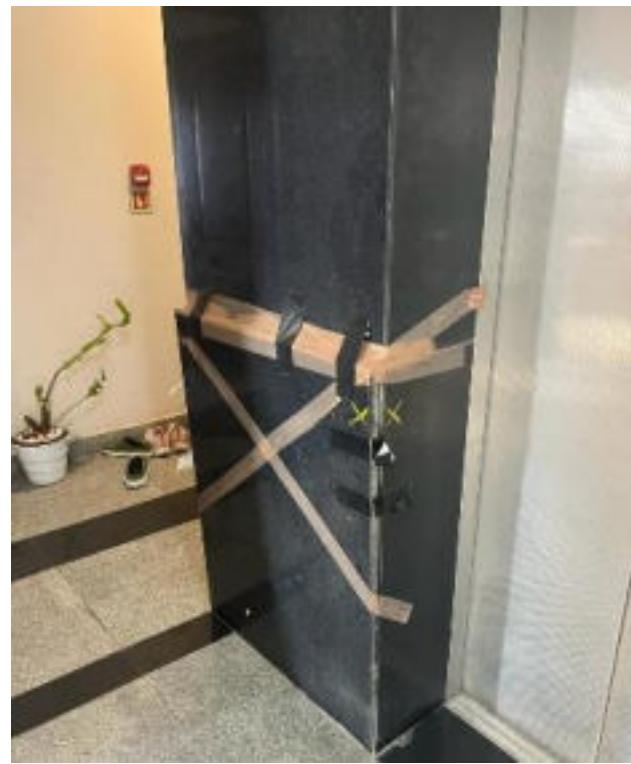
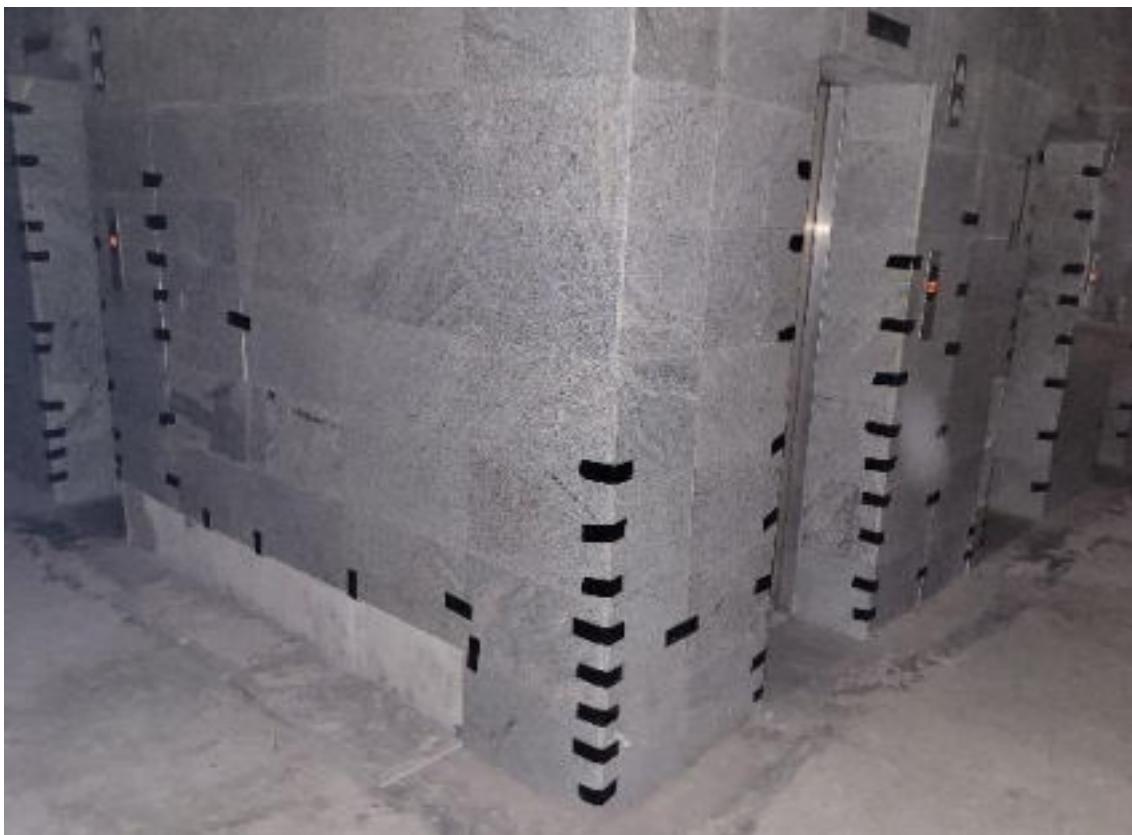
(a) De-bonded cladding inadequately held using tape

(b) De-bonded cladding inadequately held using tape around the entire elevator area in the basement

**Figure 14 De-bonded claddings of shear walls near the elevators temporarily fixed using duct-tape (severe falling hazard)**

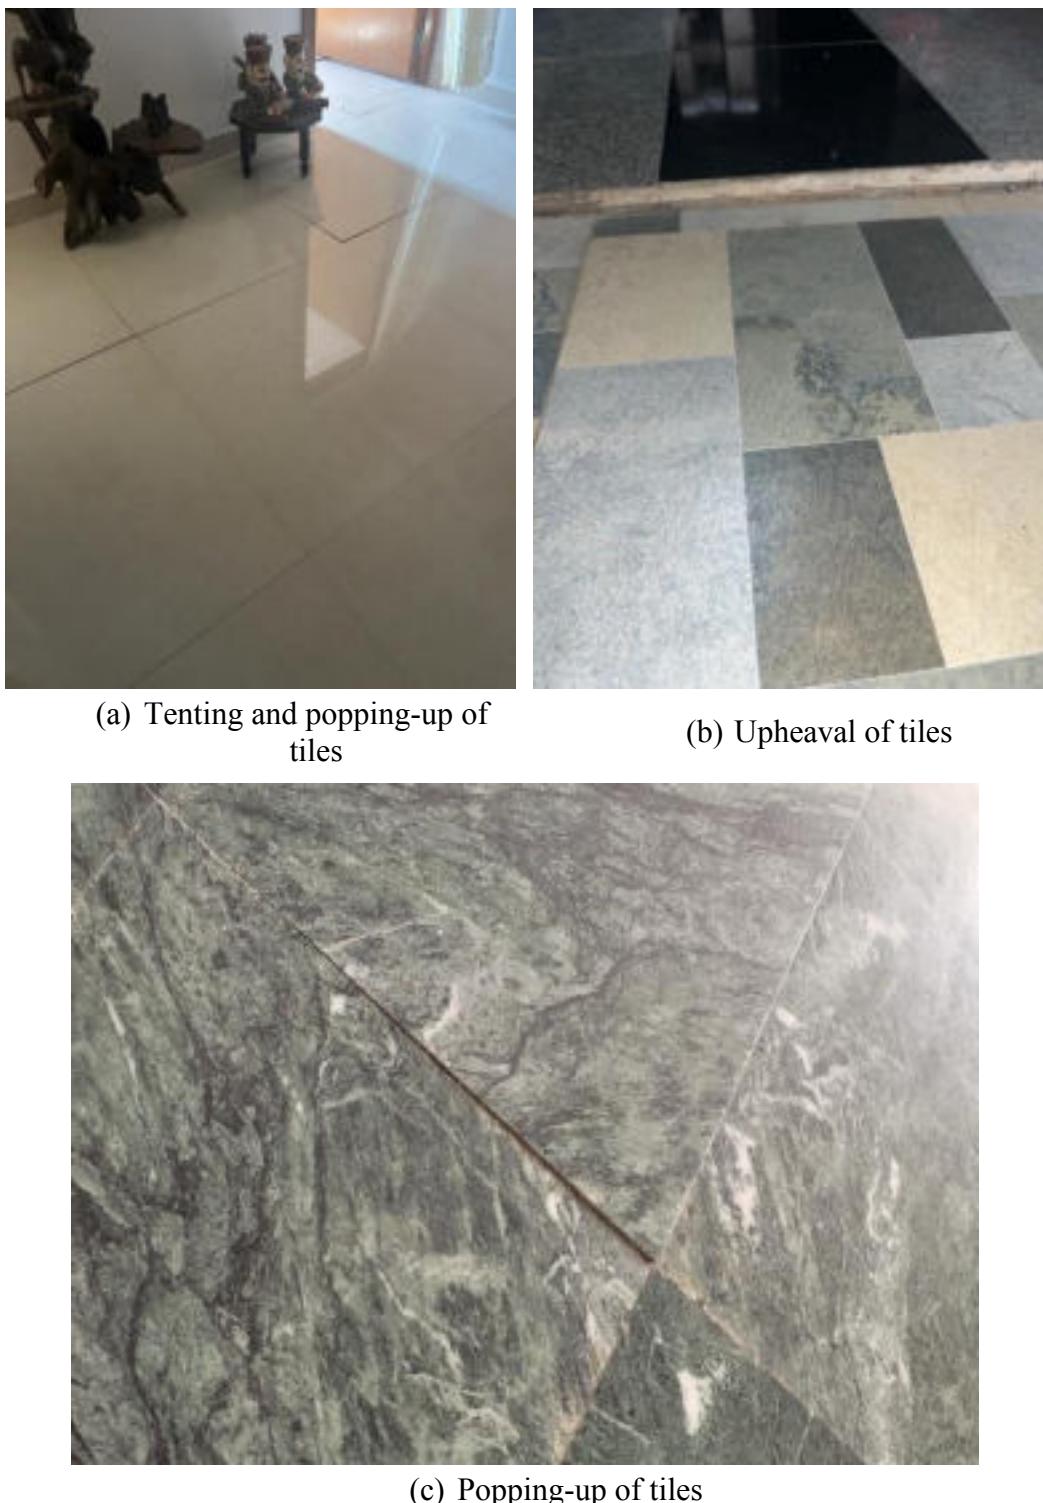
- 3.5 Tenting, popping-up and cracking of floor tiles (see Figure 15) because of corrosion of the underlying concrete slabs were observed at several locations. Upon removal of floor tiles at random locations, it was seen that many steel reinforcement have severely corroded with significant cross-sectional area loss, see Figure 16.

**Figure 15 Tenting and popping-up of floor tiles in various floors**

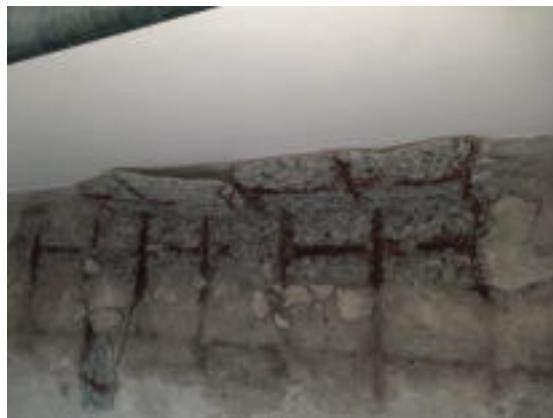
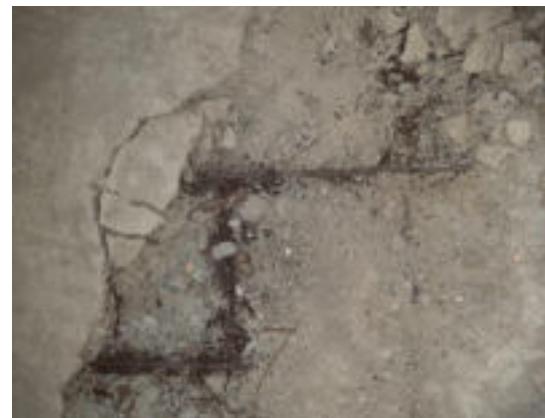
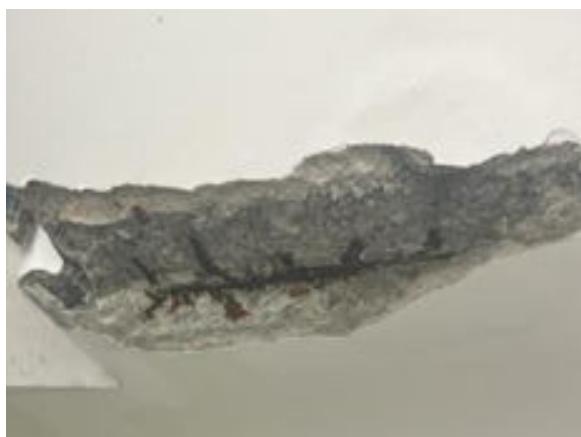
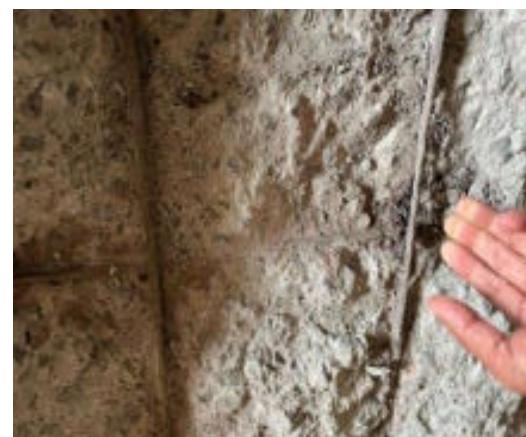
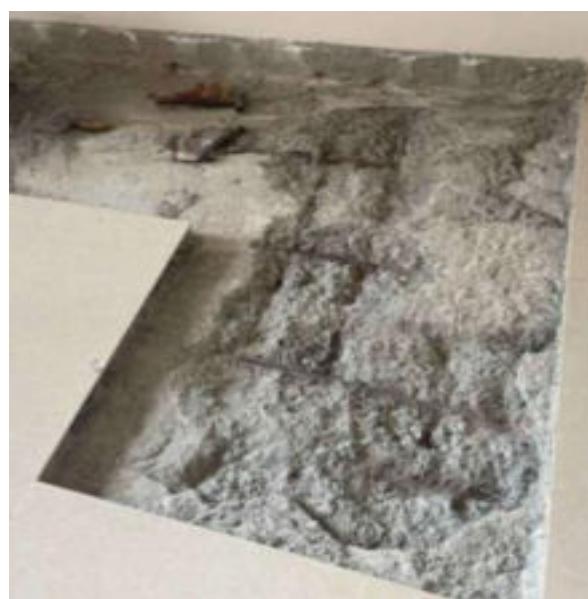
(a) Severely corroded rebars

(b) Disintegrated concrete and severely corroded rebars

(c) Spalled concrete and exposed corroded rebars

(d) Disintegrated concrete and corroded rebars with significant cross-section loss

(e) Disintegrated concrete and severely corroded rebars

**Figure 16 Deteriorated concrete and heavily corroded rebars visible upon removal of tiles**
