**Structural Condition of Chander Kunj Army Towers (CKAT) at**

**Silver Sand Island, Vytilla, Kochi**

**(IITM Report-4)**

**Prof. Radhakrishna G. Pillai**

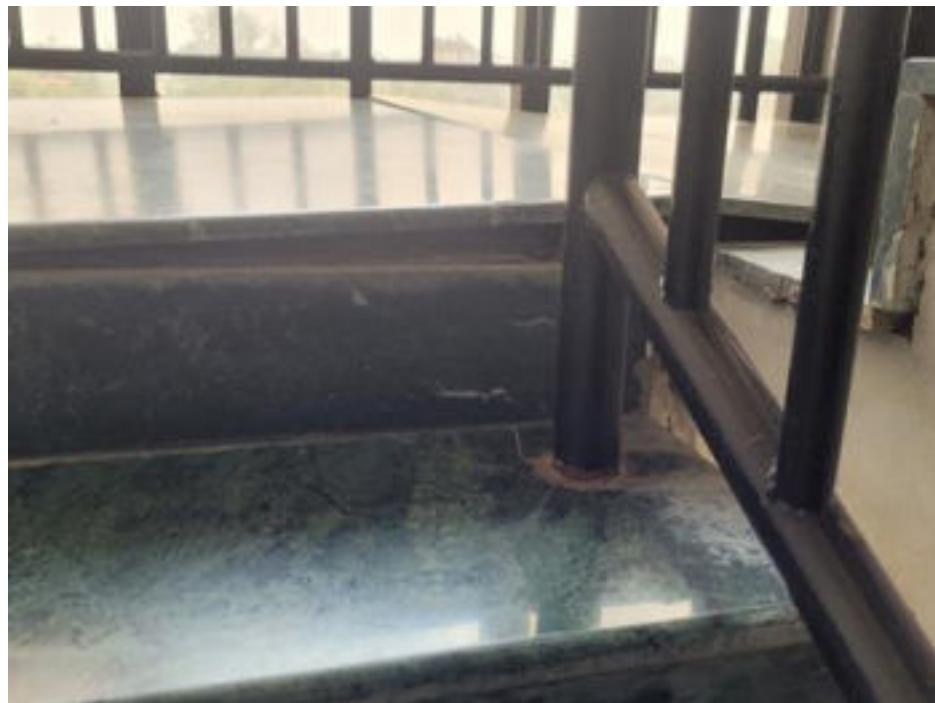
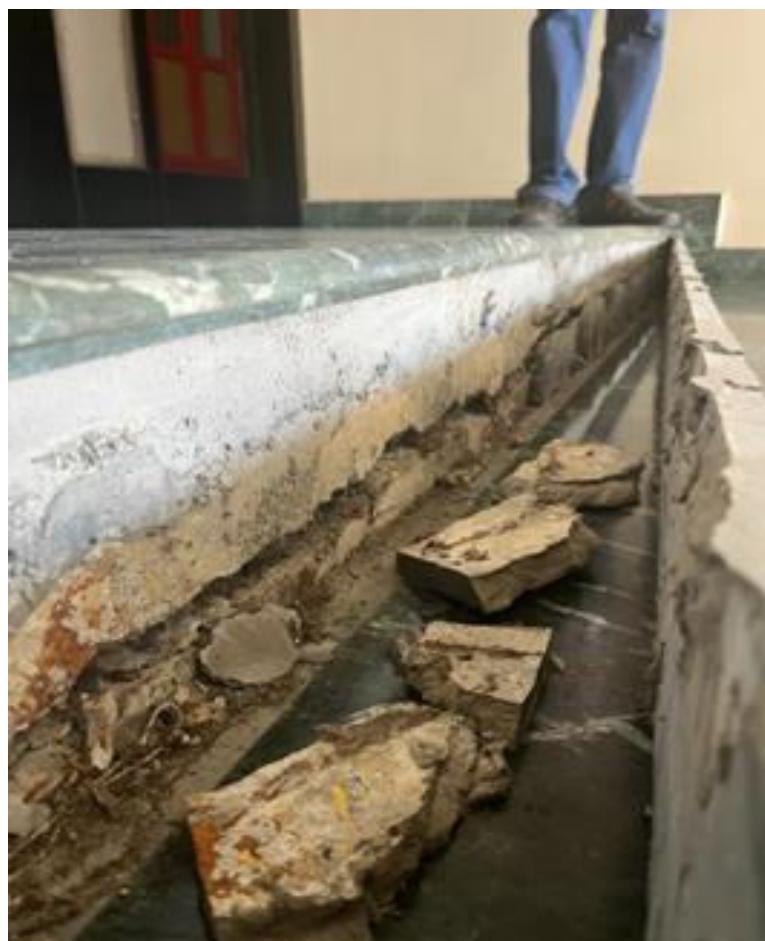
- 3.6 Tenting, popping-up and cracking of floor tiles in the landing of staircases was observed at various locations in multiple floors (see Figure 17). Also, extensive cracking and spalling of concrete were visible on the waist slab, landing beam & slab of staircases in most of the floors (see Figure 18). Further, cracks were observed in the

(a) Upheaval and tenting of tiles

(b) Disintegrated concrete and corrosion stains

**Figure 17 Tenting and popping-up and cracking of floor tiles in the mid-landing of staircases and ground floor stairs**

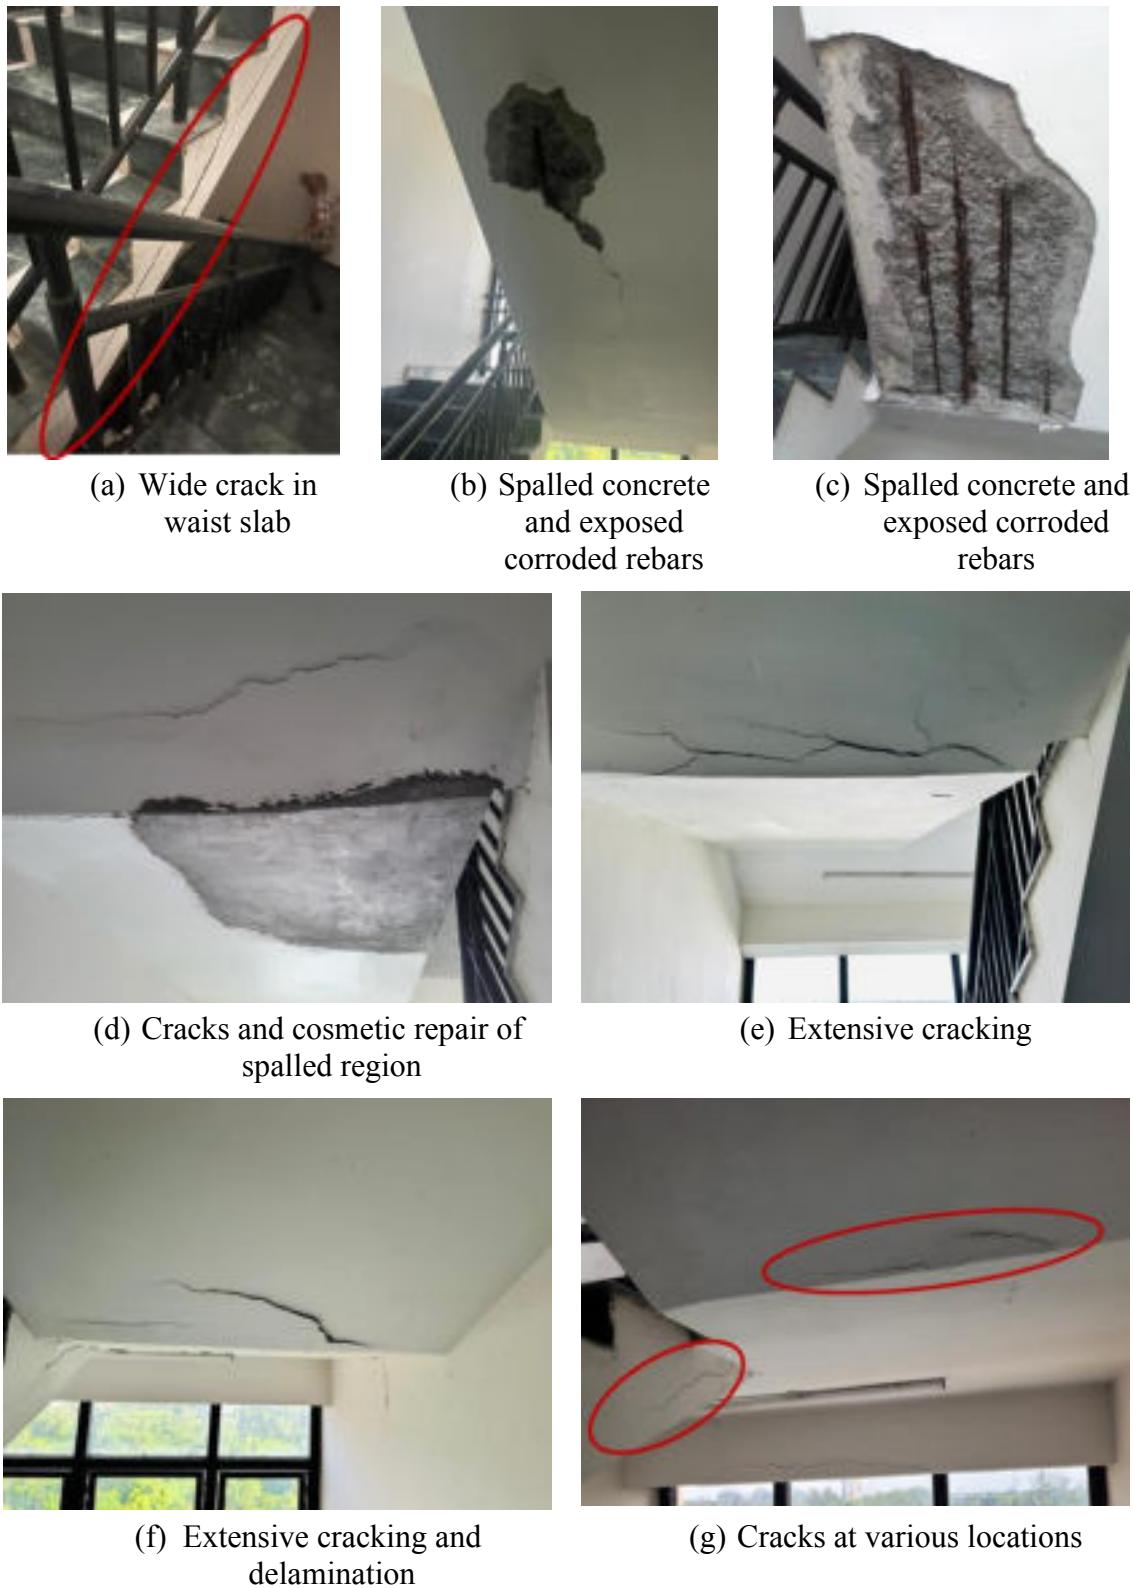
periphery of the patch-repaired regions of the waist slabs, indicating corrosion induced by the halo effect.

**Figure 18 Extensive cracking and spalling of concrete in staircases**

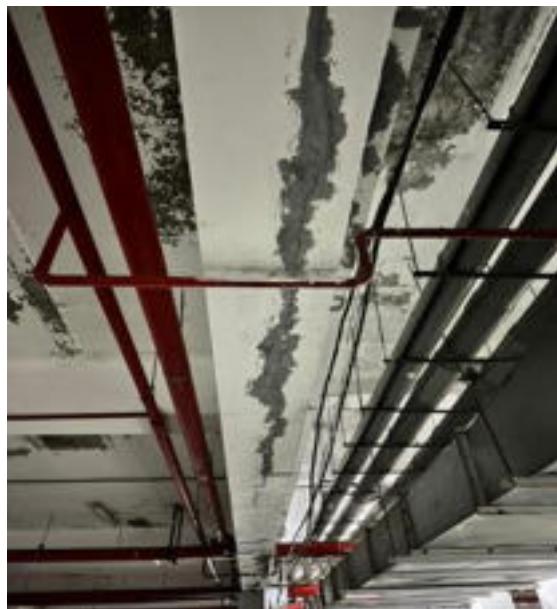
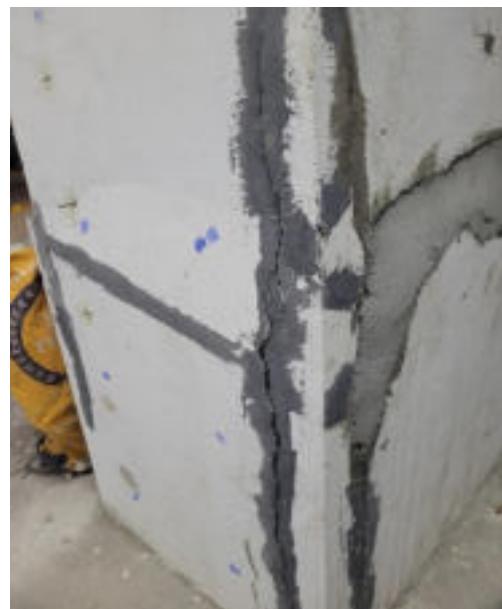
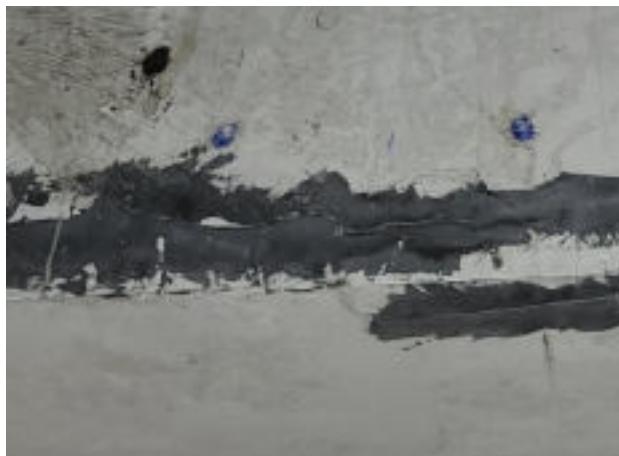
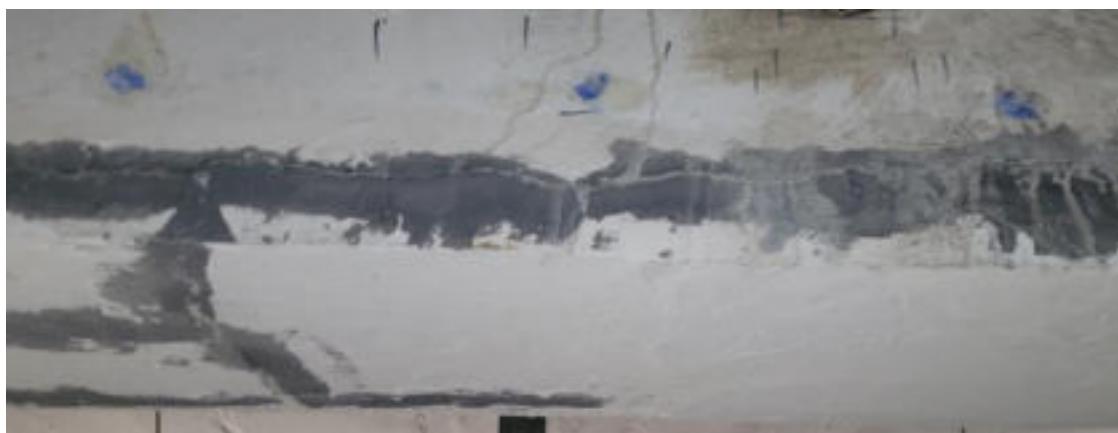
- 3.7 Repeated unscientific patch repairs to cover up the distress due to corrosion of rebars were observed at various locations on the numerous RC elements. The cracks were found to be repaired by placing filler materials/mortar without taking adequate measures to address the root cause and prevent halo effect. These patch-repairs are not durable and are failing within a few months (see Figure 19). Propagation of earlier cracks, formation of new cracks and repeated repairs associated with these indicate ongoing active corrosion and inadequate repair procedures. Patch-repairs without electrochemical treatments or undercutting cannot control corrosion due to the residual chloride effect and halo effect. The residual chloride effect is due to possible chlorides in the substrate concrete and inadequately cleaned rebars. surface/presence of rust and the halo effect is due to the pH difference between the repair and substrate concretes. Such repairs are not appropriate for ensuring long-term safety of the occupants.

(a) Cracks reappeared in patch-repaired beam

(b) Cracks reappeared in patch-repaired shear wall

(c) Cracks reappeared in patch-repaired beam

(d) Cracks reappeared in patch-repaired shear wall

(e) Cracks reappeared in patch-repaired beam

**Figure 19 Reoccurrence of cracks in already patch-repaired locations**

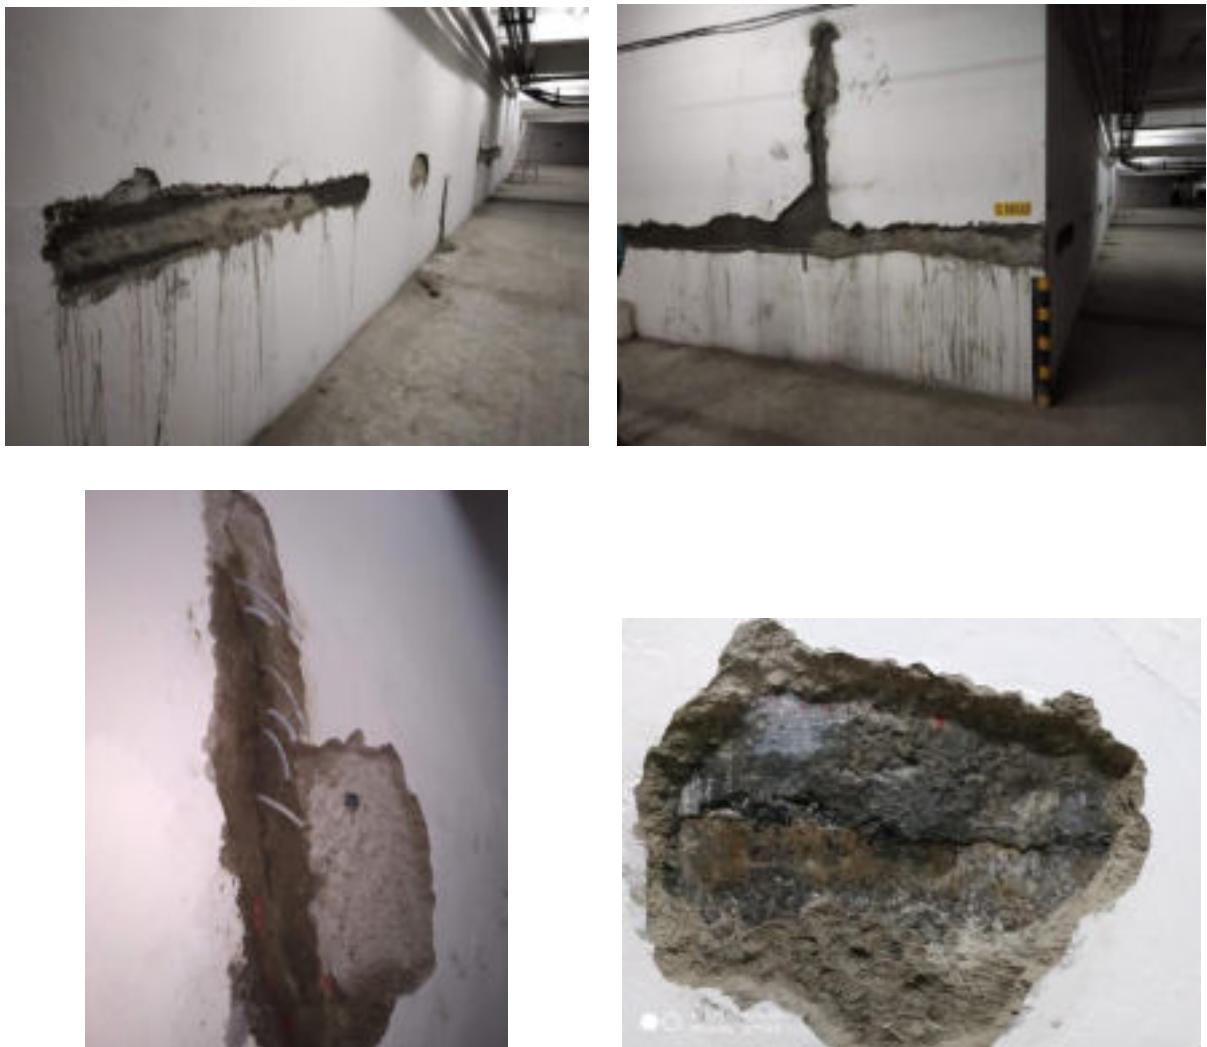
Figure 1. Repairing of the leaking portions in the basement

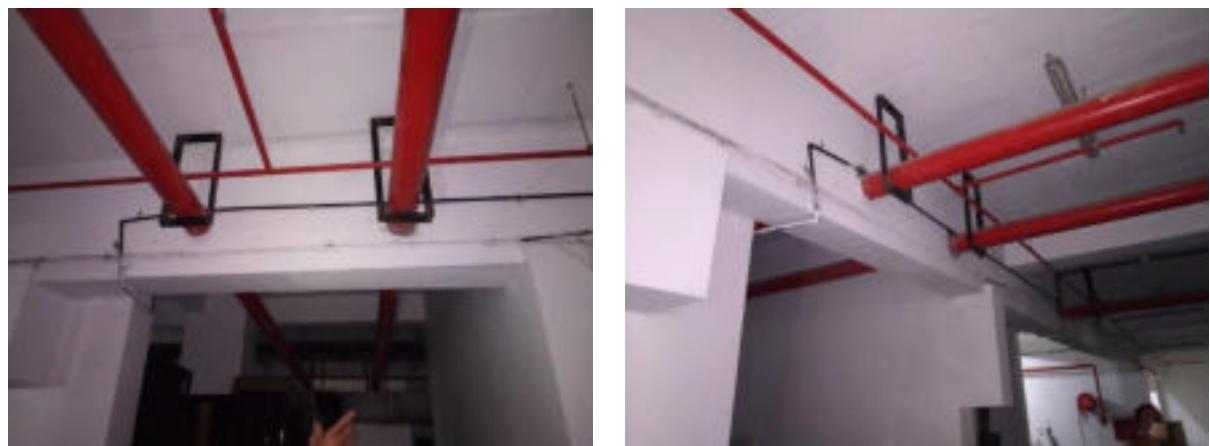
Figure 2. Improper cutting of the beams for fire pipes

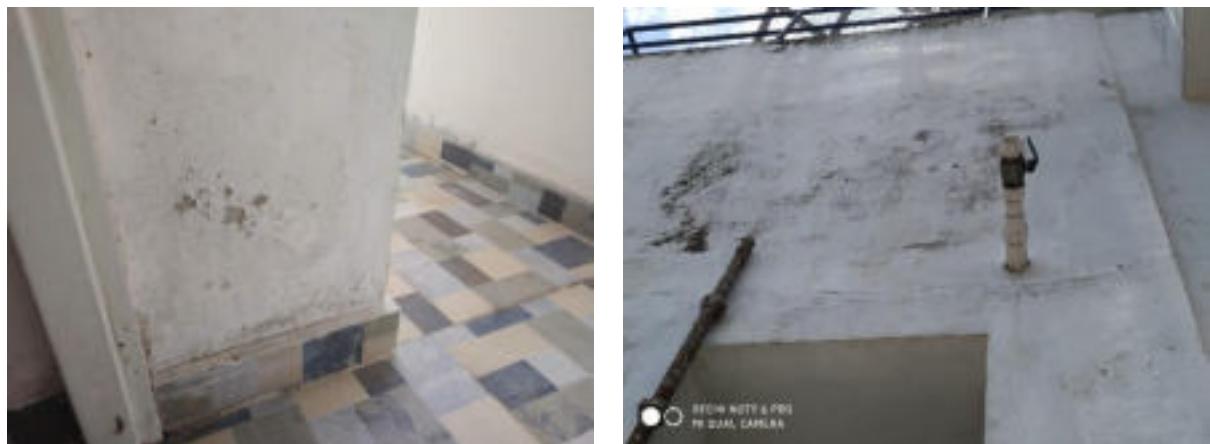
Figure 3. Dampness in the walls and water tank walls

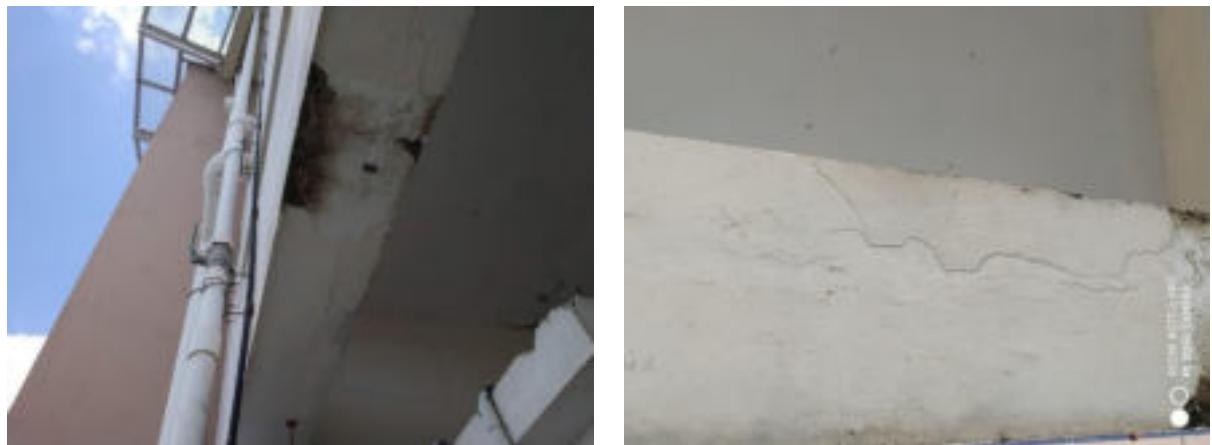
Figure 4. Cracks on the beams due to corrosion

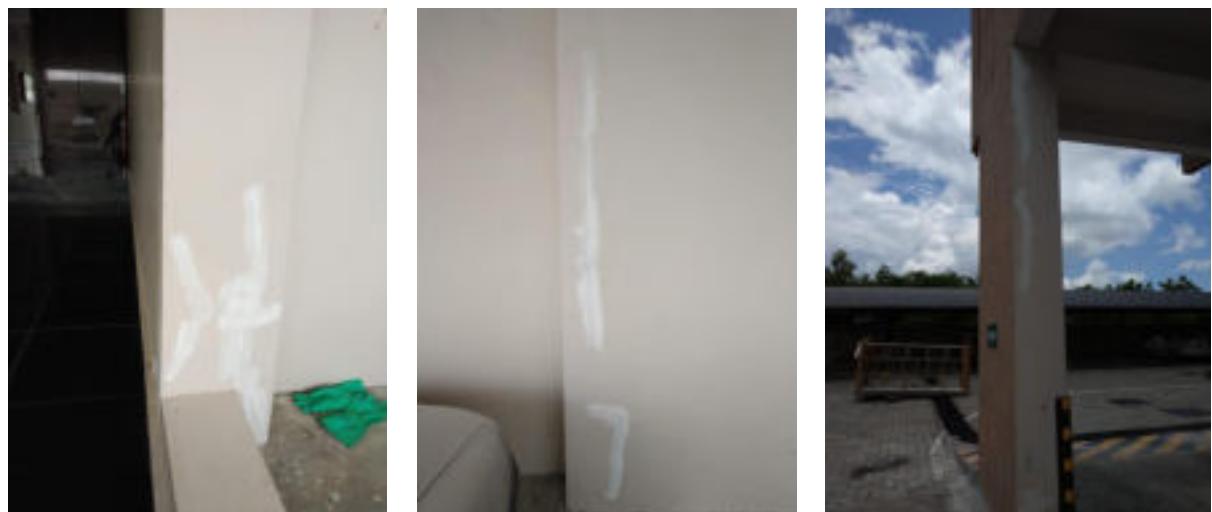
Figure 5. Improper repair of cracks in columns with filler material

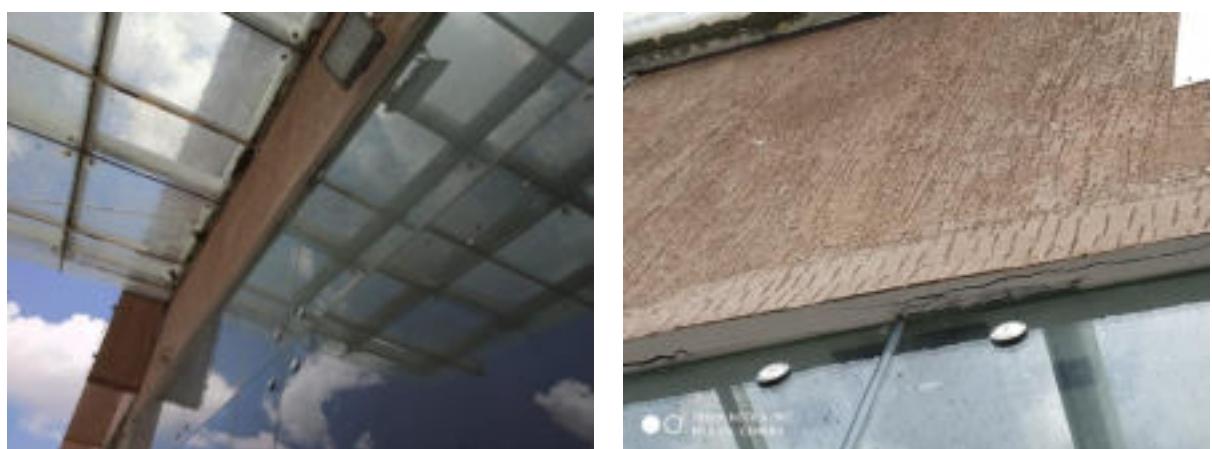
Figure 6. Reoccurrence of cracks in the already repaired beams

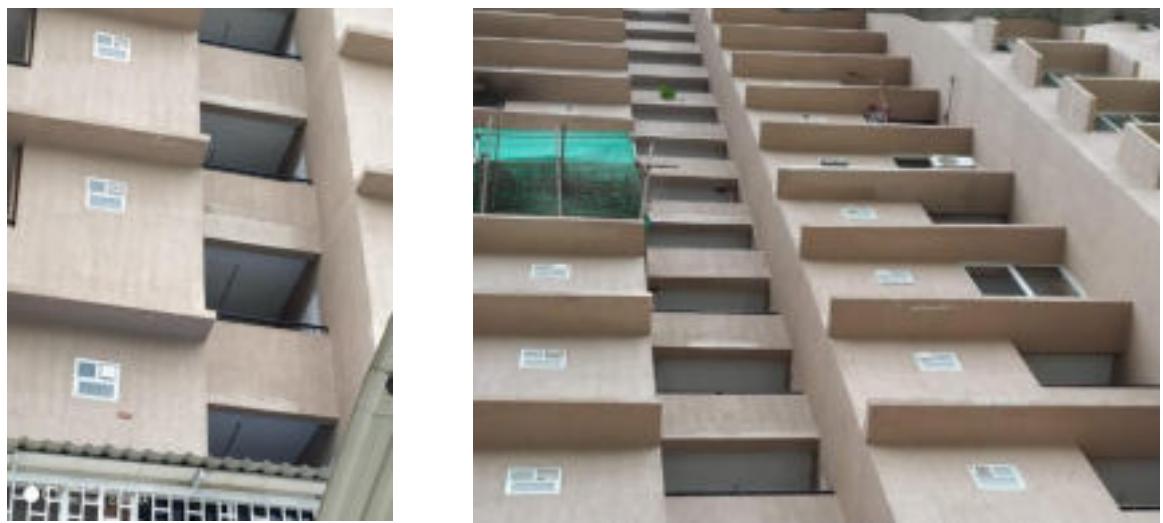
Figure 7. Rapaired beams on the balcony of almost every floor and many shades

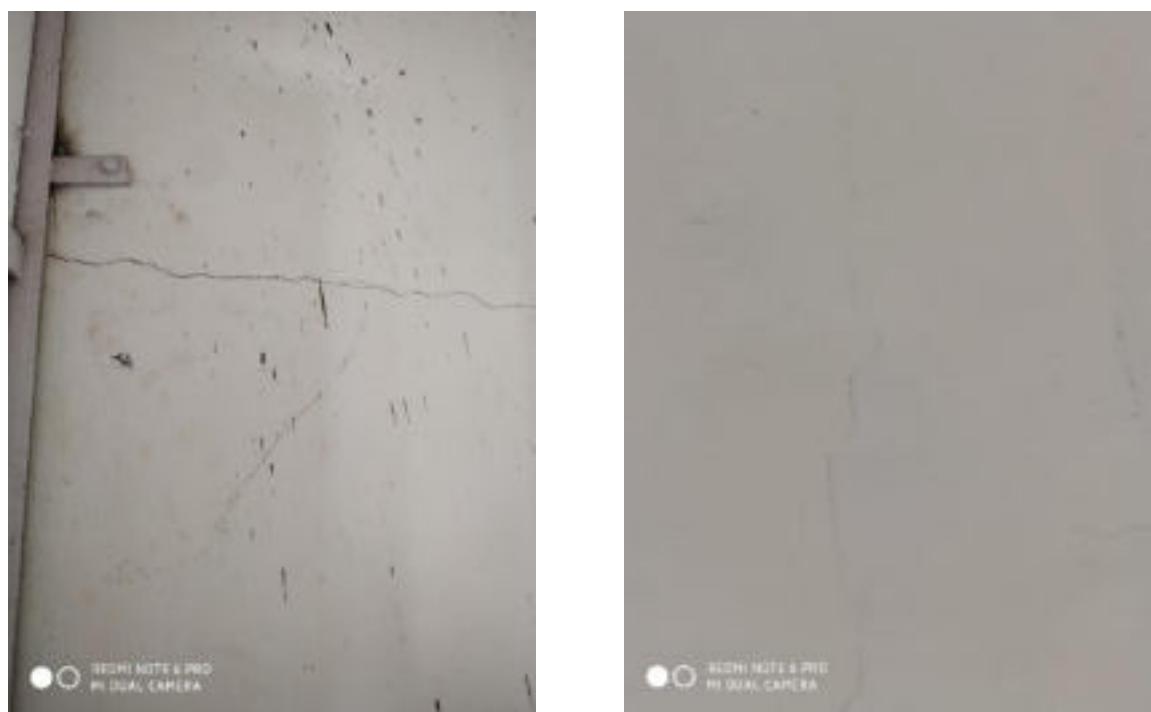
Figure 8. Cracks in structural elements

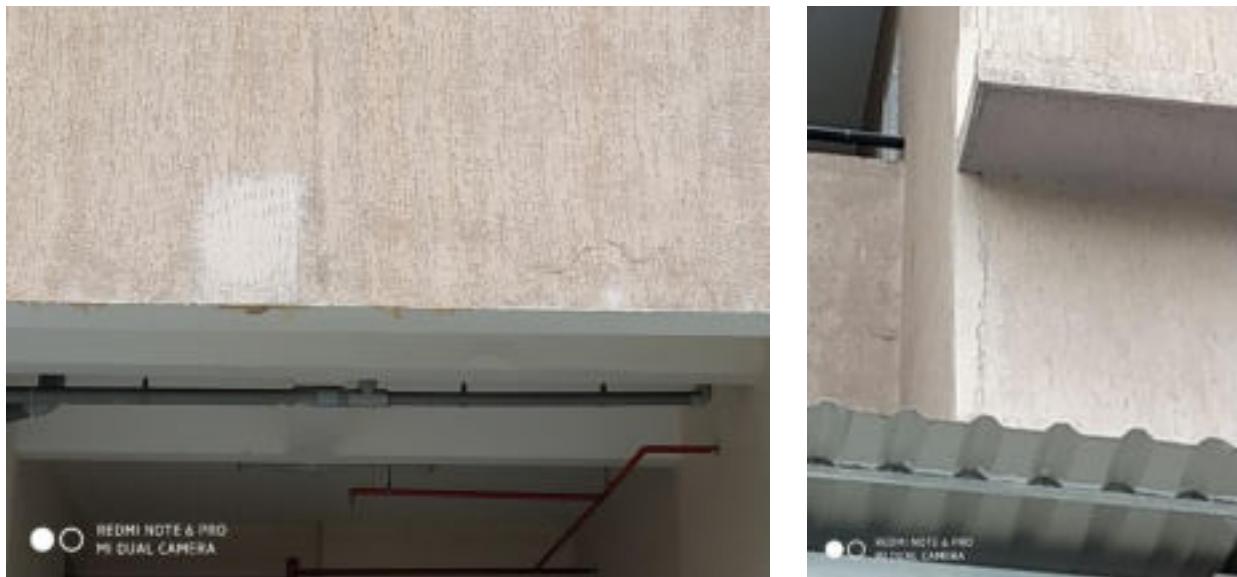
Figure 9. Occurance of cracks in the visinity of already repaired portion

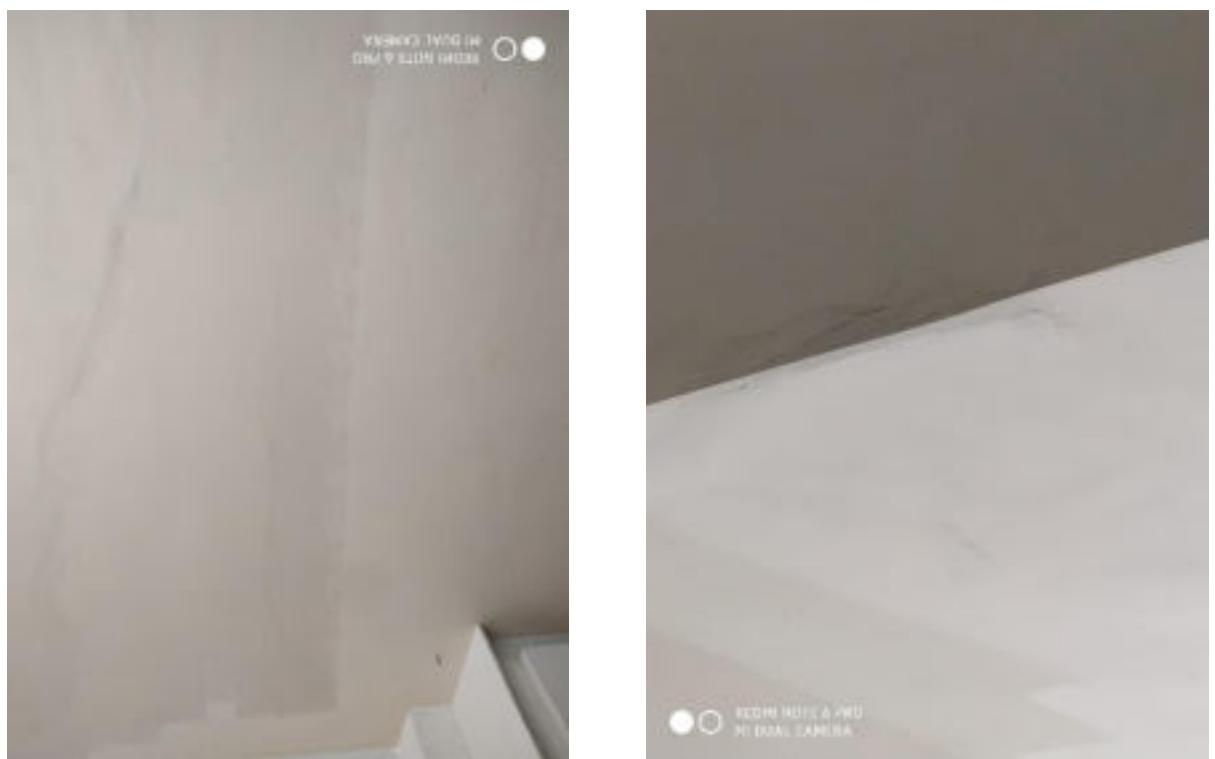
Figure 10. Reoccurrence of cracks in the repaired portions

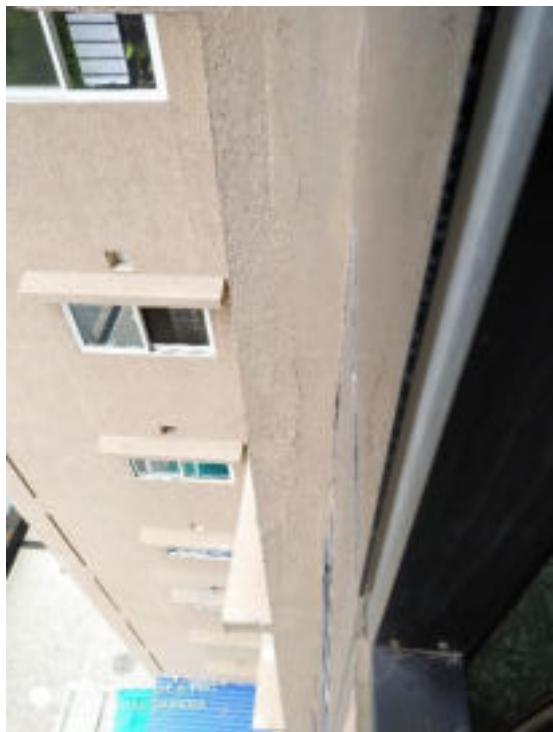
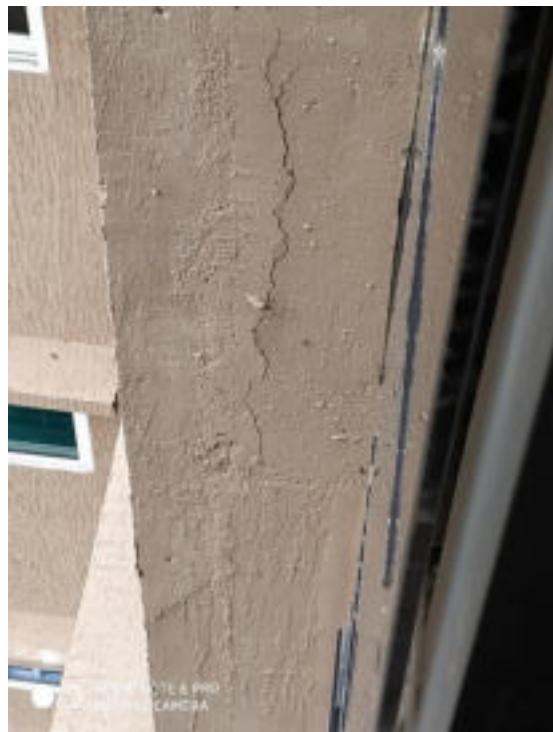
Figure 11. Cracks in columns due to corrosion of reinforcement

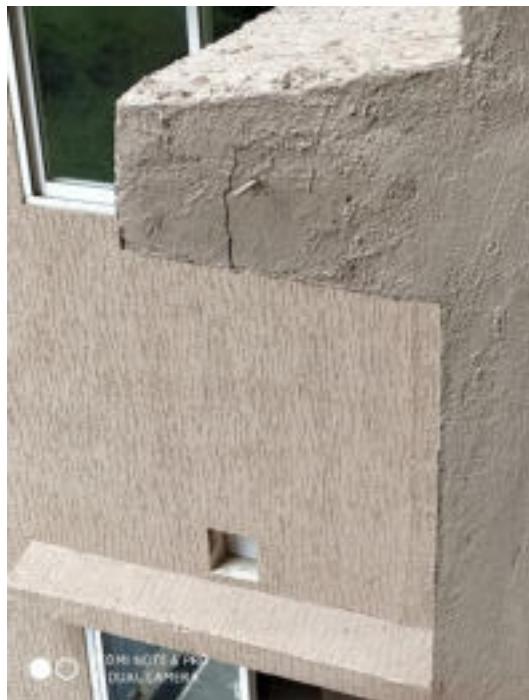
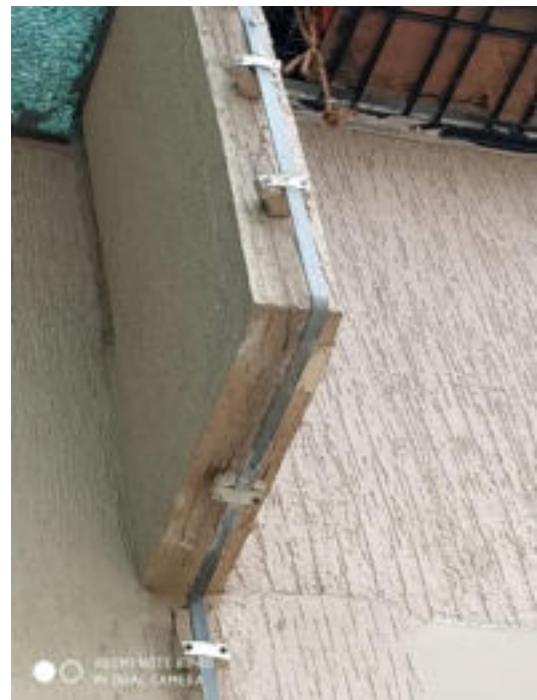
Figure 12. Cracks in shade

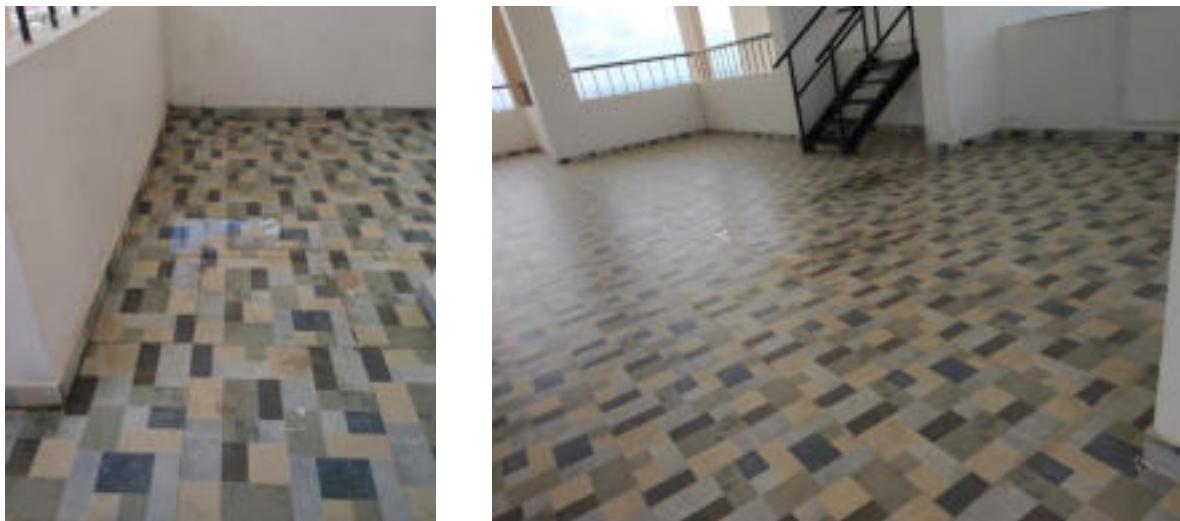
Figure 13. Water is getting stagnated in the floor

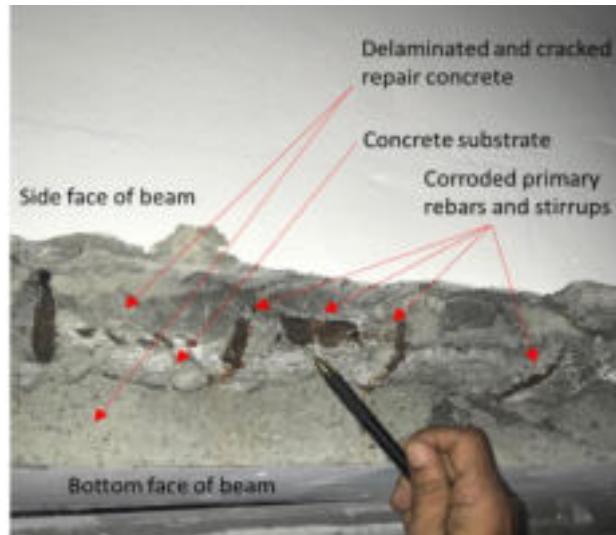
In the presence of the RWA authorities, walk-through inspections of Towers B and C were conducted. Severe corrosion-induced cracking of structural elements, associated patch repairs (repeated patch repairs at same locations, as informed by tenants), signs of leakages etc. were observed. As a particular case and to confirm the corrosion condition, the cracked/delaminated location of one of the long beams in the basement was autopsied (i.e., delaminated cover concrete was removed using a hammer and chisel). This region was found to be an already repaired region and significant steel rust/corrosion products were observed (see Figure 1).

This cracking and delamination might have occurred because the prior repair could not arrest the corrosion of the primary reinforcement and stirrups. This is due to the possible presence of sufficient chlorides in the concrete in contact with the steel. As informed and observed, it seemed that the repair was done by covering the substrate concrete and steel using repair concrete (without any undercutting and electrochemical treatments). The lack of coarse aggregates in this repair concrete indicated that this was possibly microconcrete. Such patch repairs with microconcrete and without undercutting and electrochemical treatments cannot

**Figure 1 Ongoing corrosion in the repaired beam in the basement**

control corrosion due to (i) the residual chloride effect and (ii) the halo effect. The residual chloride effect is due to the possible chlorides in the substrate concrete and the inadequately cleaned steel surface/rust present and the halo effect is due to the difference in the chemistry between the repair and substrate concretes. The microconcrete was about 2-inch thick, which seemed more than required cover thickness for such members. Also, non-metallic mesh for confinement was observed at the side faces (it seemed that mesh was not present at the bottom face), questioning the effectiveness of mesh in confining the concrete.

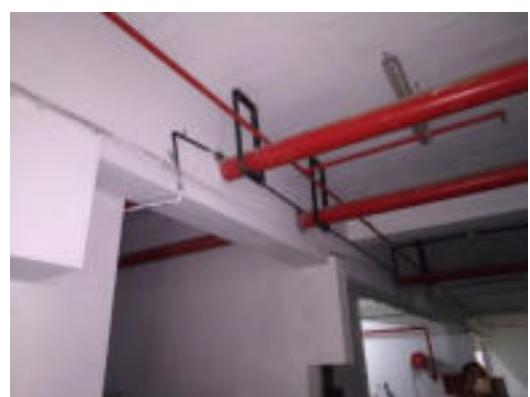
Figure 3. Fire pipes passing through the beams  
(the consequences must be checked by a  
structural consultant)

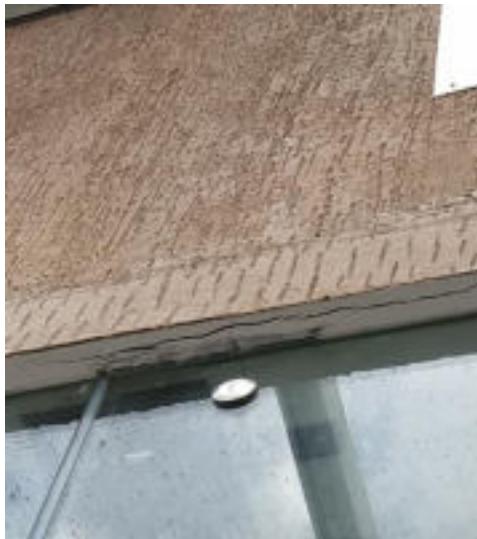
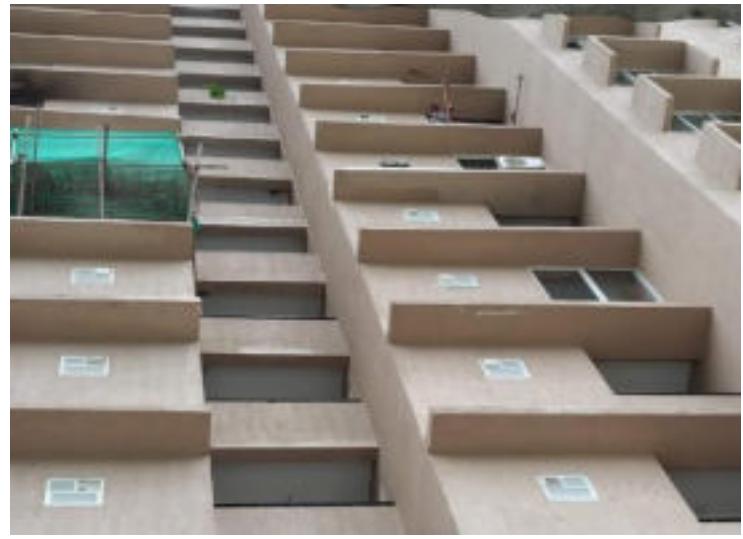
Figure 6. Repaired beams, columns, sunshades, etc. at many floors (see the changes in texture and colour) exhibiting additional cracks - indicating inadequate repair practice
