**EVALUATION STUDY OF REPORTS**  
**SUBMITTED BY**  
**BUREAU VERITAS INDIA PVT LIMMITED**

# **STRUCTURAL STABILITY ASSESSMENT OF EXISTING CHANDERKUNJ ARMY RESIDENTIAL TOWER-B & C OF ARMY WELFARE HOUSING ORGANIZATION (AWHO) AT SILVER SAND ISLAND, VYTTILA, KOCHI, KERALA**

## EVALUATION OF BVIL REPORT MAY 2023

### TOWER – B & C, CHANDERKUNJ ARMY TOWERS, SSI, KOCHI

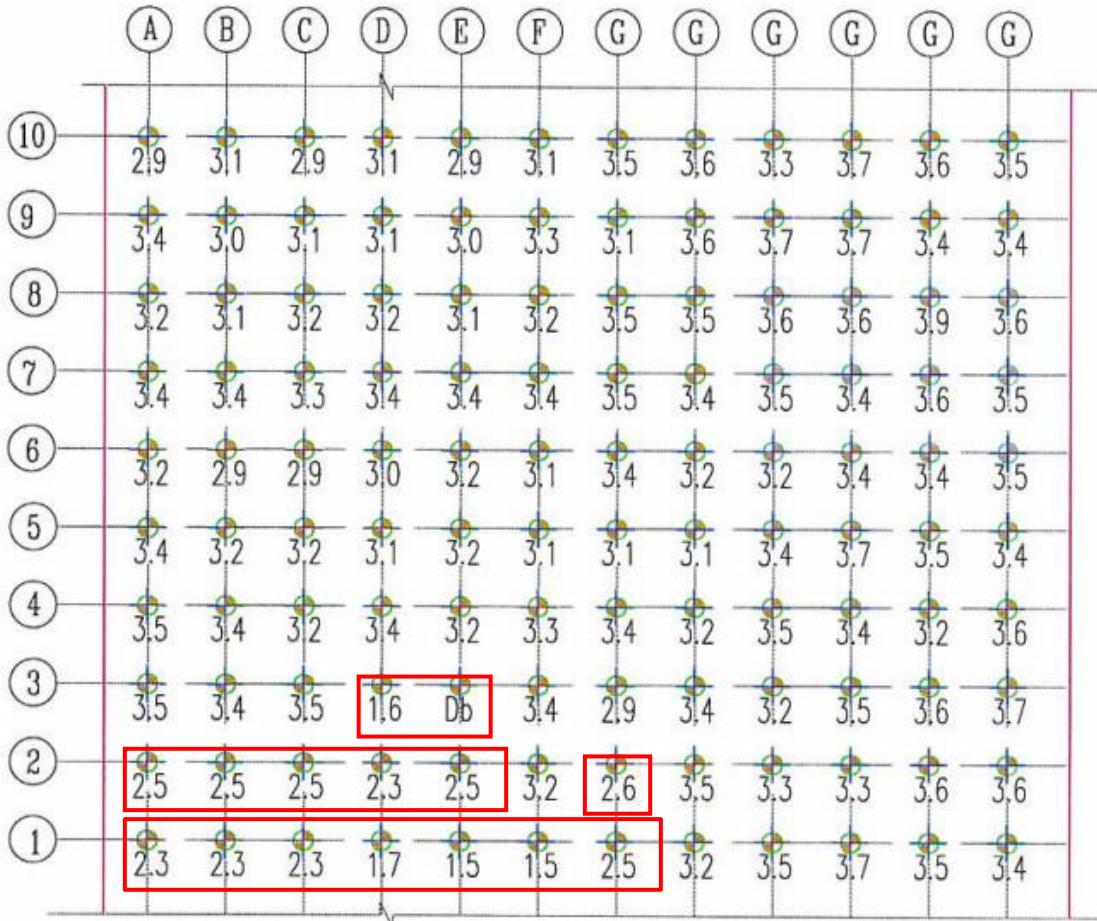
**Note:** The portion of the member marked in red is a region within the member which could be having internal flaws or micro-cracks

**Fig 1.** Individual UPV test results on shear wall in Tower-C as per details in table above.

14. This brings out another important aspect, that is, the selection of the sample location in the concrete member. From Fig. 1, it may be observed that the area having internal flaws would vary depending on the selection of the test location based on visual inspection. If there is any deliberate attempt to avoid any particular distressed location based on visual inspection, the validity of the result would be adversely affected. In the present BVIL report, there is no mention about the methodology of sample selection, hence the validity of the test results cannot be established.
