A Review on the Report by Bureau Veritas on
Investigation of distress in basement floor and terrace level overhead tanks of
Army Welfare Housing Organisation “Chanderkunj Army Towers”
at Silver Sand Island, Vytilla, Kochi, Kerala (November 2020)

**Review of the report by Bureau Veritas (dated Dec 3, 2020) for
Chander Kunj Apartments, Silver Sand Island, Vytilla, Kochi**

Results of the chloride tests conducted at IIT Madras

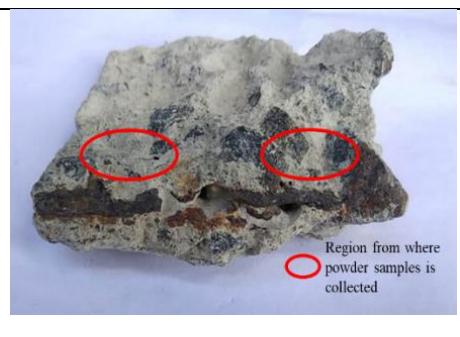
</td> <td data-bbox="1144 1327 1367 1664">2.46</td> </tr> <tr> <td data-bbox="668 1664 1144 1978">

<p>Some of the obtained chloride contents are above the allowable chloride concentration as per Table 7 in IS 456 (see below).</p>

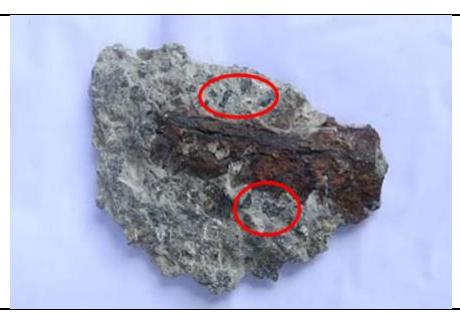
</td> <td data-bbox="1144 1664 1367 1978">4.94</td> </tr> </tbody> </table>	Location	Chloride content reported (kg/cm ³)	Retaining wall - Basement floor	0.045 0.04 0.028 0.096	Tower-B basement floor	1.12 1.12	Tower-C basement floor	0.34 0.26	Parking area	0.37 0.04	Tower A - stilt floor	0.4 0.045	Water tank	0.045 0.045 0.079	Photo of the sample collected	Acid soluble chloride content (kg/m ³ of concrete)
