IND.B.7.2022.300DR-R3

**VISUAL INSPECTION OF RESIDENTIAL CHANDERKUNJ ARMY
TOWER - A OF ARMY WELFARE HOUSING ORGANISATION (AWHO)
AT SILVER SAND ISLAND, VYTILLA, KOCHI, KERALA**

APRIL 2023

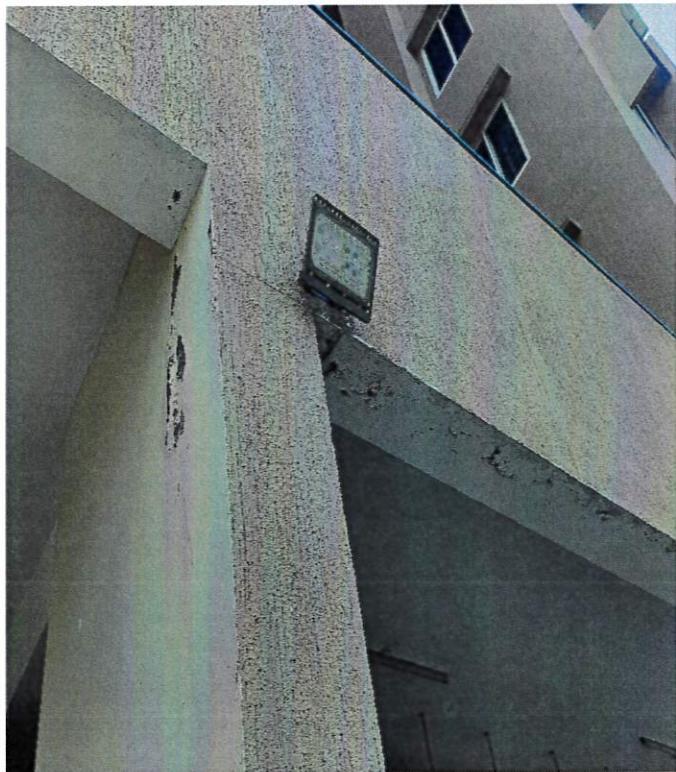
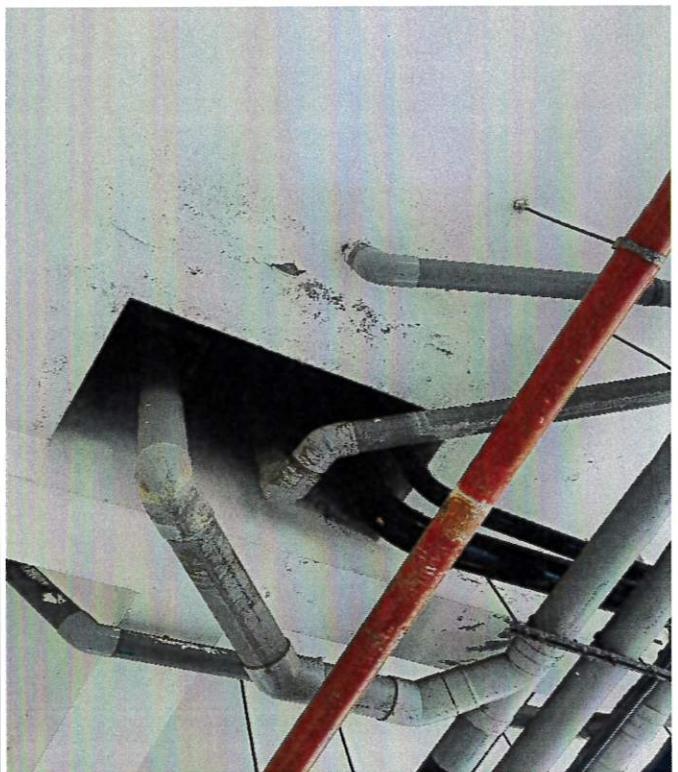
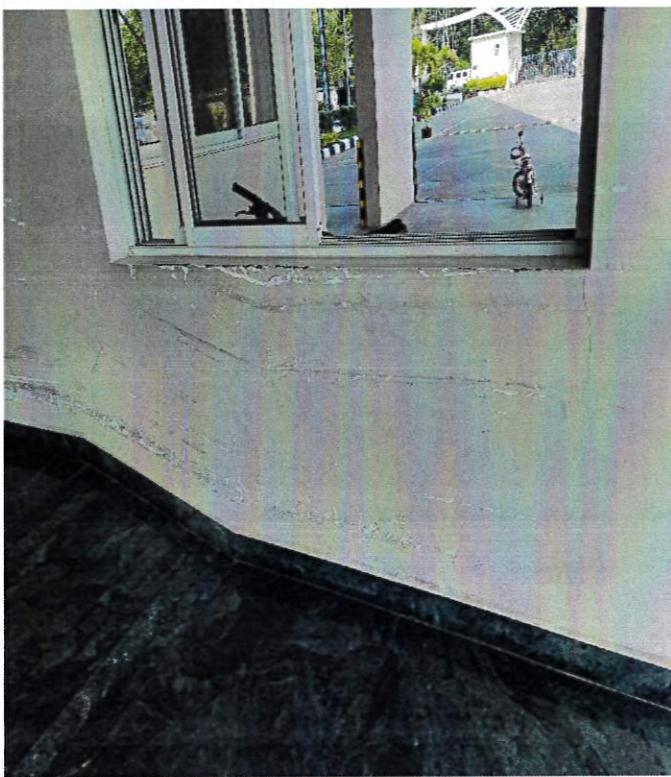
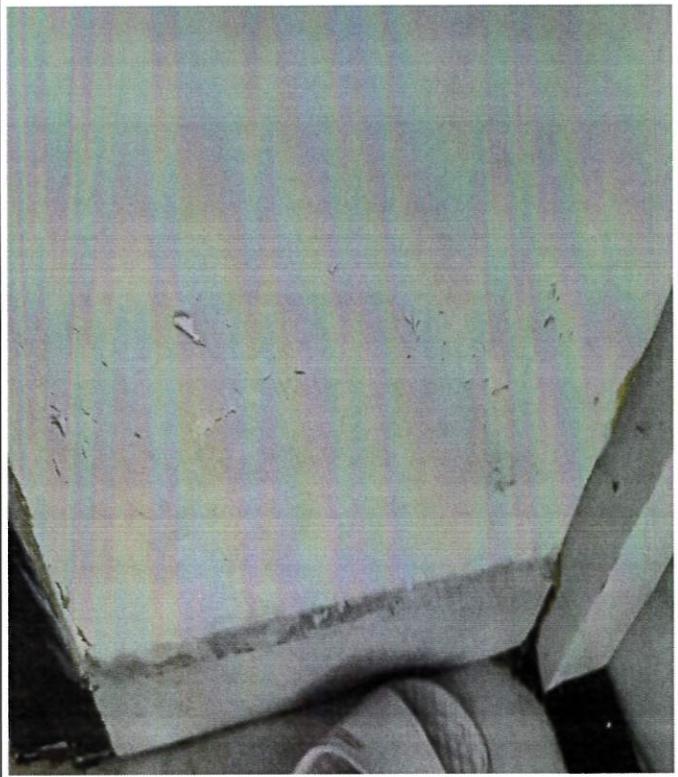
View of dampness/ damp patches/ peeling of paint

4. **Treatment for dampness region of masonry wall.**
 - a. The deteriorated plaster on masonry walls shall be removed by gentle chipping.
 - b. The mortar joints in walls shall be deep raked and re-pointed with CM 1:4 as per the standard practice followed by re-plastering in CM 1:3 mixed with waterproofing plasticizers.

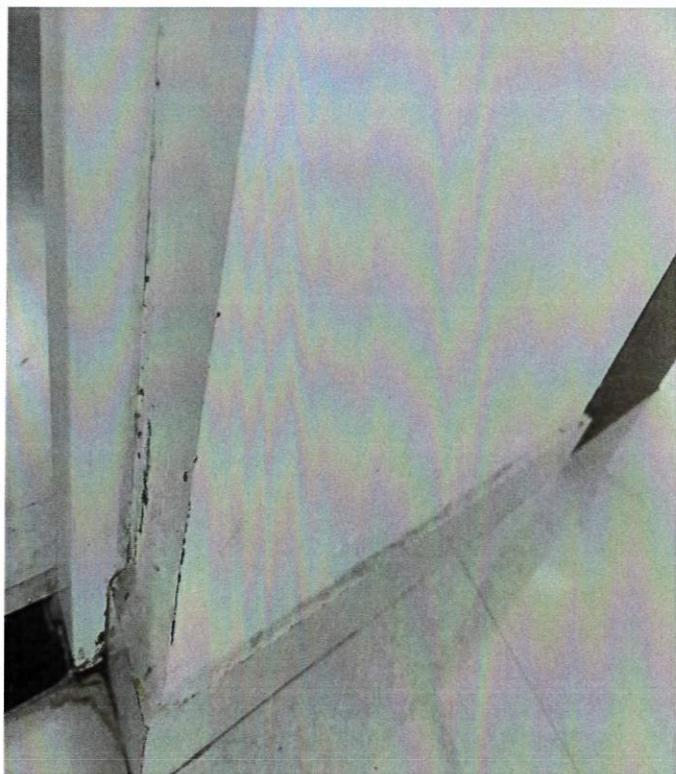
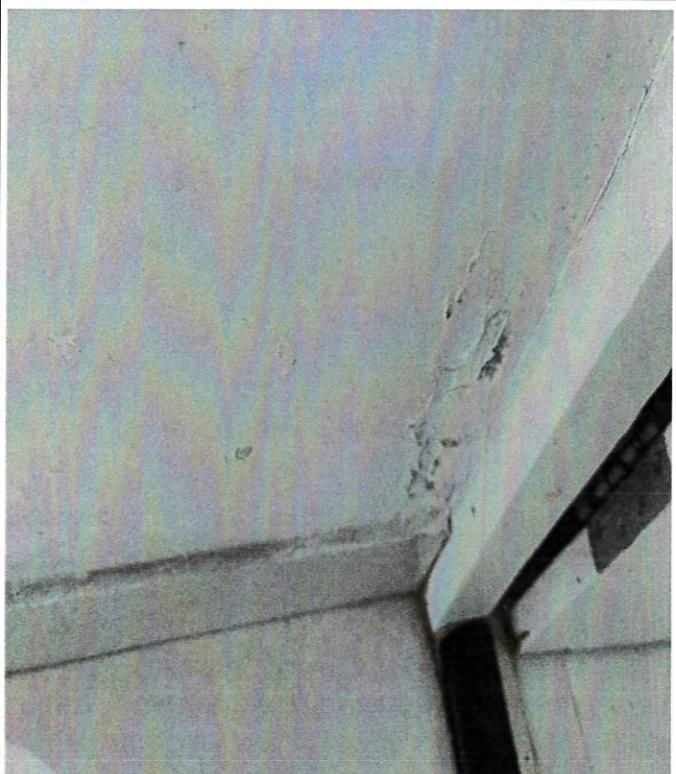
View of dampness/ damp patches/ peeling of paint inside the Flats

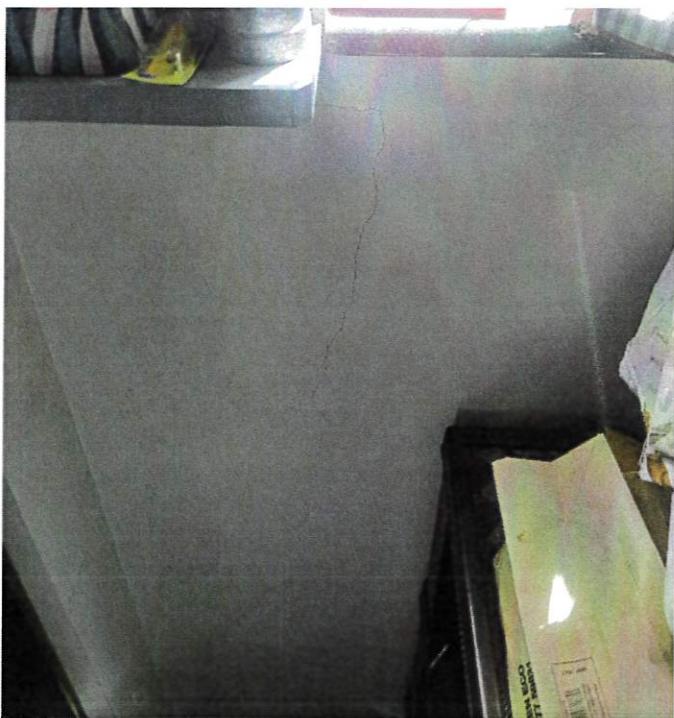
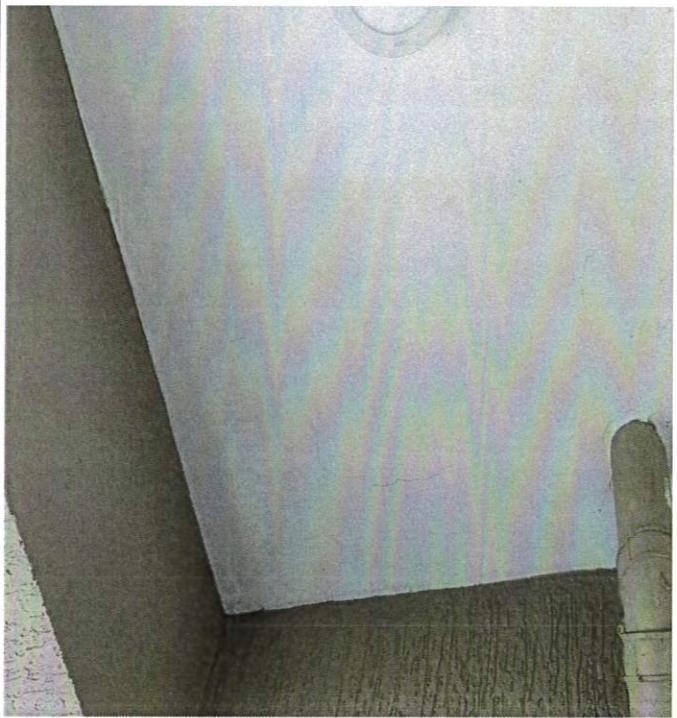
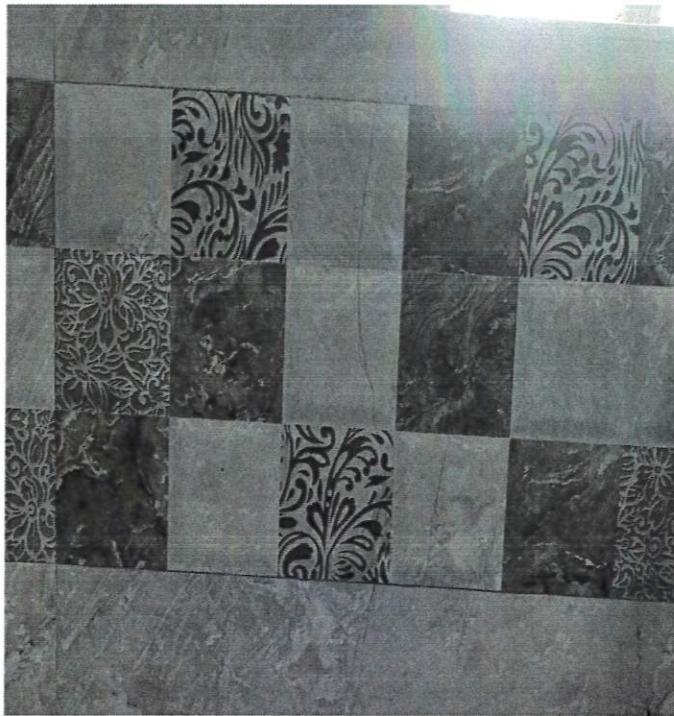
View of Cracks in masonry wall inside the Flats

3. **Treatment for cracks in Masonry wall.**
 - a. Existing plaster along the crack shall be removed on either side of the crack for a width of about 300 mm (on either side of the wall) and cleaned.
 - b. Mortar joints along the crack shall be deep raked and filled with cement mortar.
 - c. Weld-mesh of size 50 x 50 x 3 mm shall be fabricated and fixed across the crack using 'U' nails.
 - d. Re-plastering the region with CM 1:4 as per standard practice

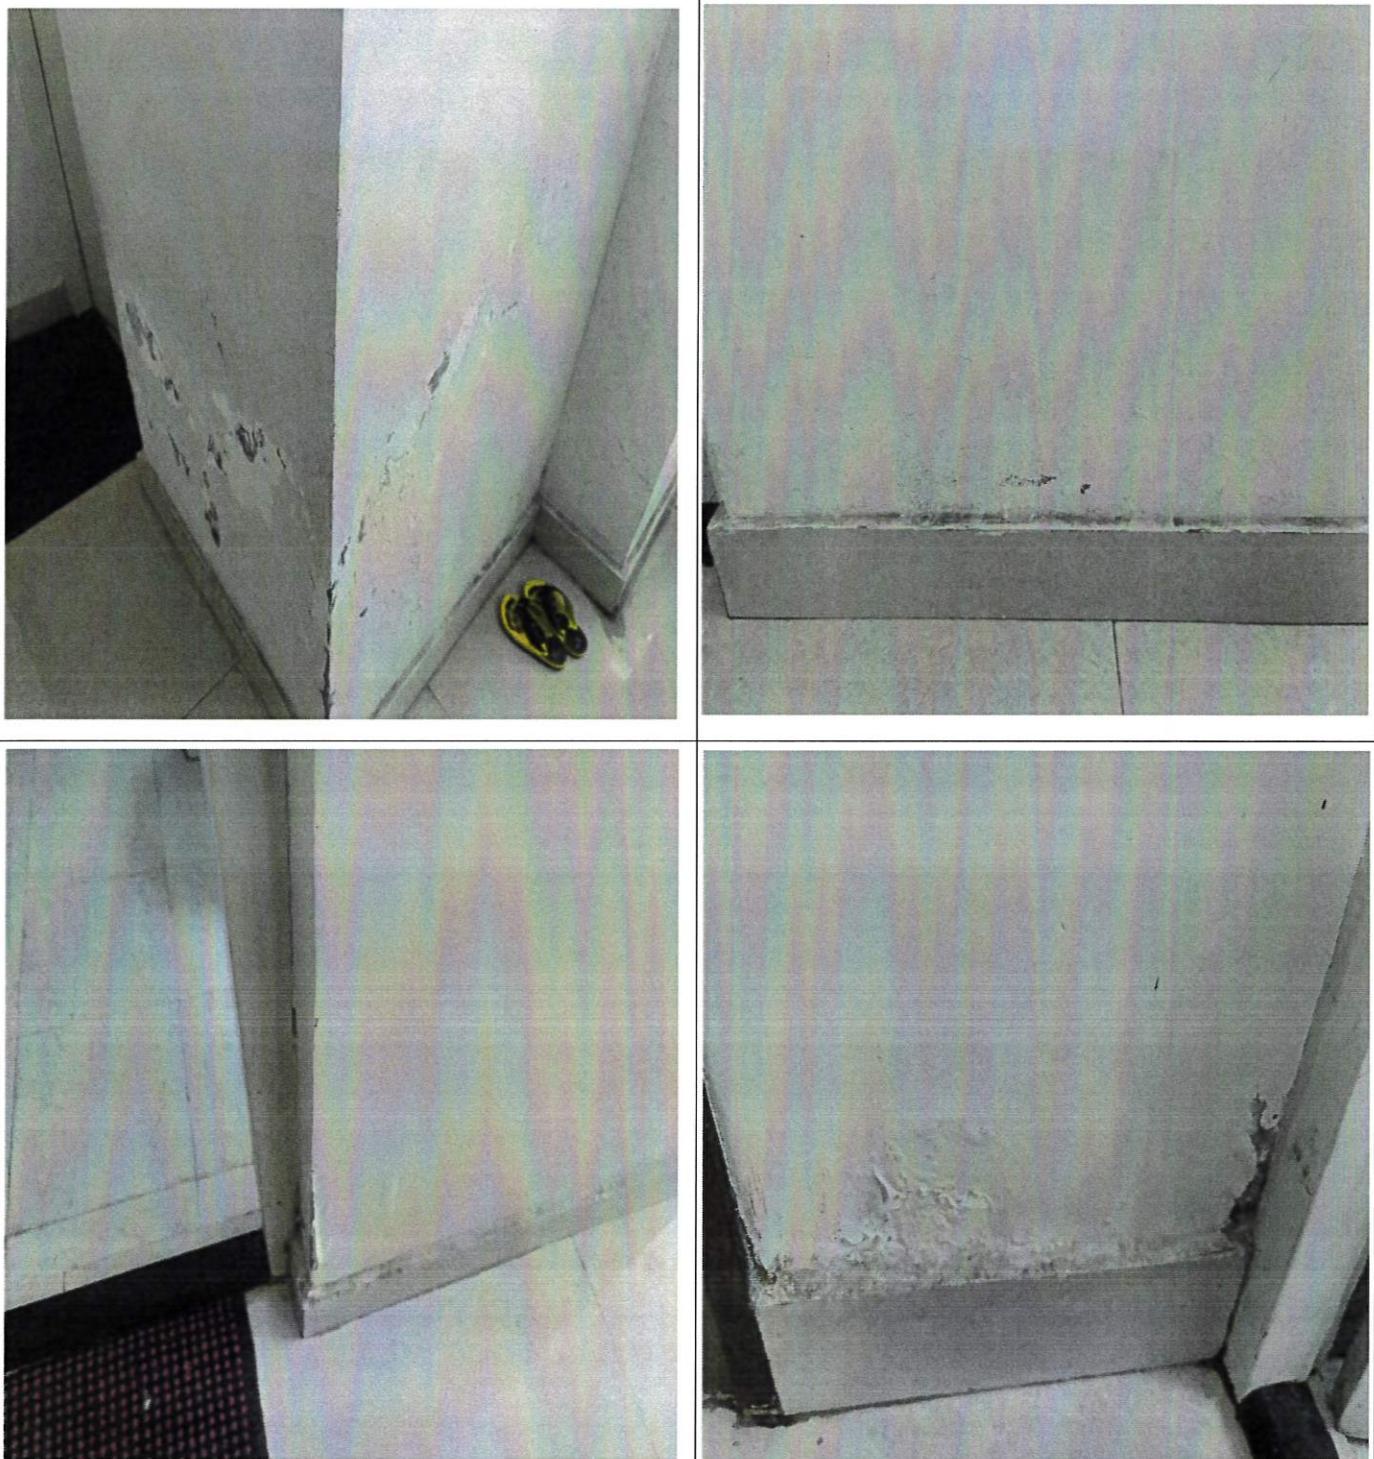
View of dampness/ damp patches/ peeling of paint inside the Flats

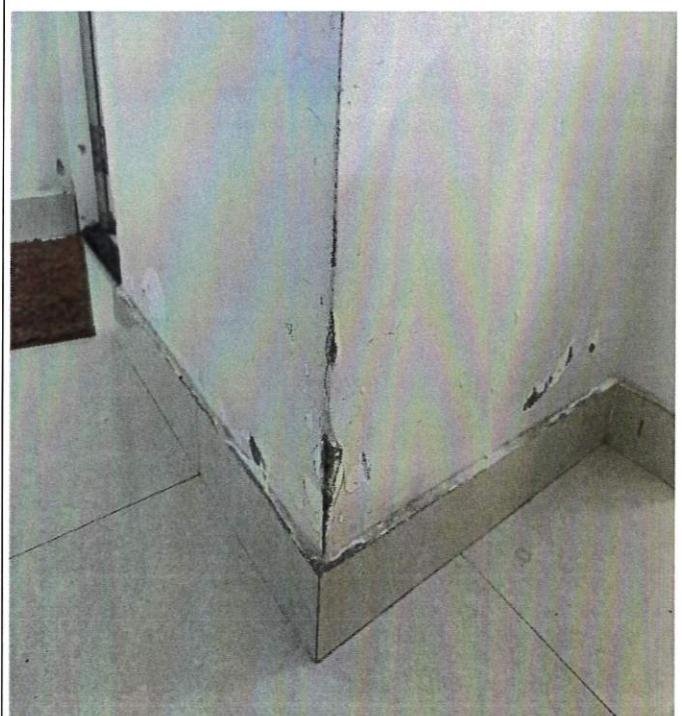
View of dampness/ damp patches/ peeling of paint inside the Flats

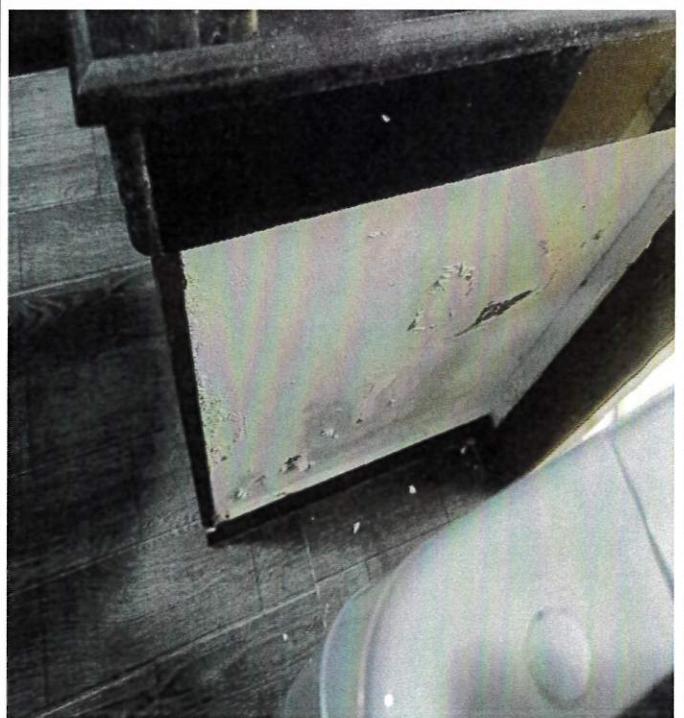
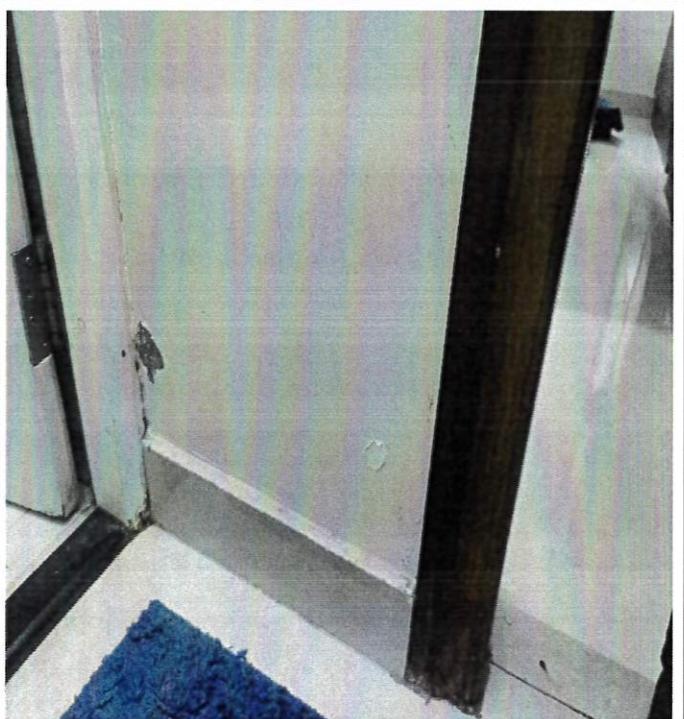
View of dampness/ damp patches/ peeling of paint inside the Flats

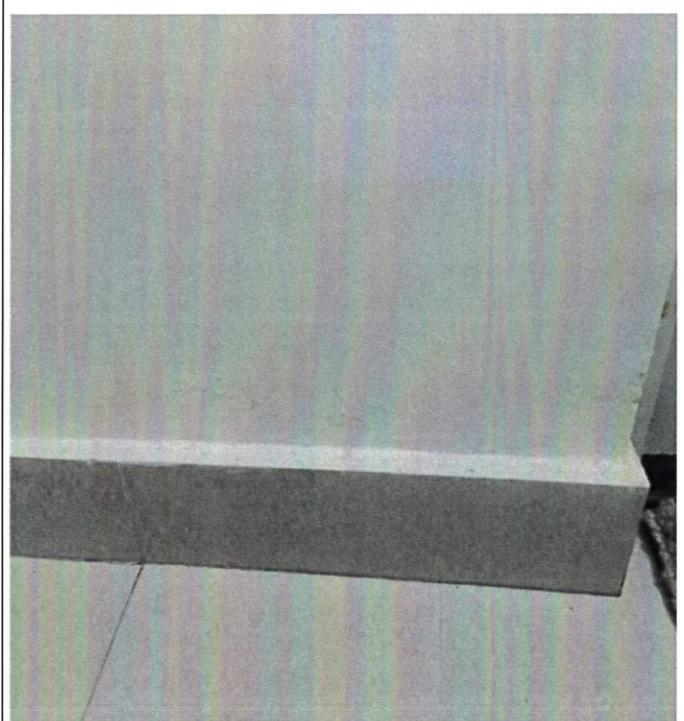
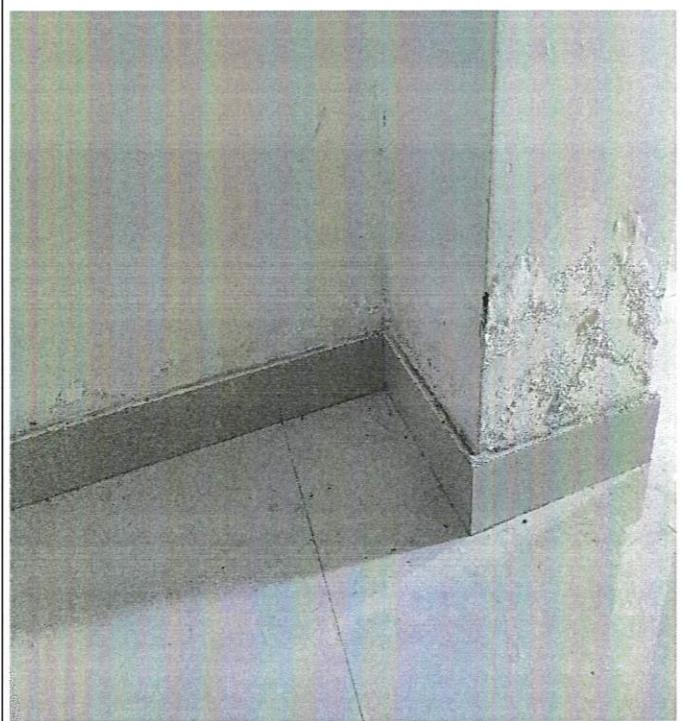
View of dampness/ damp patches/ peeling of paint inside the Flats

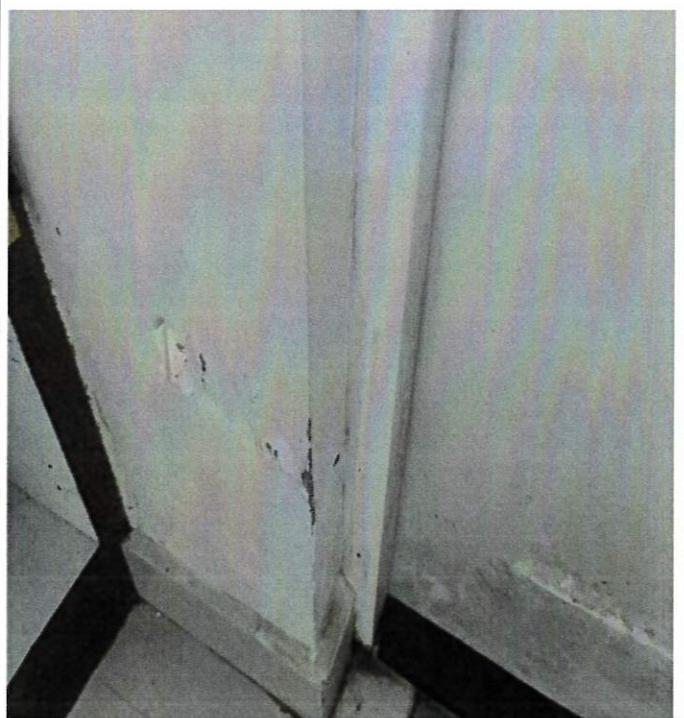
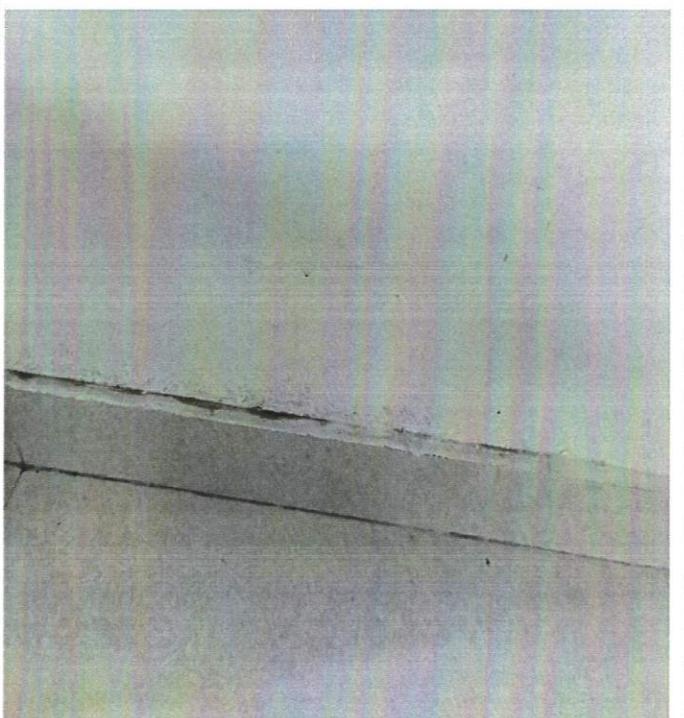
View of dampness/ damp patches/ peeling of paint inside the Flats

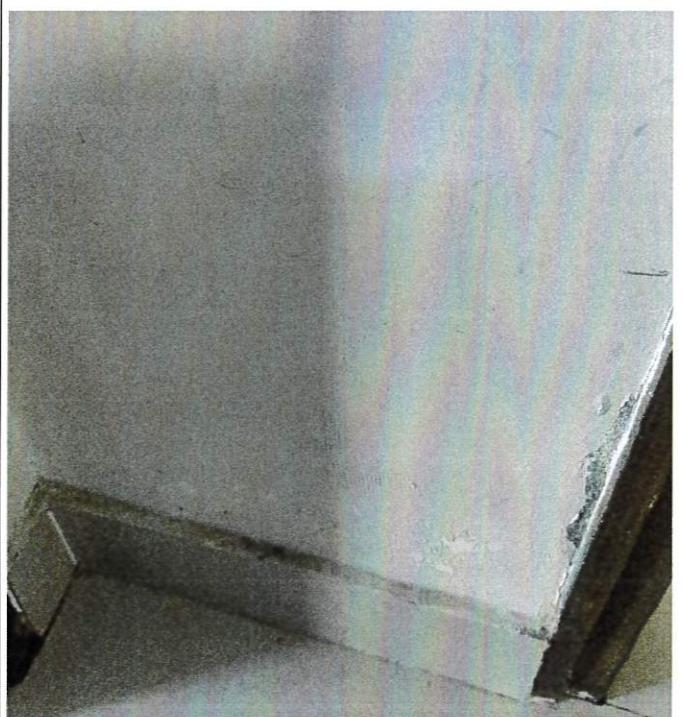
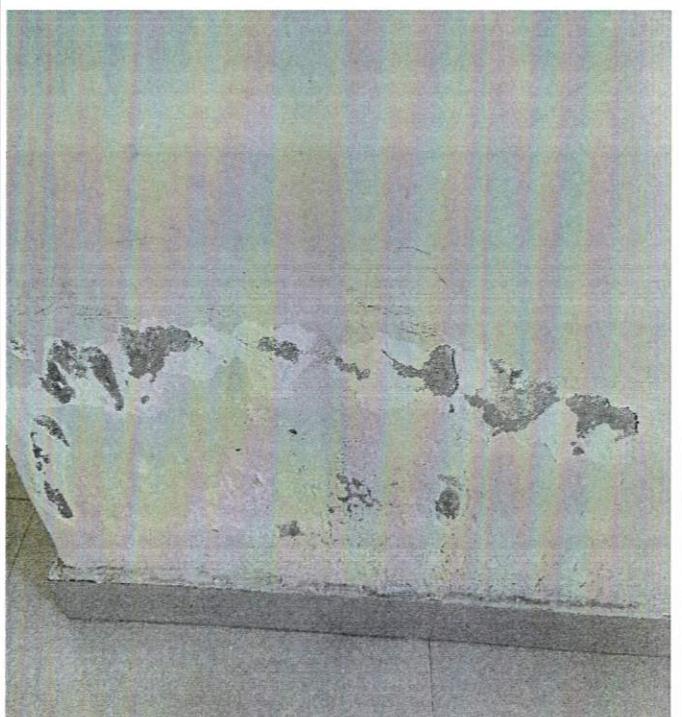
View of dampness/ damp patches/ peeling of paint inside the Flats

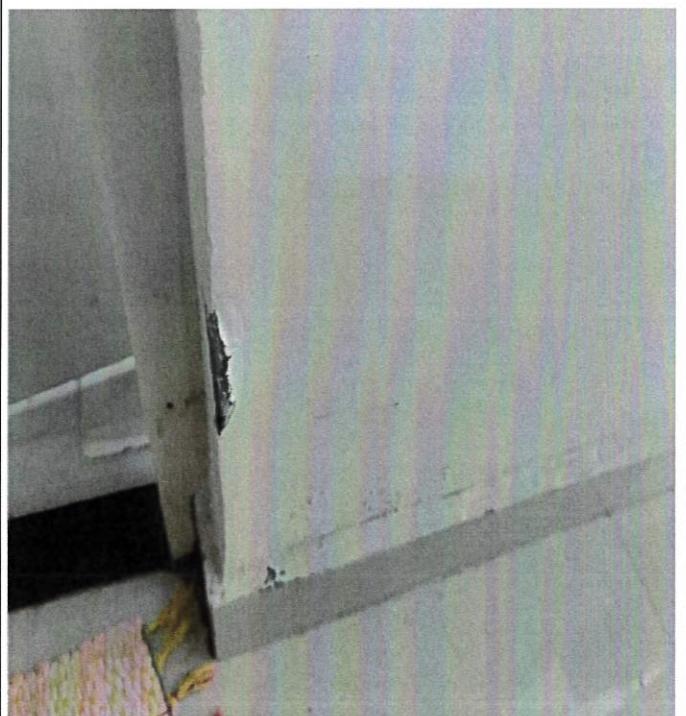
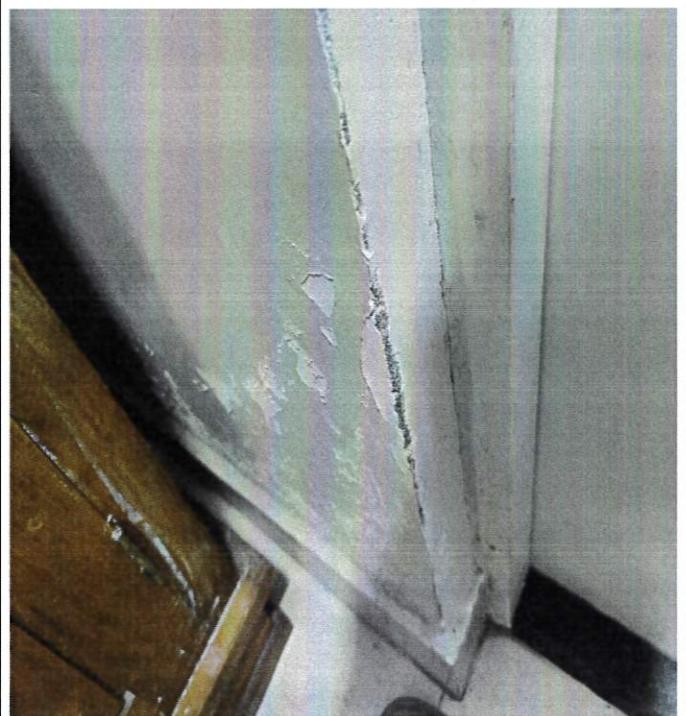
View of dampness/ damp patches/ peeling of paint inside the Flats

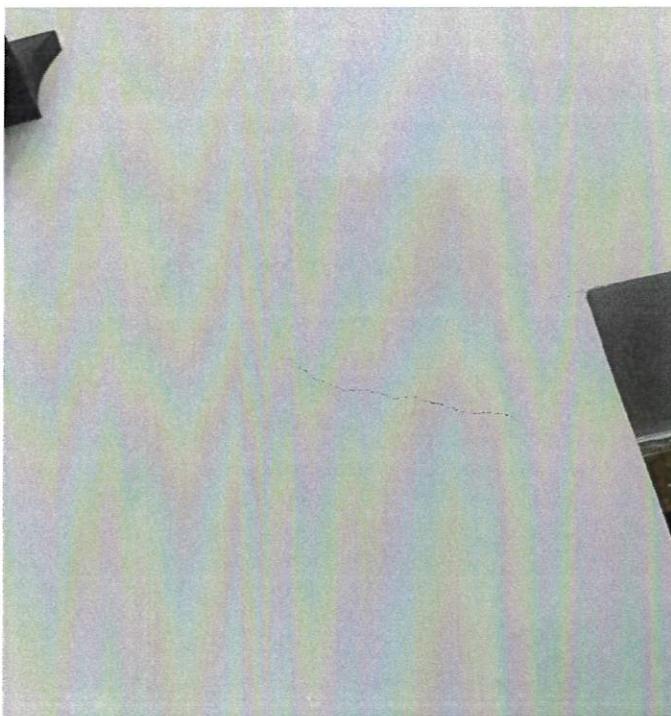
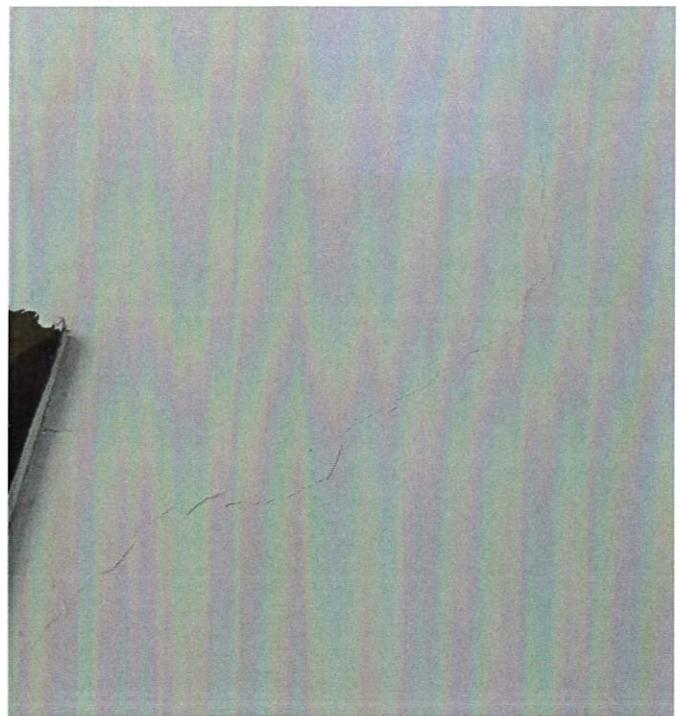
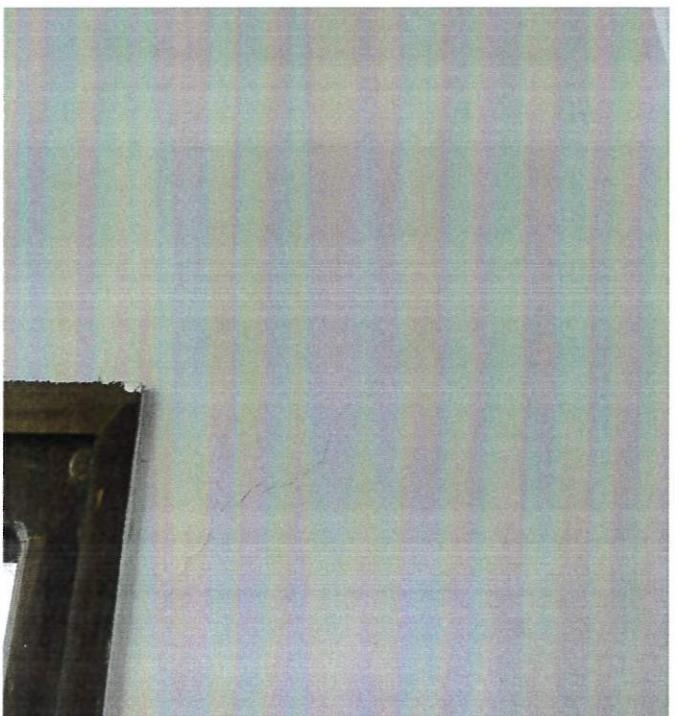
View of cracks in masonry wall

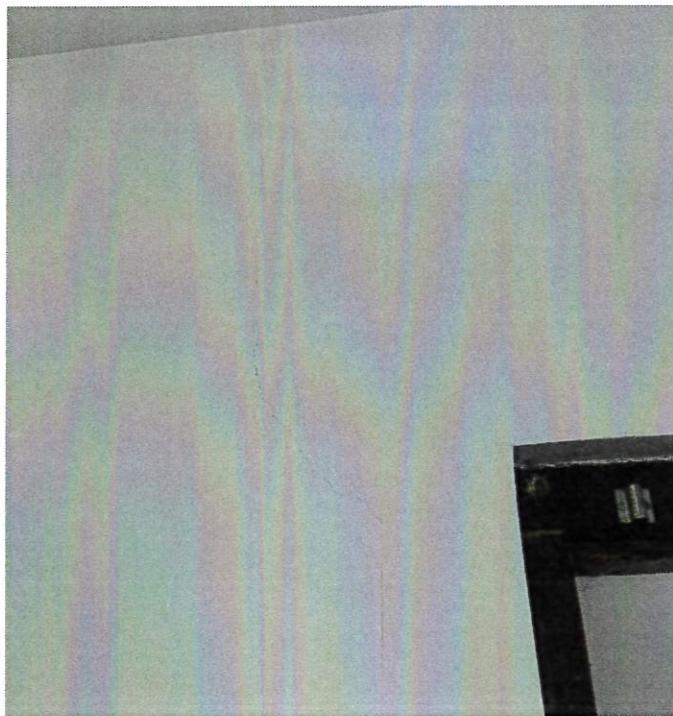
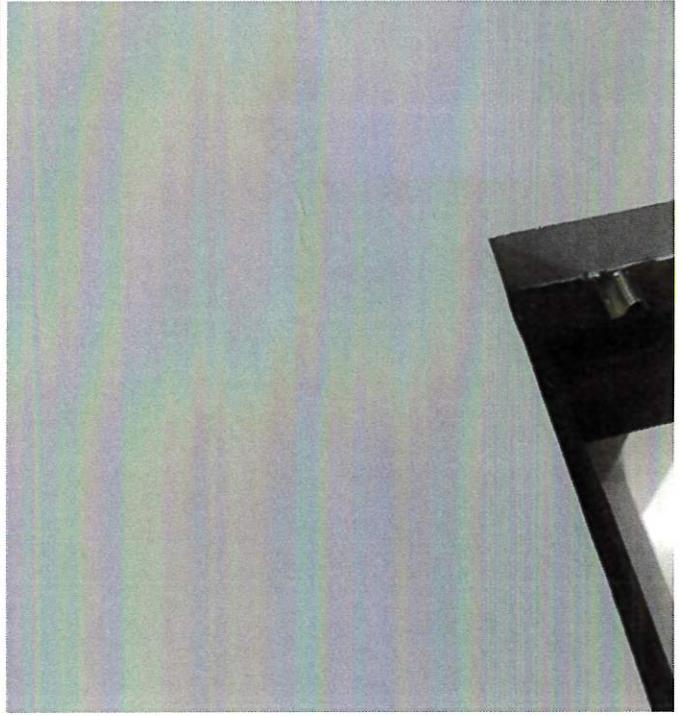
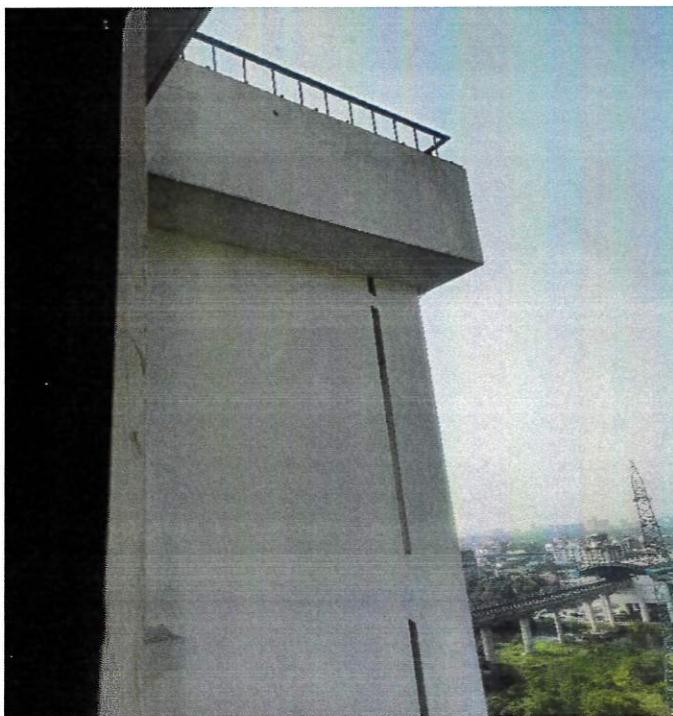
View of cracks in masonry wall

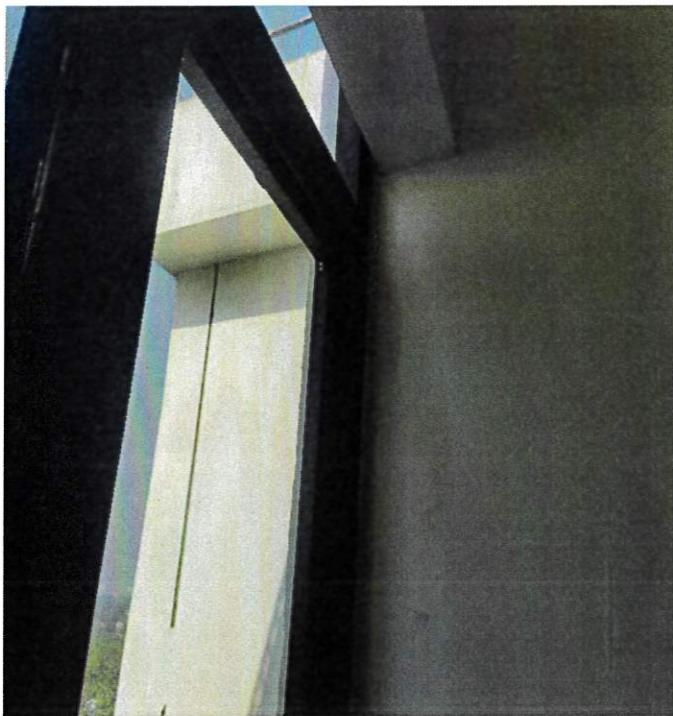
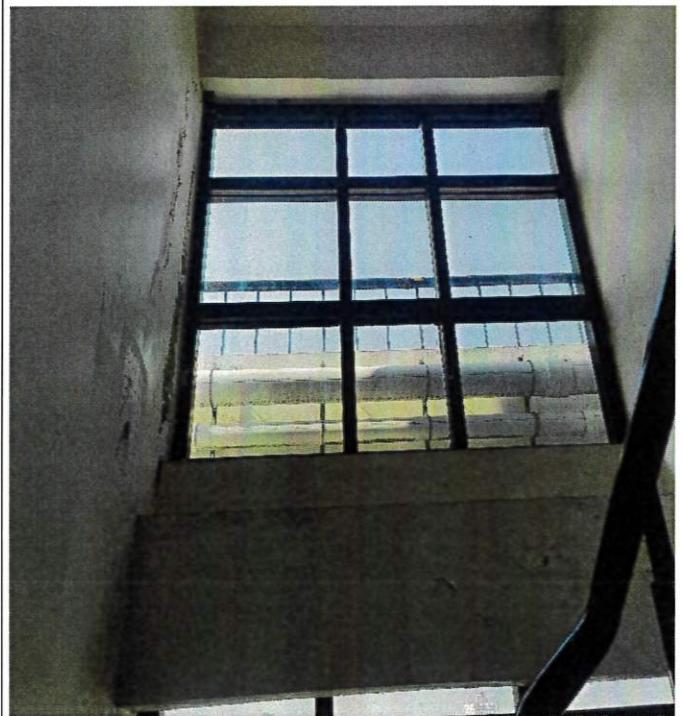
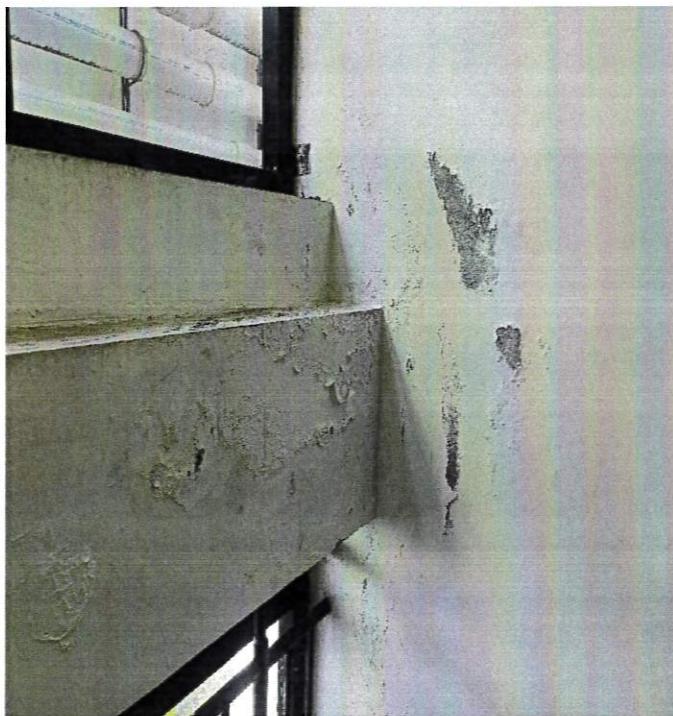
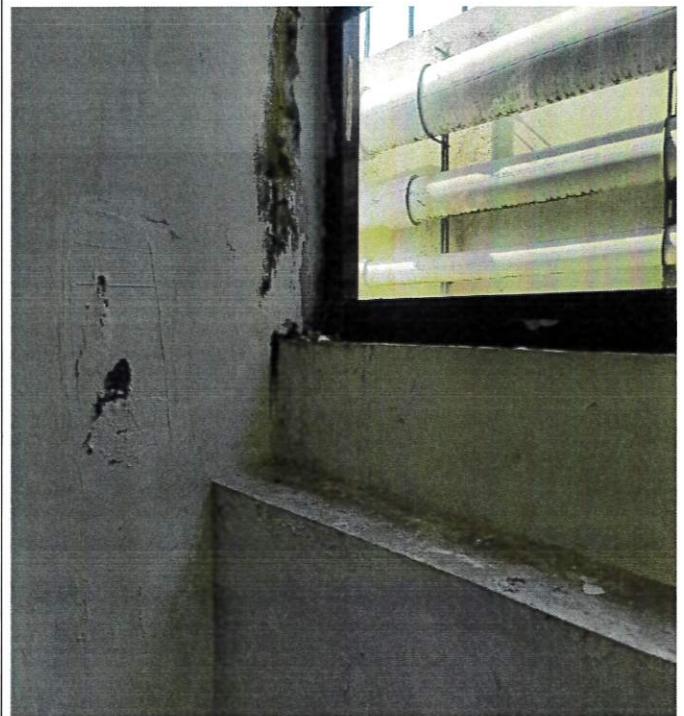
View of cracks in masonry wall
