Ref. No: IND.B.7.2022.300DR-R3

**SOUNDNESS ASSESSMENT OF EXISTING AWHO CLUB HOUSE  
BUILDING IN THE PREMISES OF  
M/S ARMY WELFARE HOUSING ORGANIZATION,  
KOCHI, KERALA.**

**APRIL 2023**

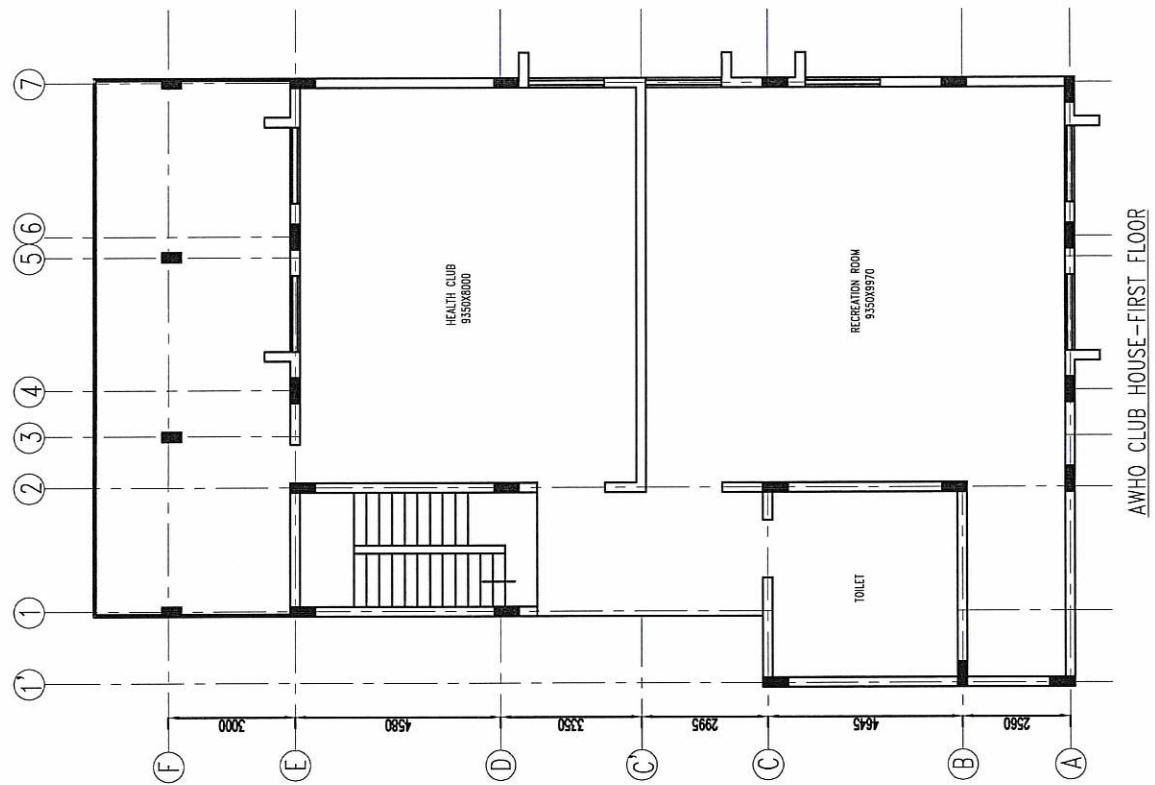
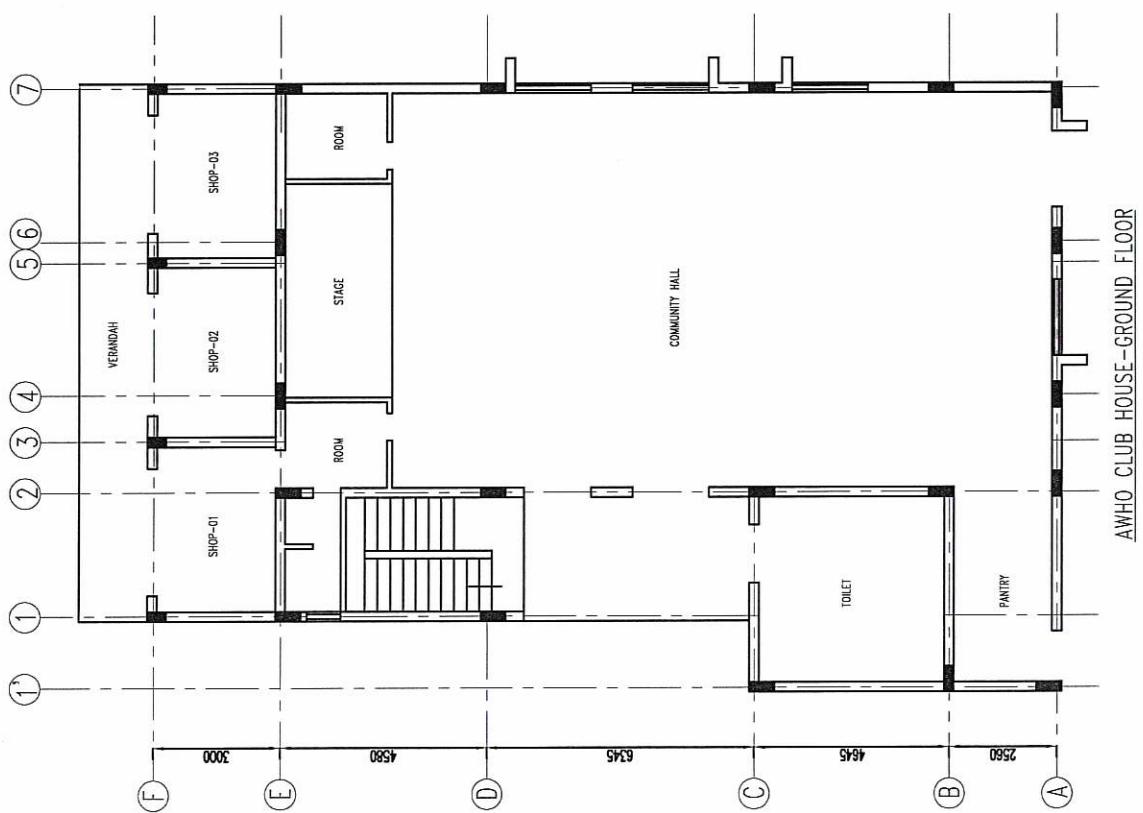
- No signs of settlement in foundation system was observed in any part of the building.
- Minor separation cracks were observed at the junction of RC members and masonry wall at few locations.

- Peeling of paint, growth of fungus and damp patches were observed over the external masonry walls in staircase regions at several locations.
- Minor separation cracks were observed at the junction of RC members and masonry wall at several locations.

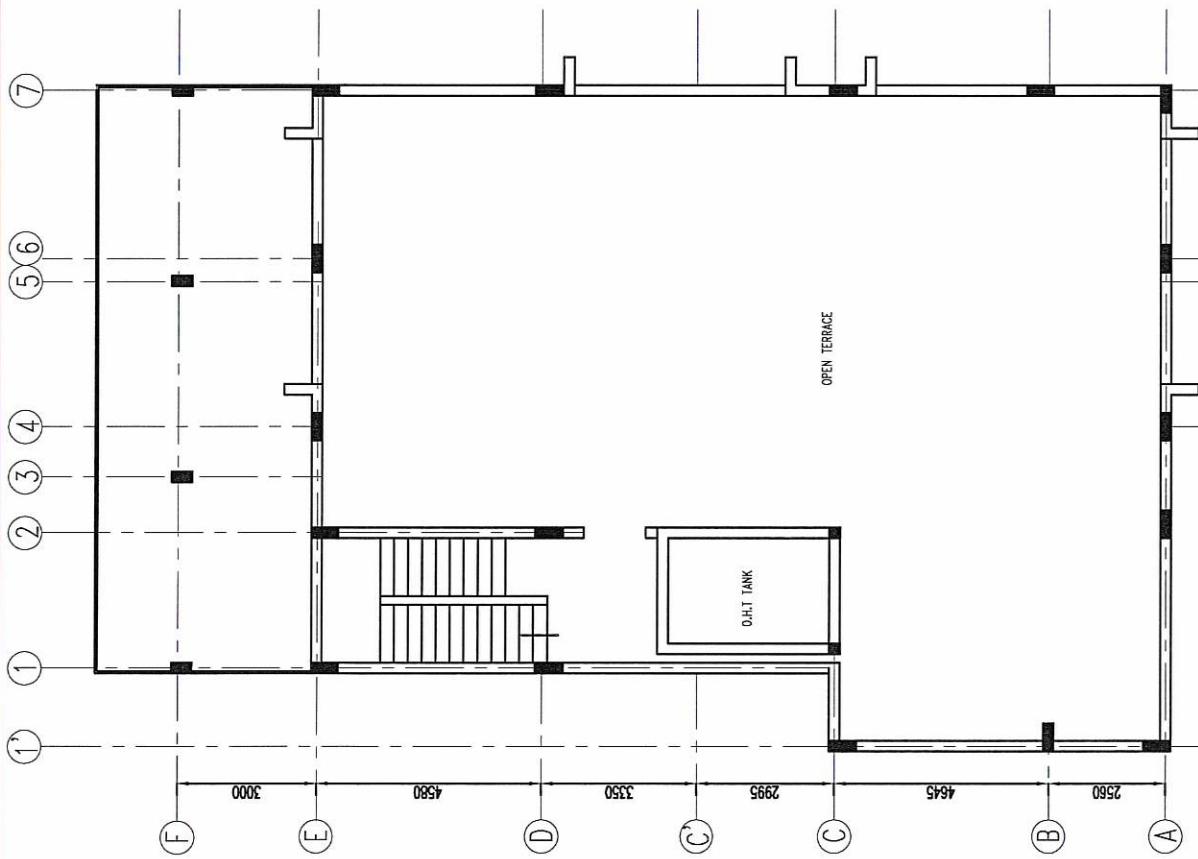
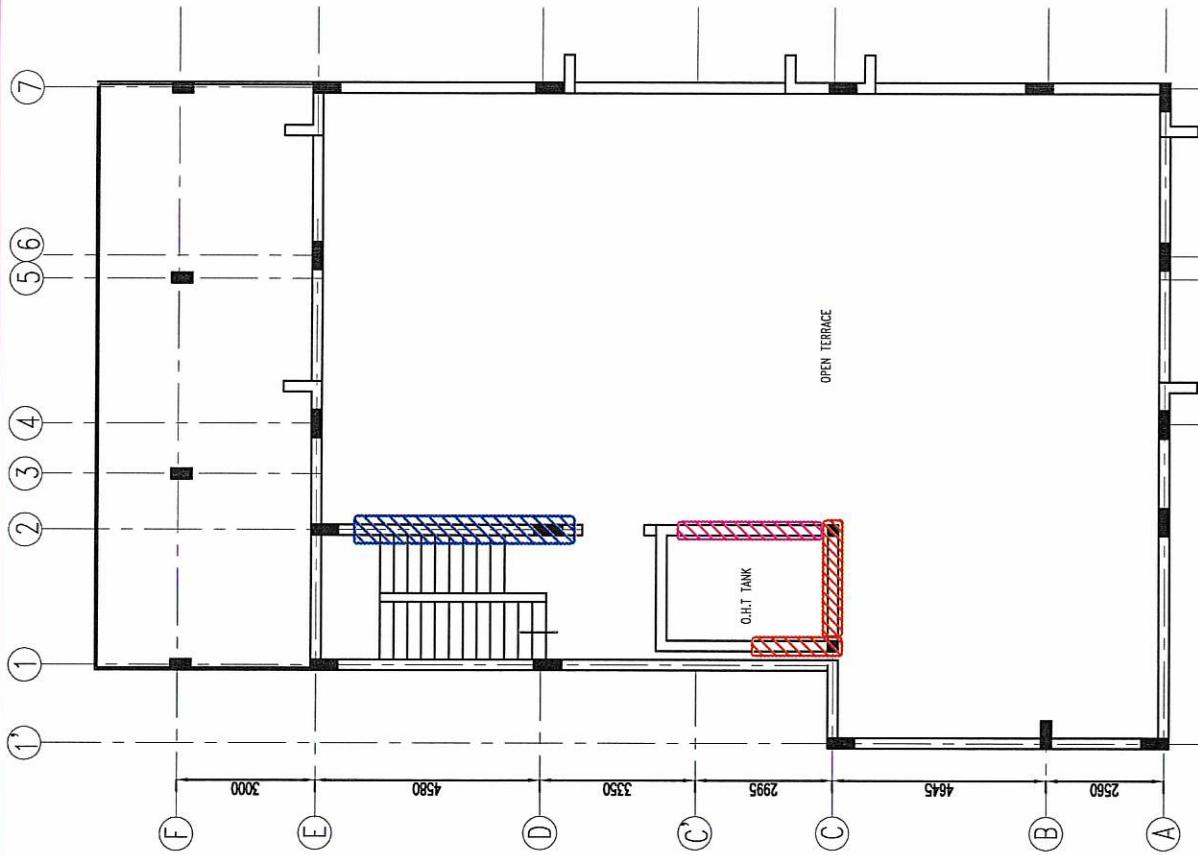
- Cracks were observed in overhead tank wall at few locations.
- Stagnation of water were observed over the terrace flooring at few locations.
- Leakage of water was observed from RC overhead tank at isolated location.

(Refer Sketch DWG No. DM/ CH/ TF-02)

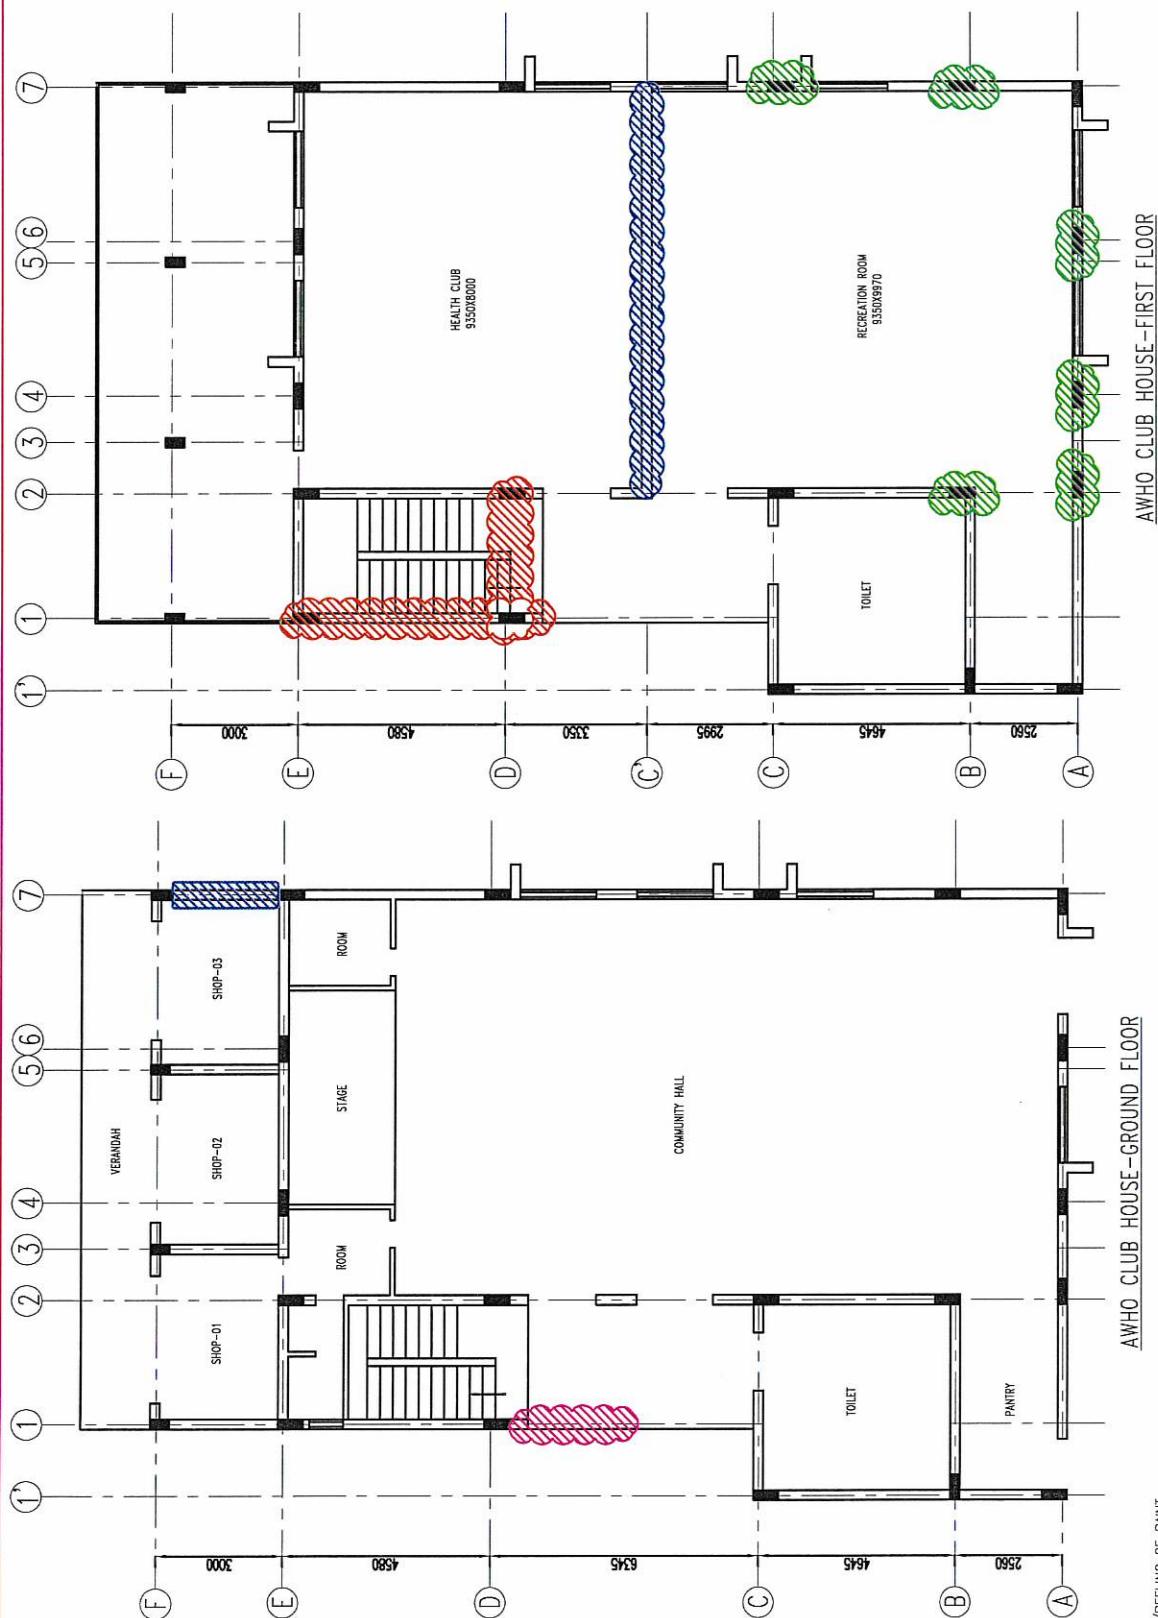
**(Refer Sketch DWG No. DM/ CH/ GF, 1F-01)**

EFFLORESCENCE/DAMPNESS/DAMP PATCHES/PEELING OF PAINT.

PLASTERING CRACKS IN RC BEAM/RC WALL

SEPARATION CRACKS BETWEEN RC BEAM AND MASONRY WALL

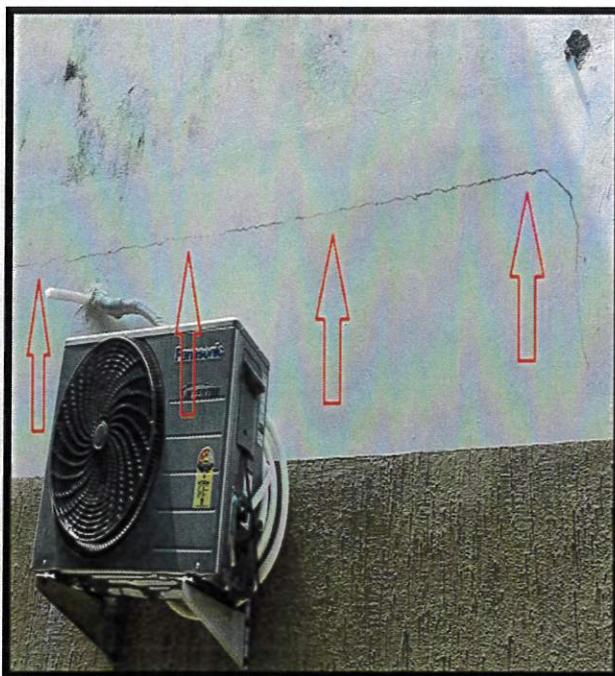
1. Dampness/ damp patches/ growth of fungus and peeling of paint in masonry wall are mainly due to the constant spilling of water from overhead tank.
2. Separation cracks observed are due to dissimilar materials, improper filling of joints / not provided with mesh between masonry and RC members during construction stages. Further, thermal effects caused by expansion and contraction of building have aggravated the cracks.
3. Stagnation of water over terrace is mainly due to inadequate slope provided in WPC.
4. Cracks in plaster might be due to shrinkage effect.
5. From the results of the non-destructive ultrasonic pulse velocity test & rebound hammer test, it is inferred that the quality/strength of concrete in tested regions of RC members is found to be satisfactory.
6. From the results of covermeter studies, the cover provided to the rebars is adequate in most of the tested RC members.

**View of Separation Cracks Between  
Masonry Walls and RC Members**

1. Existing plaster in the region about 20 mm on either side of the crack should be removed and loose particles shall be cleaned using wire brush.
2. 'U' groove of 12 mm wide 6 mm deep shall be made all along the crack at the interface of masonry wall and RC member junction and cleaned.
3. Groove shall be filled with flexible sealant like tackseal/ Polysulphate sealant/ silicon sealant or any other equivalent.
4. Treatment should be carried out as per sketch.

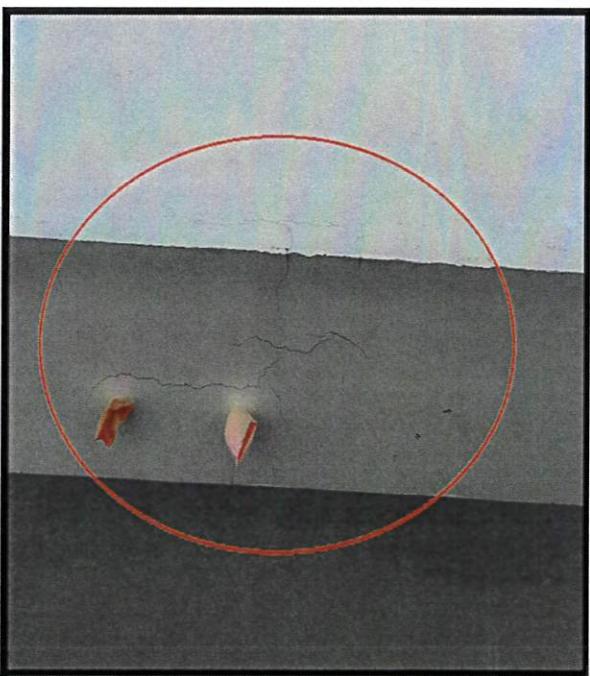
**View of Plaster Cracks in RCC beam  
along grid 1/C-D**

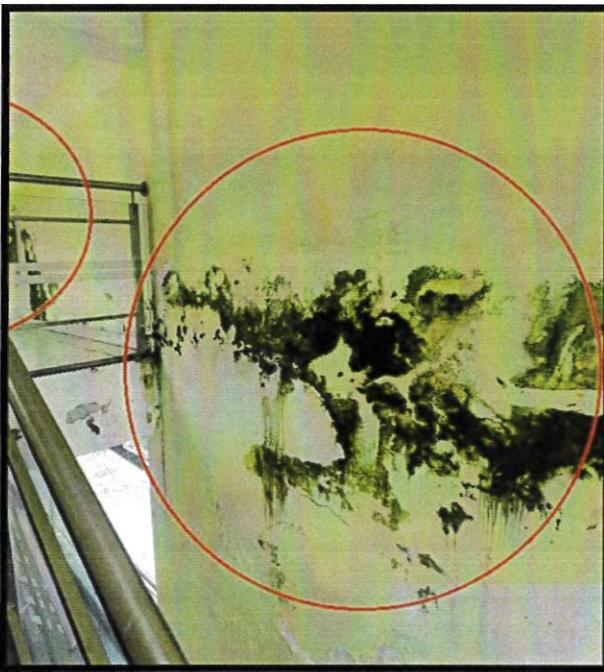
**View of Peeling of paint and damp patches in masonry wall at stair case regions**

1. The deteriorated /debonded plaster on masonry walls shall be totally removed by gentle chipping.
2. The mortar joints shall be deeply raked for about 10 to 15 mm & repointed using CM 1:4 as per standard practice.
3. Re-plastering to be carried out using 1:4 cement mortar as per specification added with polypropylene fibres and cured as per standard practice.

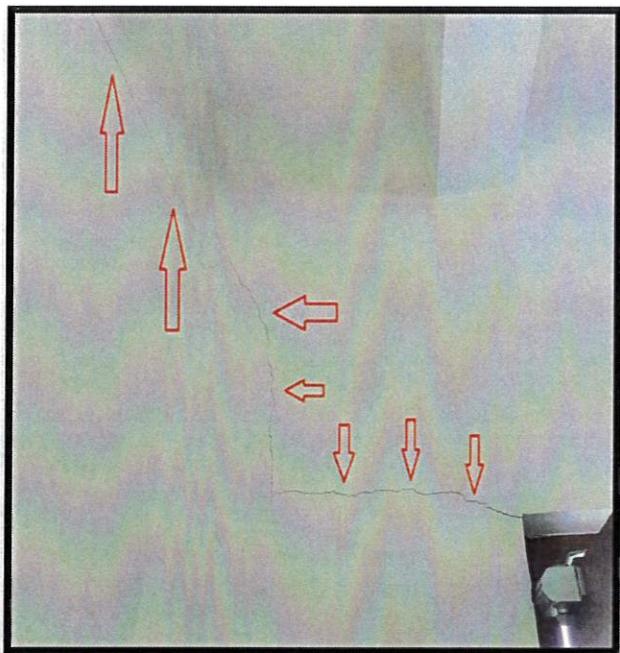
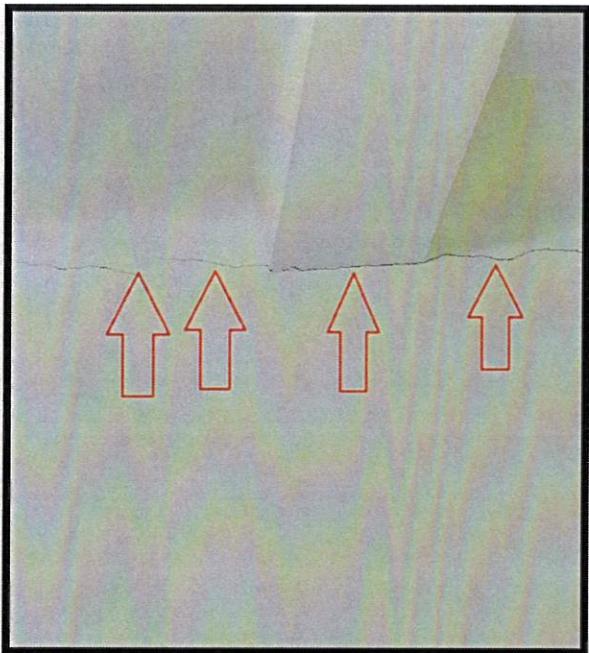
View of Separation Cracks Between Masonry Walls and RC Members

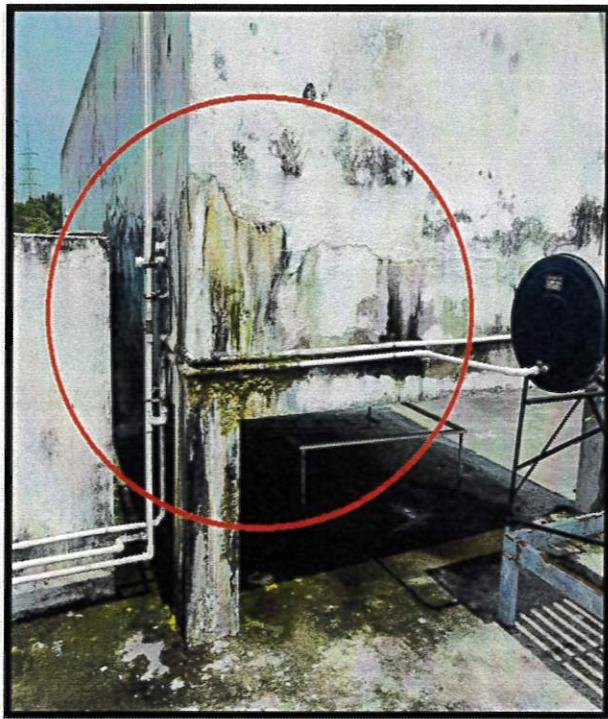
View of Cracks in OHT tank wall

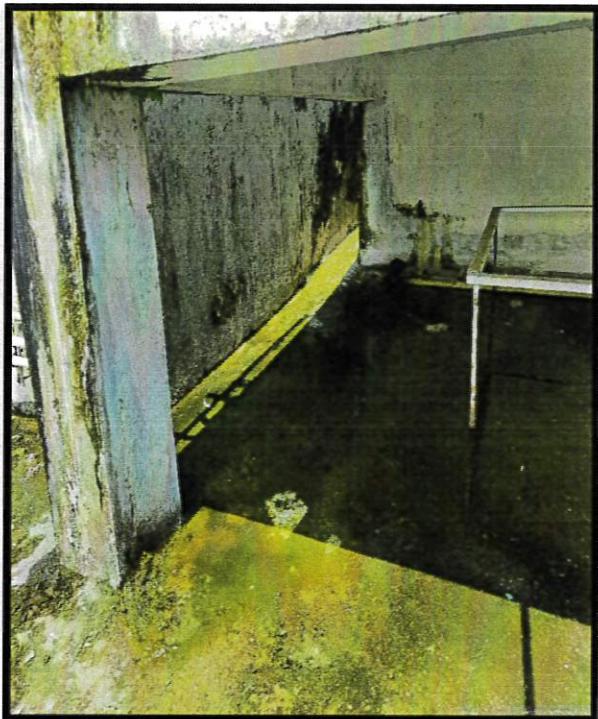
View of Stagnation of water over the terrace flooring
