**INVESTIGATION OF DISTRESS IN BASEMENT FLOOR AND
TERRECE LEVEL OVER HEAD TANKS OF ARMY WELFARE
HOUSING ORGANISATION “CHANDERKUNJ ARMY TOWERS” AT
SILVER SAND ISLAND, VYTILLA, KOCHI, KERALA**

NOVEMBER 2020

**Date of submission of
report** : 03rd December 2020

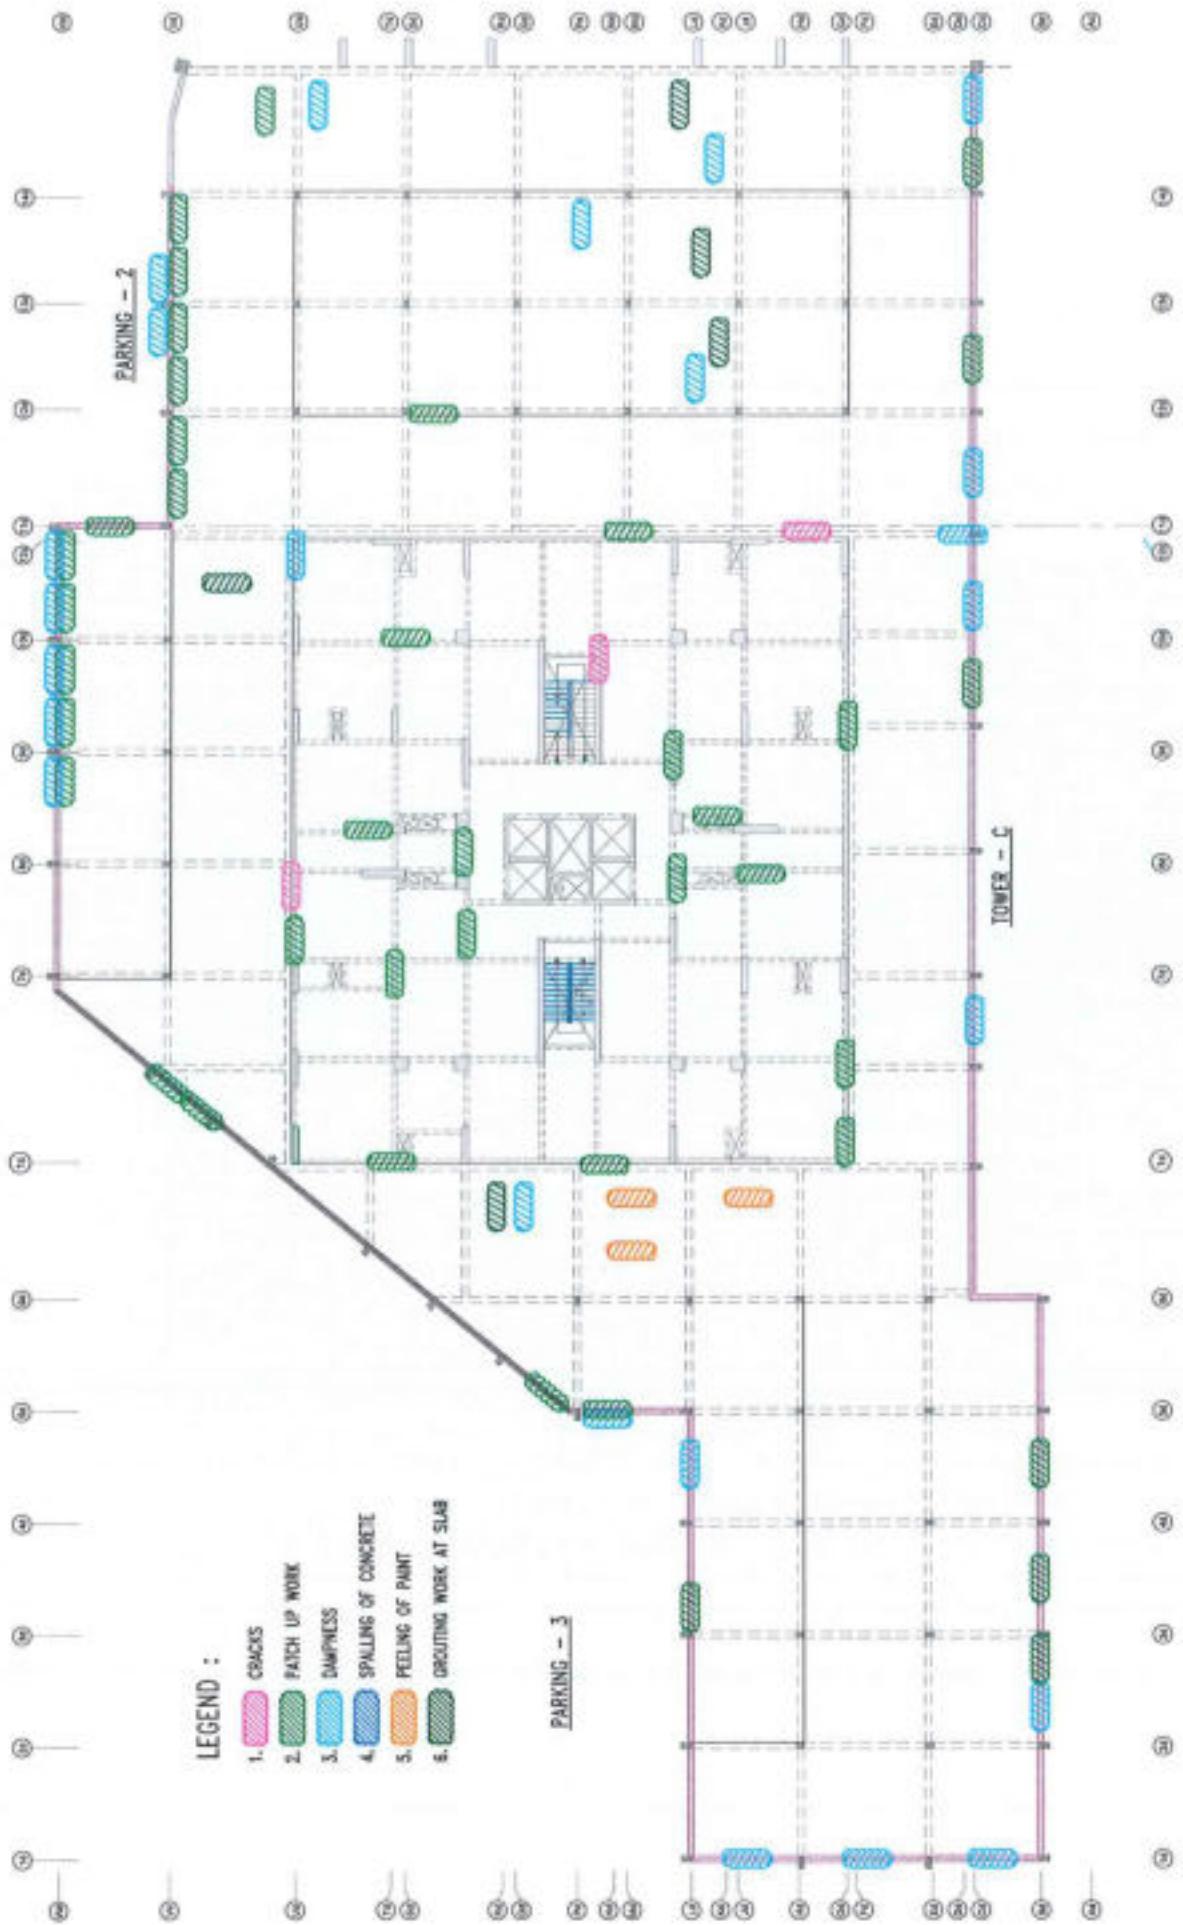
CLIQUE: N/o ARMY WELFARE HOUSING ORGANISATION (AWHO) VITILLA, KOCHI, KERALA		PROJECT: INVESTIGATION OF DISTRESS IN BASEMENT FLOOR AND TERRACE LEVEL OVERHEAD TANKS OF ARMY WELFARE HOUSING ORGANISATION "CENTRES FOR ARMY TOWERS" AT SILVER SAND ISLAND, VITILLA, KOCHE, KERALA		THE DISTRESS LAYOUT OF BASEMENT FLOOR

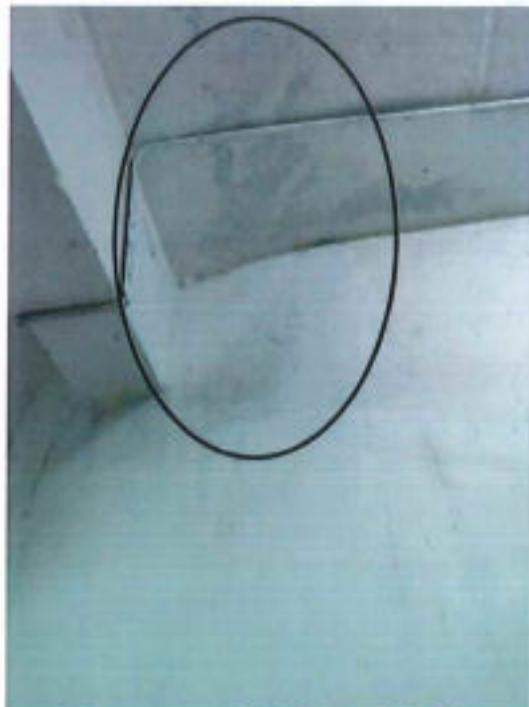
Dampness on RC Beam & Slab

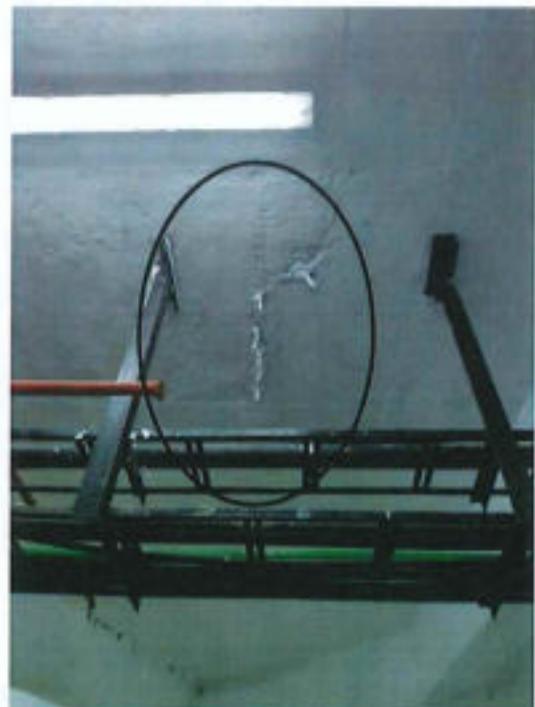
Grouting on RC slab

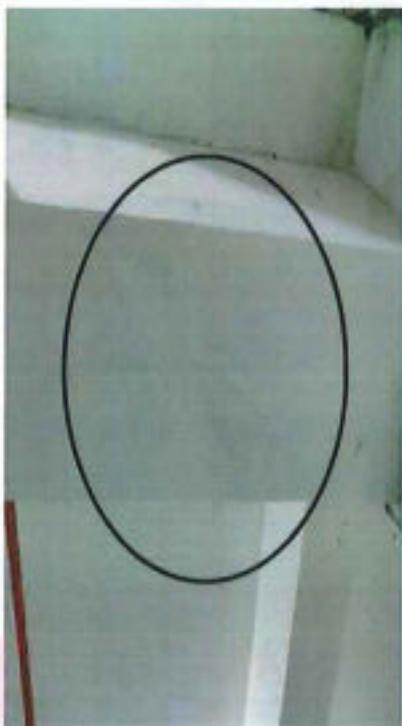
Crack on RC beam

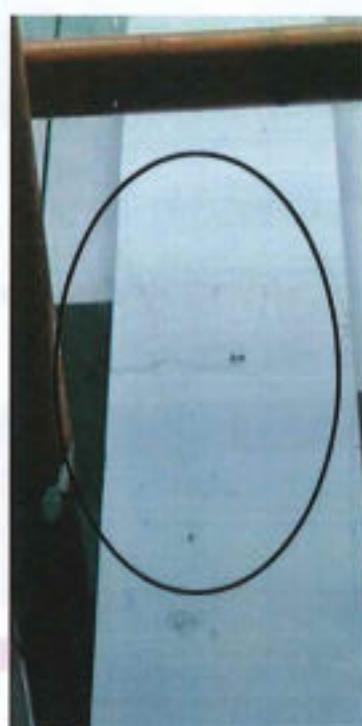
Dampness on column

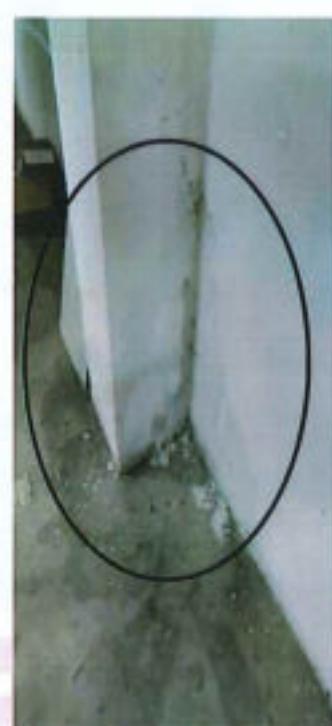
Crack on RC column

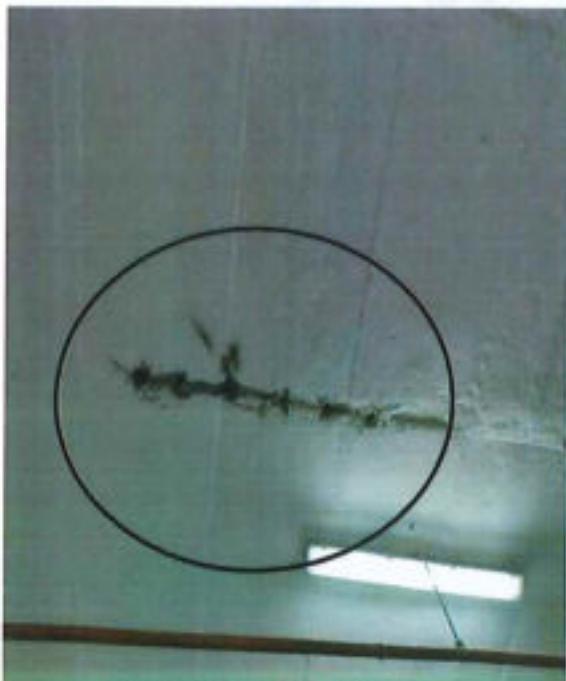
Grouting on RC slab

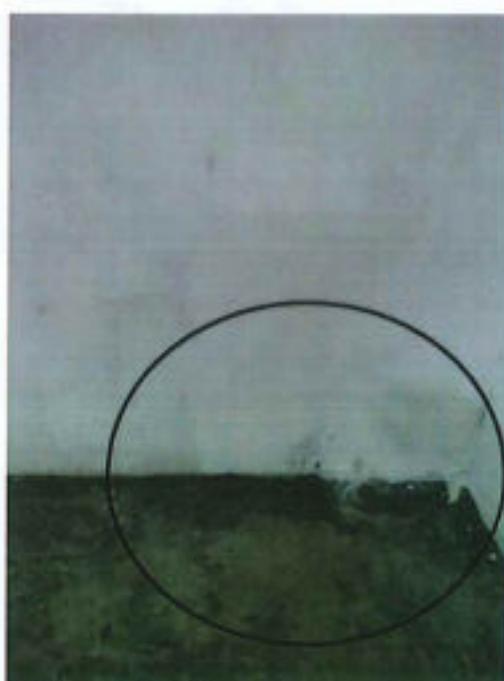
Minor leak & dampness on Retaining wall

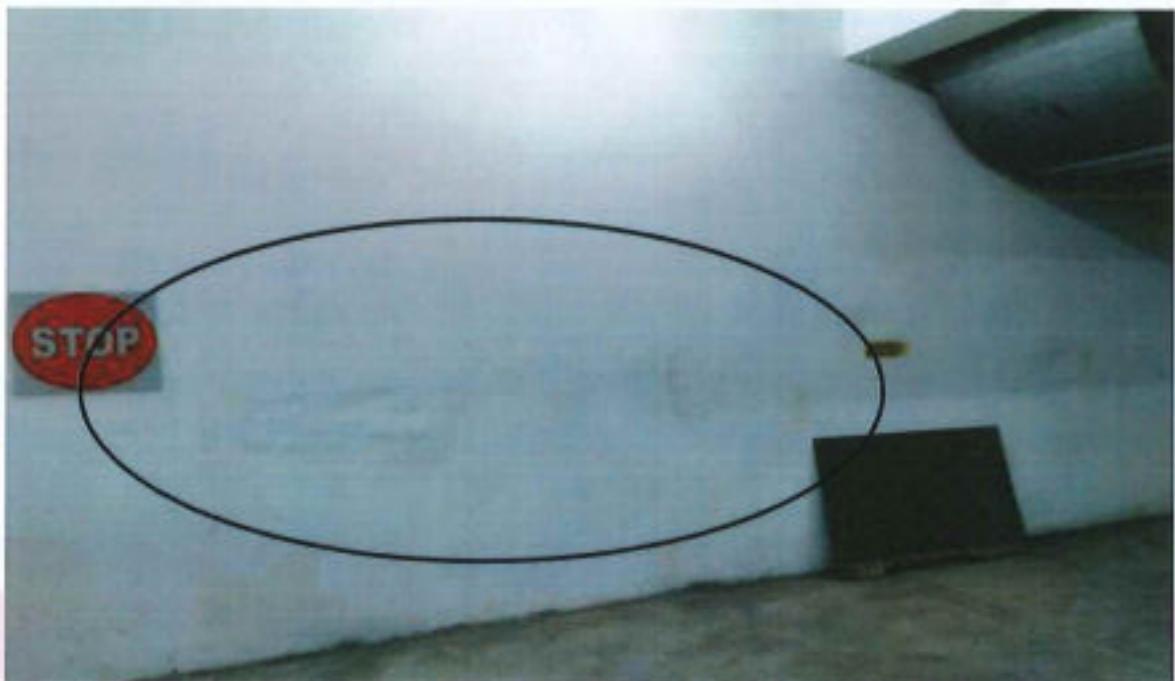
Patchup work on south side retaining wall

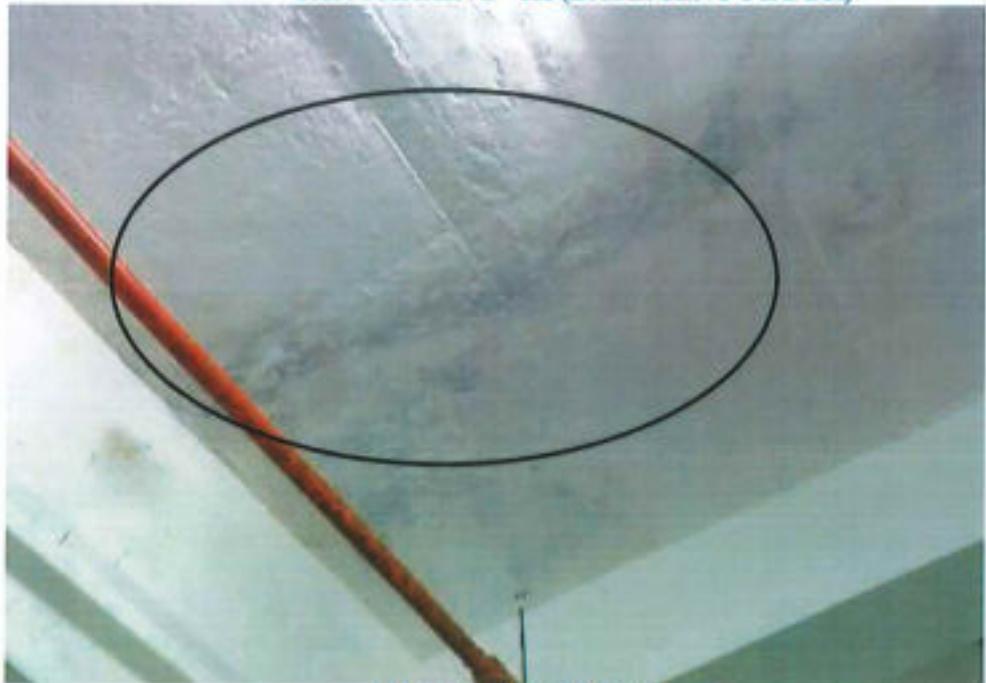
Dampness on RC Slab

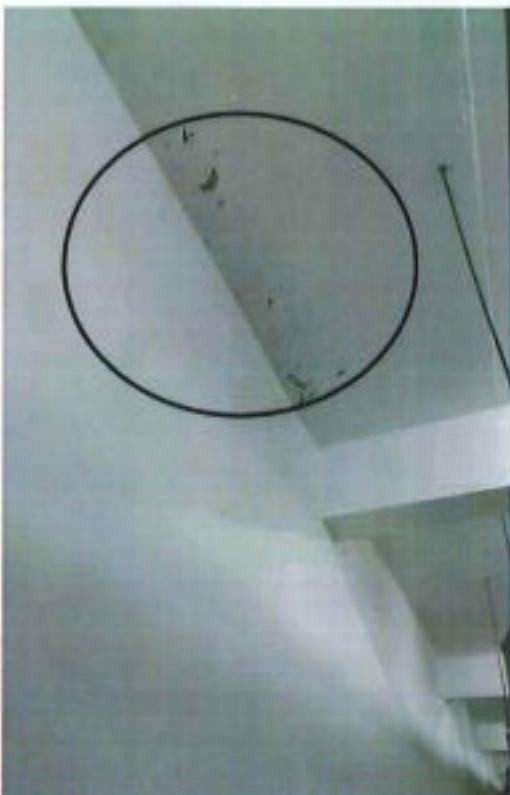
Peeling of paint on RC Slab

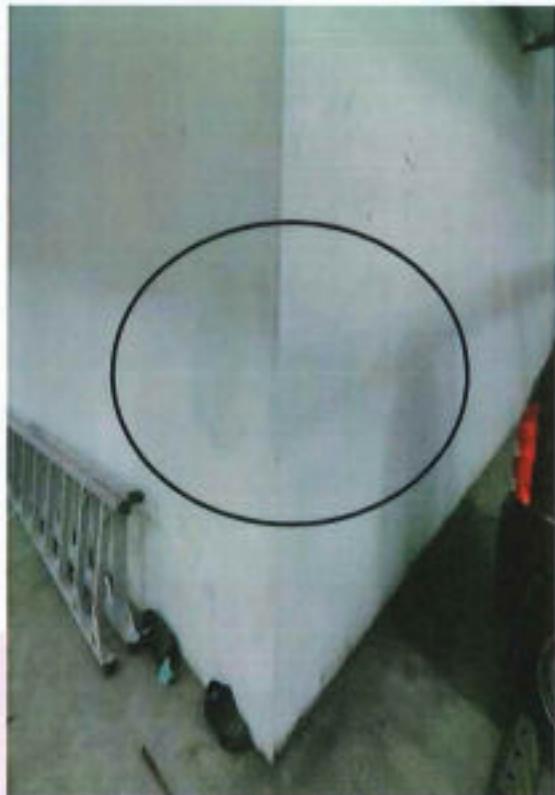
Patch-up work on west side Retaining wall

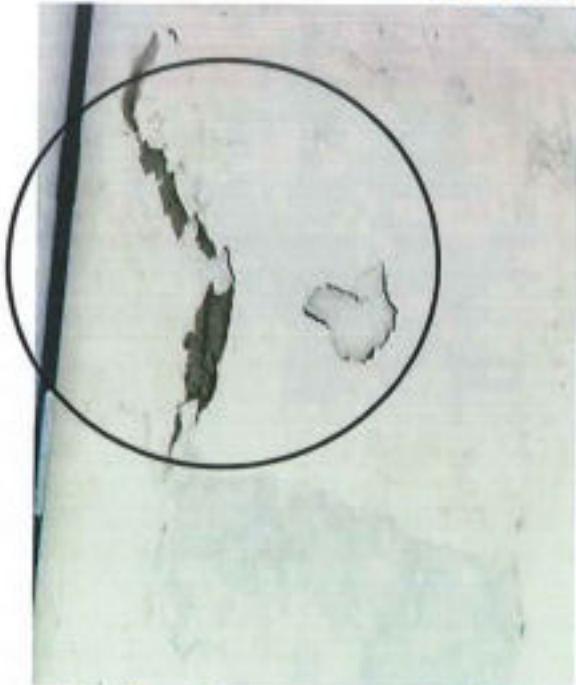
Spalling of cover concrete on RC slab

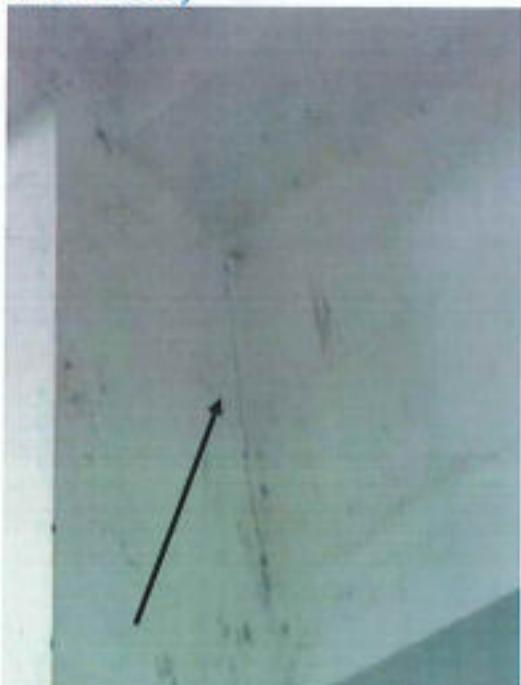
Crack between of RC column & RC beam junction

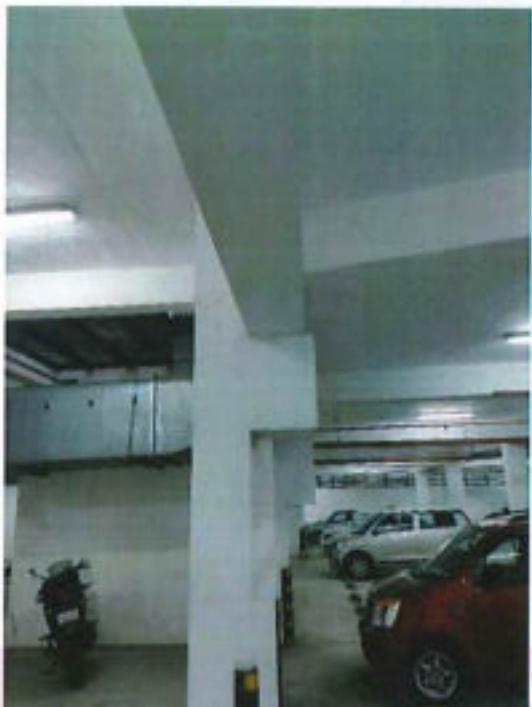
Minor Crack on corbel portion

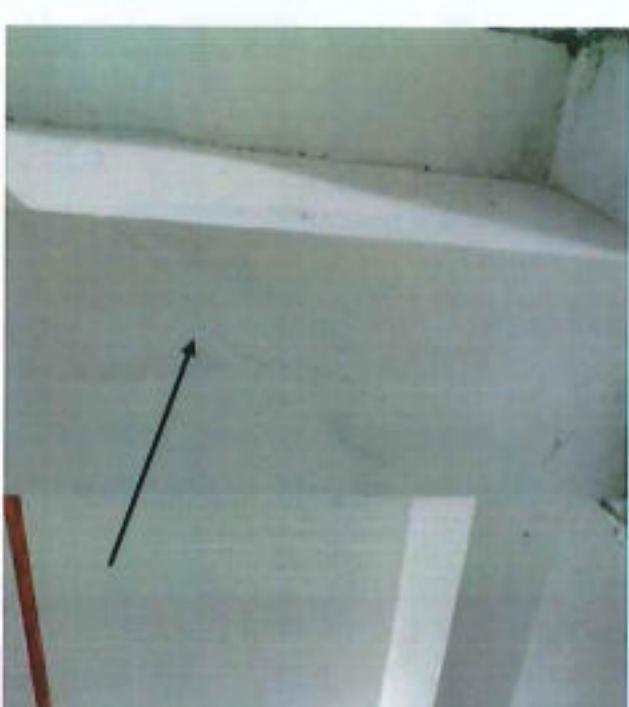
Crack on RC beam bottom

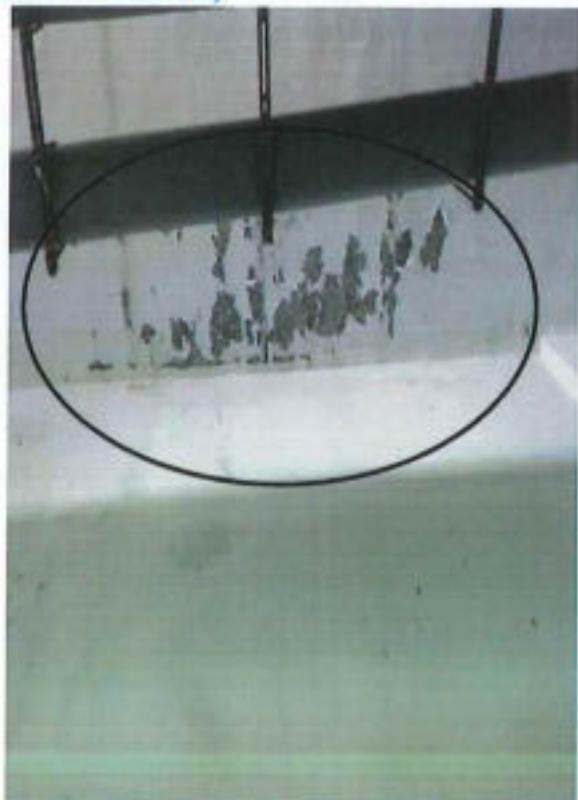
Peeling of paint on RC Slab

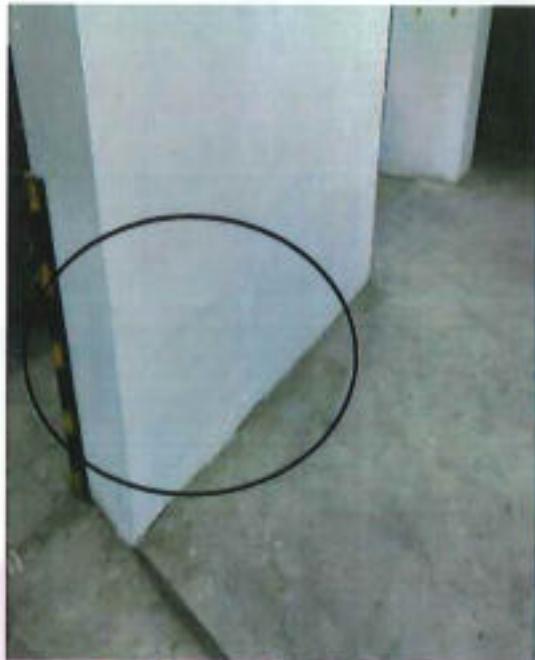
Patchup work on RC column

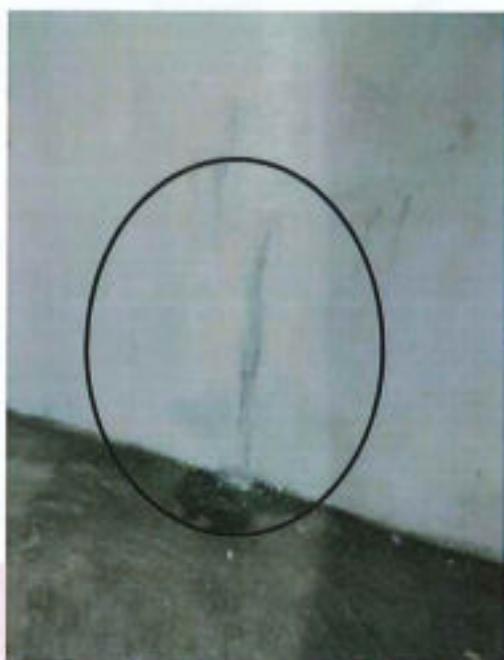
Dampness on retaining wall (south)

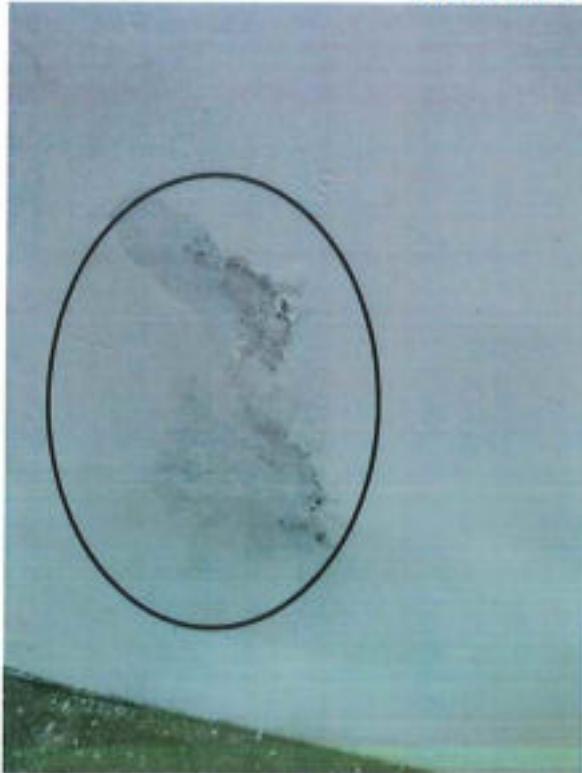
Dampness on Retaining wall

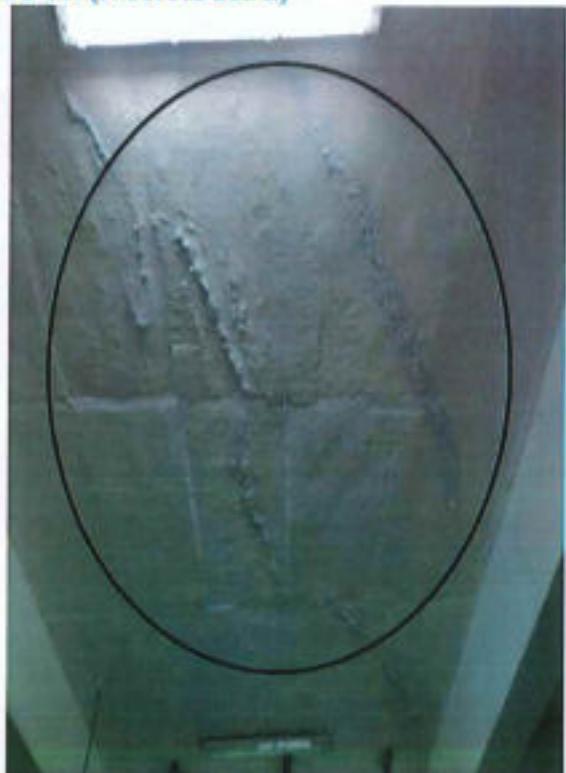
Grouting work on RC slab

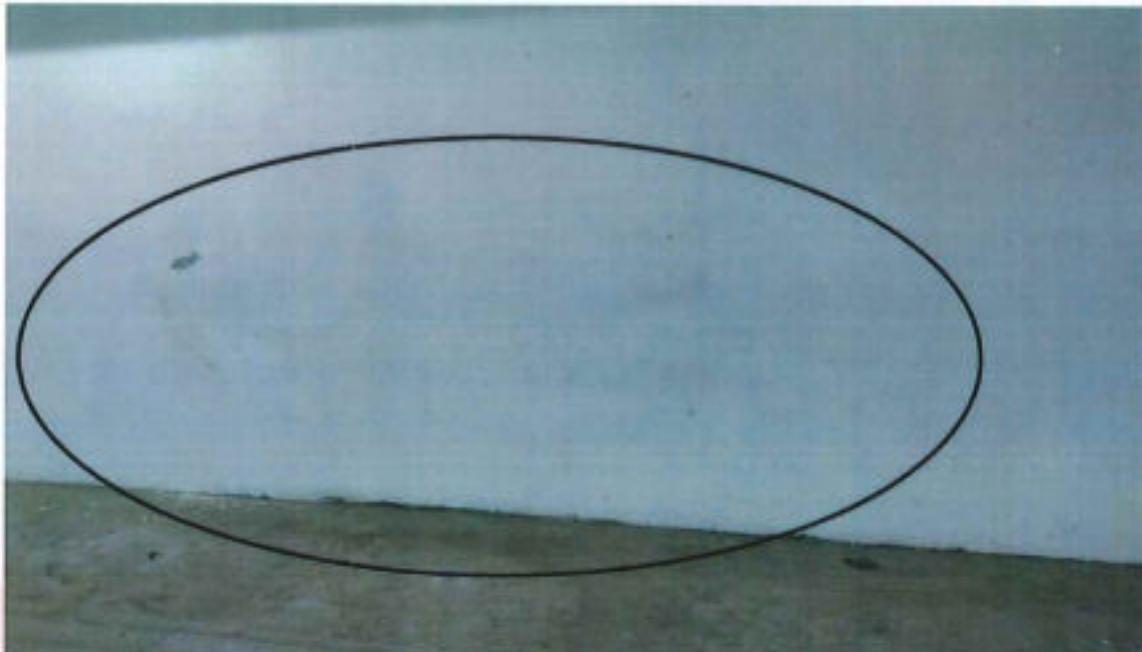
Patchup work on Retaining wall

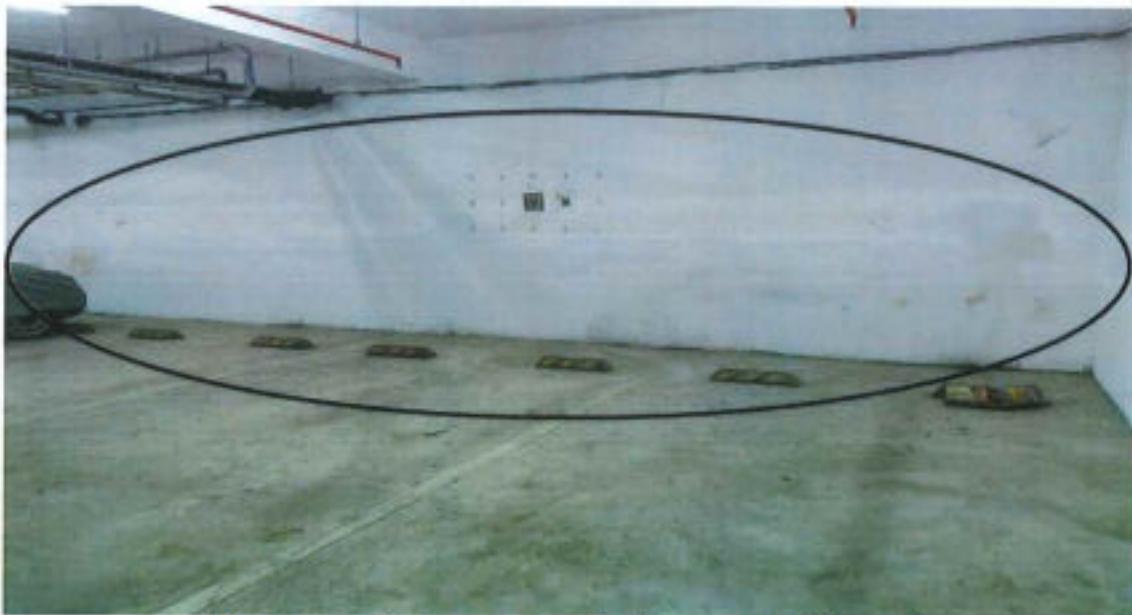
- Severe leakage / dampness were observed in peripheral retaining wall at isolated locations. Further these leakage regions were observed to be repaired by grouting technique. In spite of this leakages are still persist in these locations.

Dampness, minor seepage and patchup on retaining wall

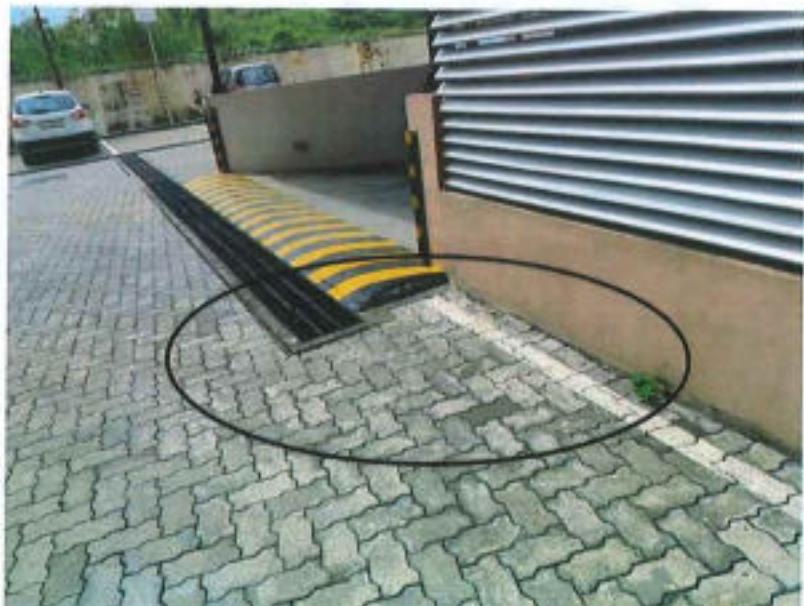
9. Leakage & damp patches in peripheral retaining walls & roof slab at basement floor are essentially due to leakage of water from the ineffective joints i.e., between the screed concrete & paving block road.

Gap between ramp wall and paver block

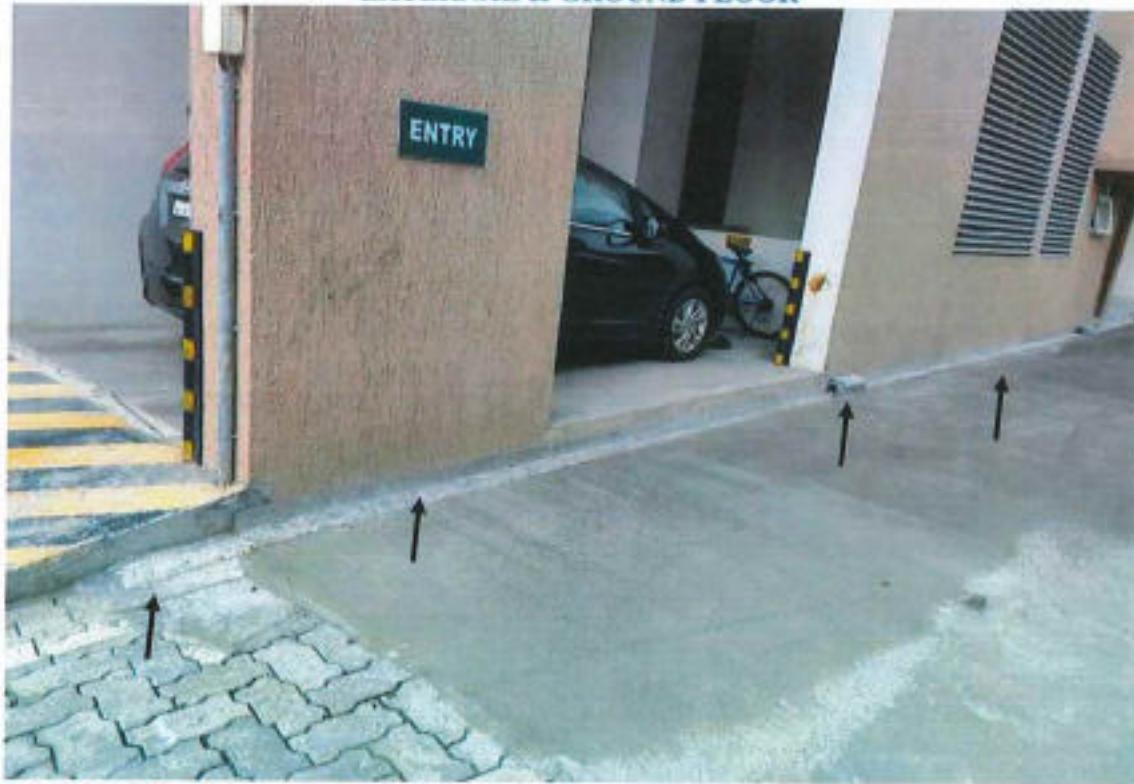
- Expansion joint was observed to be treated /provided/filled with L-shape 6mm plate in basement roof slab between tower -A, B & C and screed concrete provided region of the drive way.

6mm metal plate (L-shape) provided at expansion joint region between parking area and tower -B & C

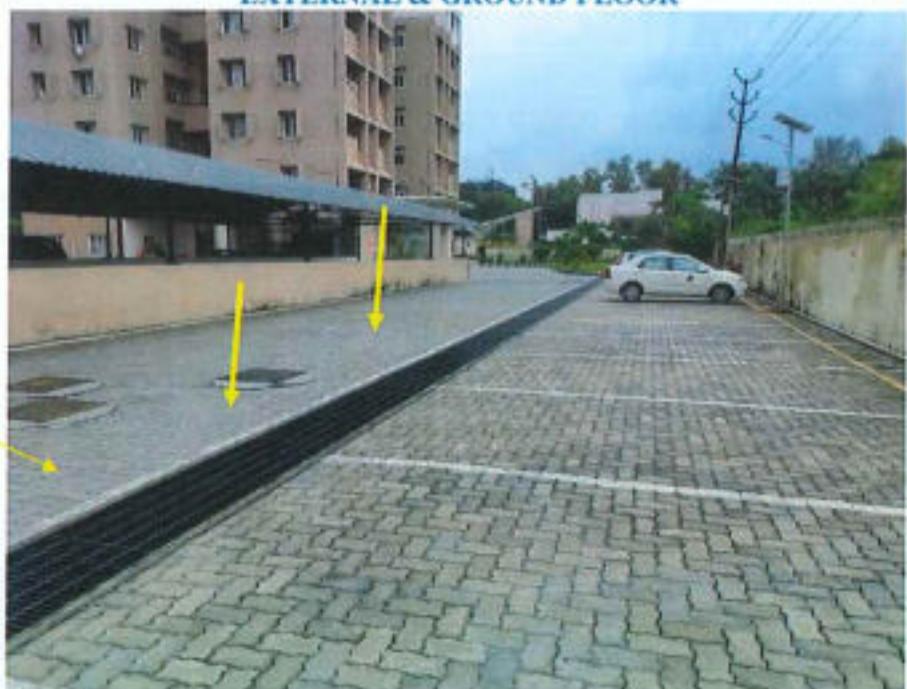
- Rainwater trench with inner smooth finish of size 900mm x 500 mm was observed to be provided at all the three towers at a distance of 6 meter from retaining wall at podium level.

Rain water trench at south face away from retaining wall

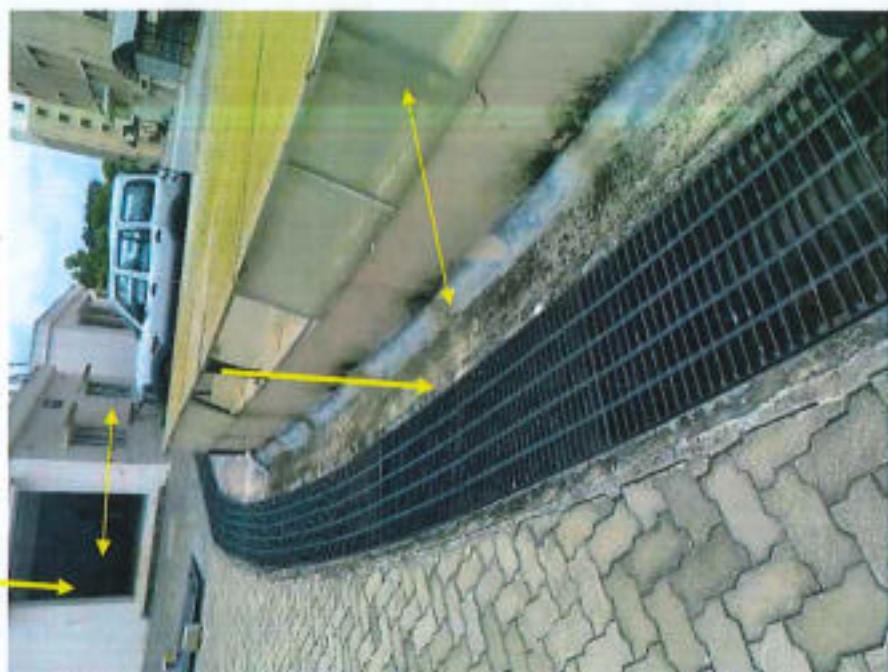
- Except at North West corner of tower -C, rainwater trench was observed to be provided at distance of one meter from retaining wall at podium level.
- Water Lake was observed at approximate distance of 600m to 800m at South face & west face from the compound wall. Further, lake was observed at approximate distance of 100m at Northwest corner face from the compound wall.

Rain water trench at northwest face nearer to retaining wall

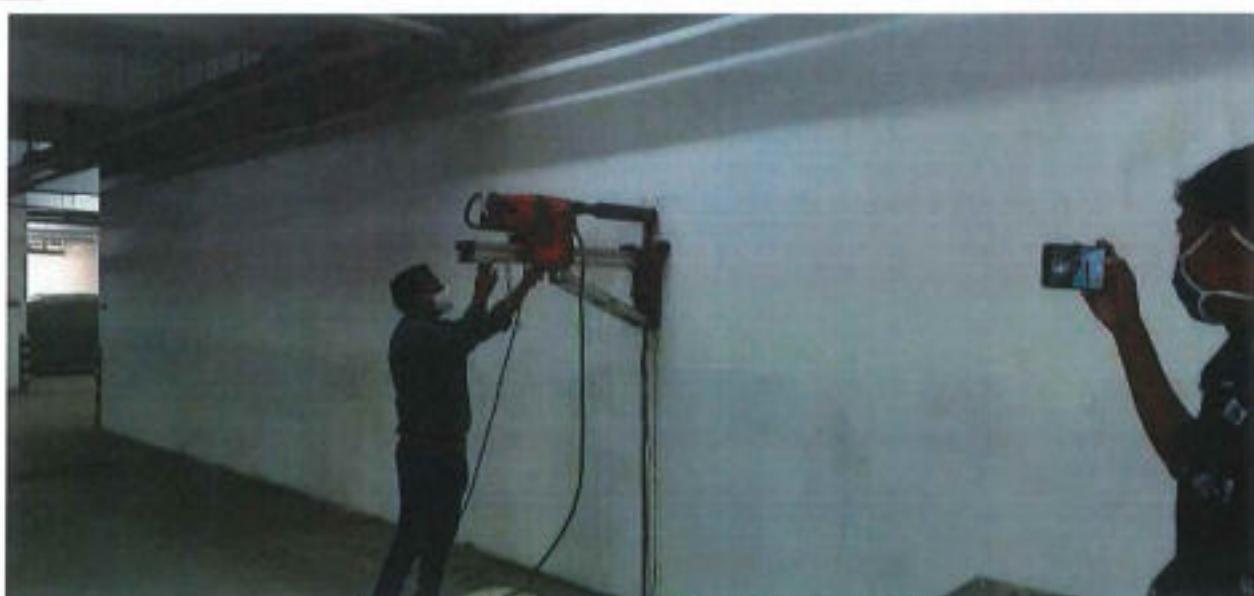
The compressive strength of in-situ concrete in the tested core samples extracted from identified Basement floor RC retaining wall is found to be in the range of **26.3 N/sq.mm to 31.1 N/sq.mm**.

Extraction of concrete core sample in progress
