Ref. No: IND.B.7.2022.300DR-R3

**SOUNDNESS ASSESSMENT OF EXISTING AWHO CLUB HOUSE  
BUILDING IN THE PREMISES OF  
M/S ARMY WELFARE HOUSING ORGANIZATION,  
KOCHI, KERALA.**

**APRIL 2023**

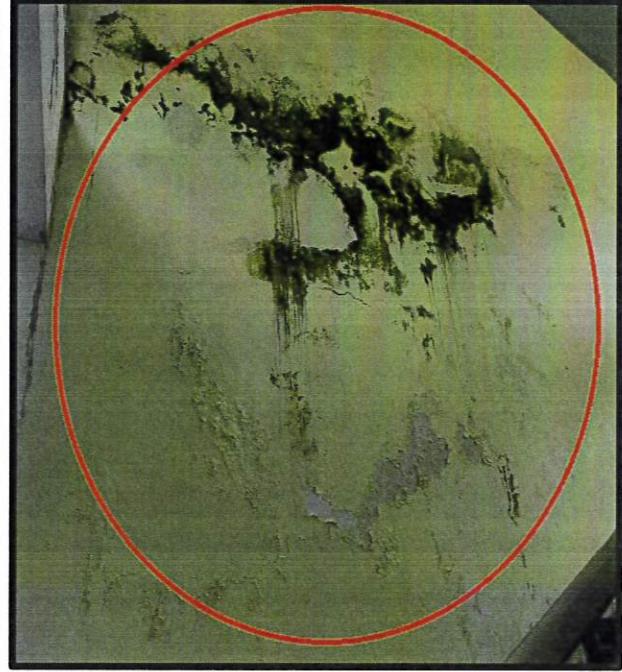
- Peeling of paint, growth of fungus and damp patches were observed over the external masonry walls in staircase regions at several locations.
- Minor separation cracks were observed at the junction of RC members and masonry wall at several locations.

1. Dampness/ damp patches/ growth of fungus and peeling of paint in masonry wall are mainly due to the constant spilling of water from overhead tank.
2. Separation cracks observed are due to dissimilar materials, improper filling of joints / not provided with mesh between masonry and RC members during construction stages. Further, thermal effects caused by expansion and contraction of building have aggravated the cracks.
3. Stagnation of water over terrace is mainly due to inadequate slope provided in WPC.
4. Cracks in plaster might be due to shrinkage effect.
5. From the results of the non-destructive ultrasonic pulse velocity test & rebound hammer test, it is inferred that the quality/strength of concrete in tested regions of RC members is found to be satisfactory.
6. From the results of covermeter studies, the cover provided to the rebars is adequate in most of the tested RC members.

**View of Peeling of paint and damp patches in masonry wall at stair case regions**

1. The deteriorated /debonded plaster on masonry walls shall be totally removed by gentle chipping.
2. The mortar joints shall be deeply raked for about 10 to 15 mm & repointed using CM 1:4 as per standard practice.
3. Re-plastering to be carried out using 1:4 cement mortar as per specification added with polypropylene fibres and cured as per standard practice.

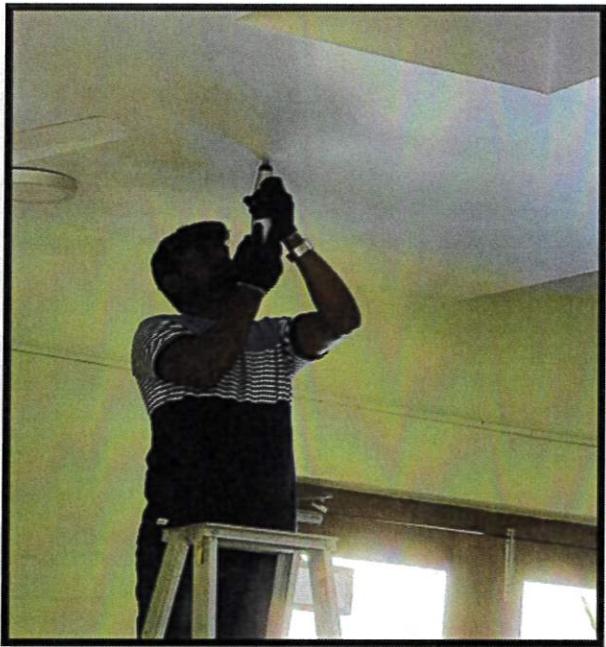
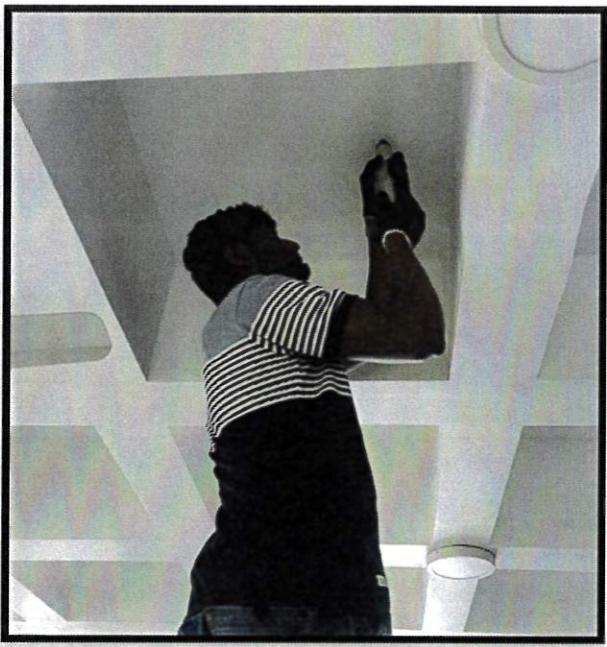
View of Rebound Hammer test in progress

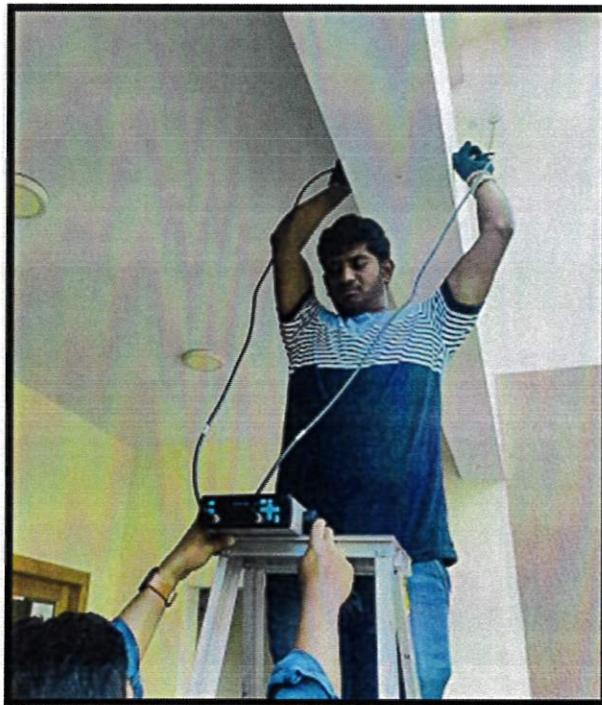
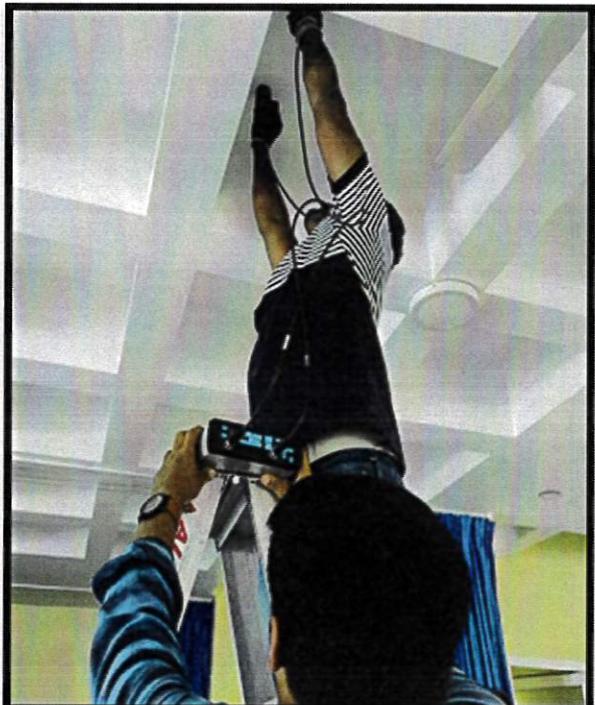
From the results of the Ultrasonic Pulse Velocity test, it is inferred that the quality of concrete in the tested regions of RC members is found to be "**Good Concrete**" as per **IS:516-(Part-5/sec-1)-2018**. Results of the tests & quality grading reference chart are furnished in **Test Report**.

View of Ultrasonic Pulse Velocity test in progress

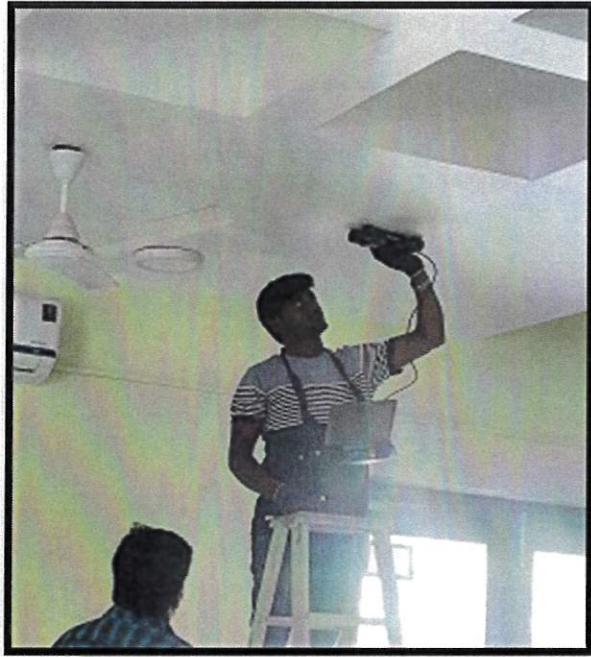
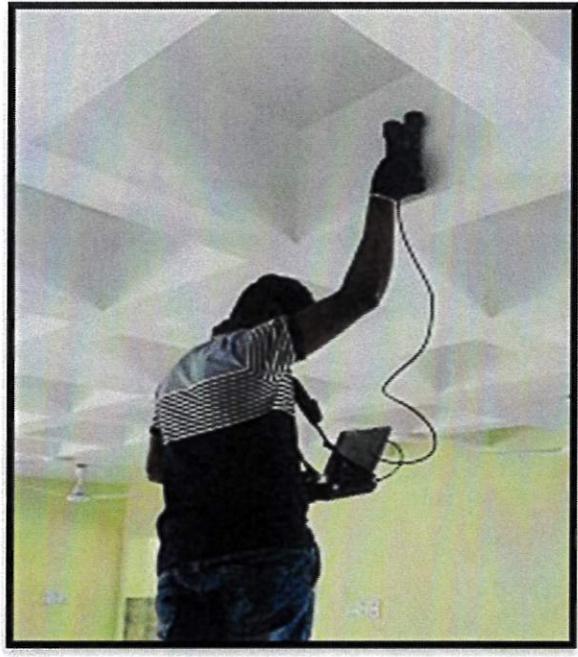
From the results of the test, it is found that cover concrete provided to the rebars is adequate in most of the tested RC members.

View of profometer (cover meter) test in progress
