**Structural Condition of Chander Kunj Army Towers (CKAT) at**

**Silver Sand Island, Vytilla, Kochi**

**(IITM Report-4)**

**Prof. Radhakrishna G. Pillai**

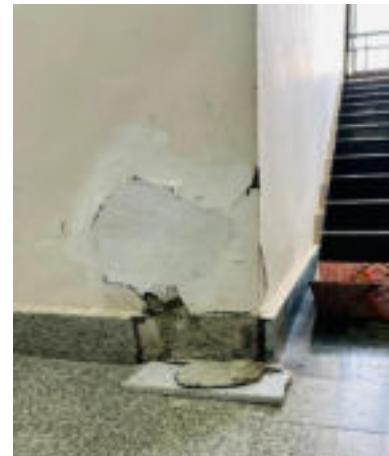
(b) Cracked, spalled concrete with cosmetic repair

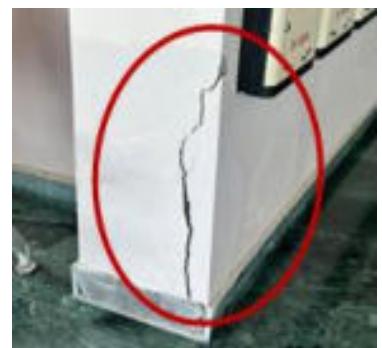
(d) Wide longitudinal crack in concrete

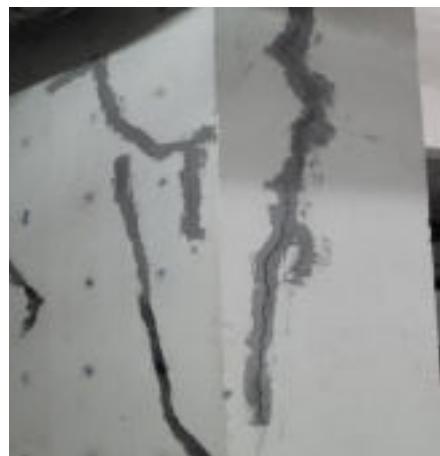
(d) Cracks reappeared in patch-repaired shear wall

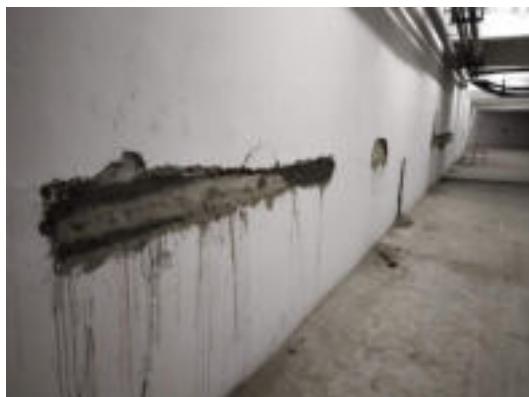
Figure 2. Leaking of basement wall  
(performance of recent repair must be checked  
during the upcoming monsoon)

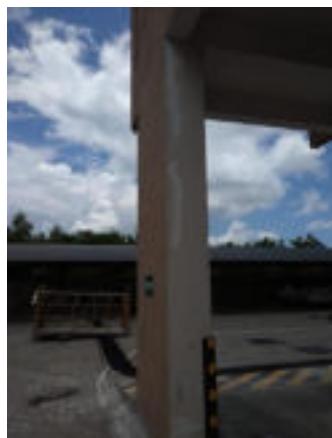
Figure 4. Patch repair of cracks in columns

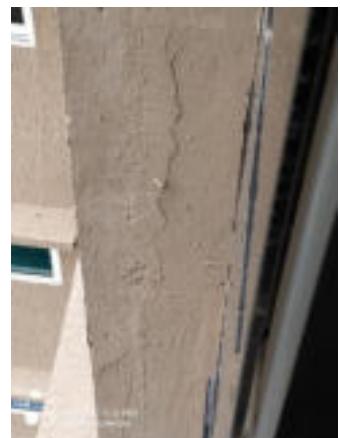
Figure 5. Cracks on patch repaired columns  
(indicate inadequate repair practice)
