IND.B.7.2022.300DR-R3

**VISUAL INSPECTION OF RESIDENTIAL CHANDERKUNJ ARMY
TOWER - A OF ARMY WELFARE HOUSING ORGANISATION (AWHO)
AT SILVER SAND ISLAND, VYTILLA, KOCHI, KERALA**

APRIL 2023

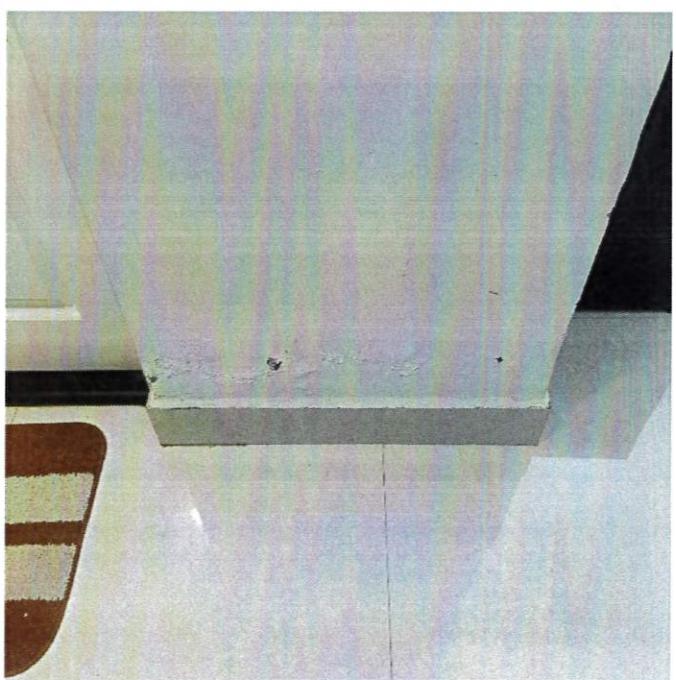
View of dampness/ damp patches/ peeling of paint inside the Flats

4. **Treatment for dampness region of masonry wall.**
 - a. The deteriorated plaster on masonry walls shall be removed by gentle chipping.
 - b. The mortar joints in walls shall be deep raked and re-pointed with CM 1:4 as per the standard practice followed by re-plastering in CM 1:3 mixed with waterproofing plasticizers.

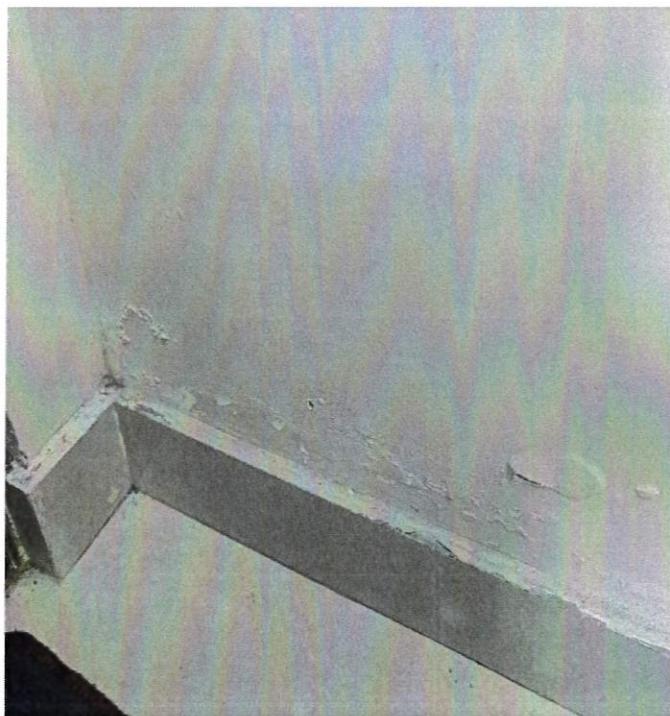
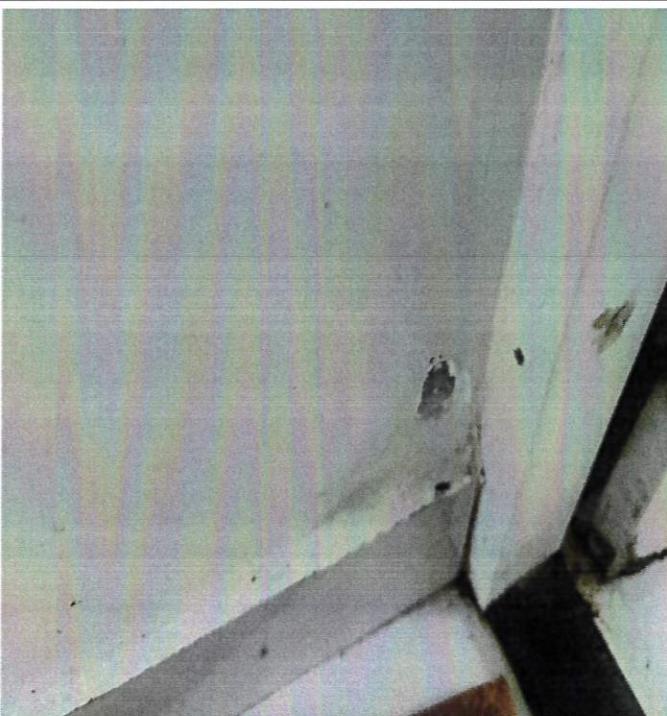
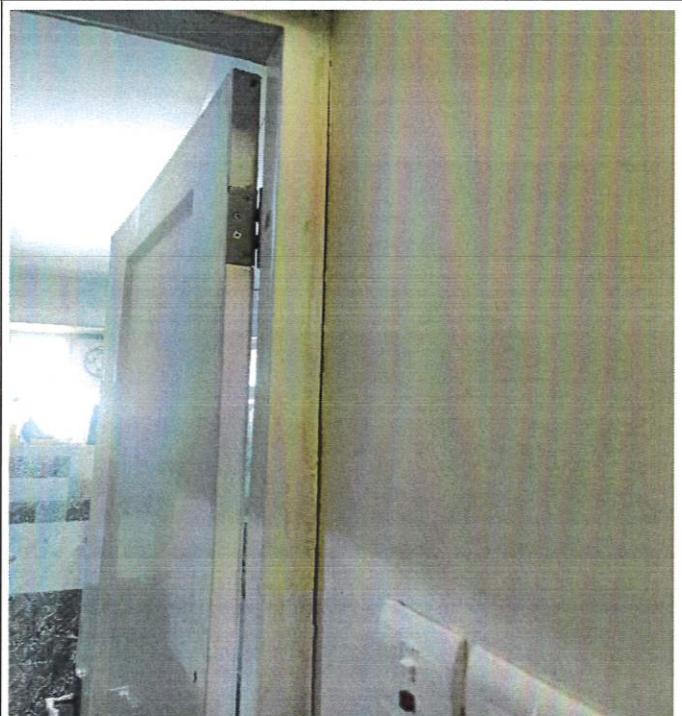
View of dampness/ damp patches/ peeling of paint inside the Flats

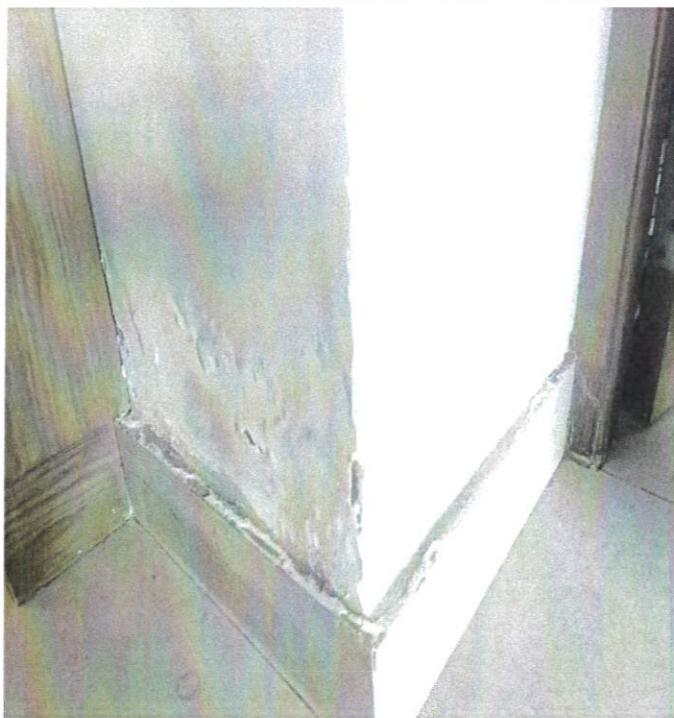
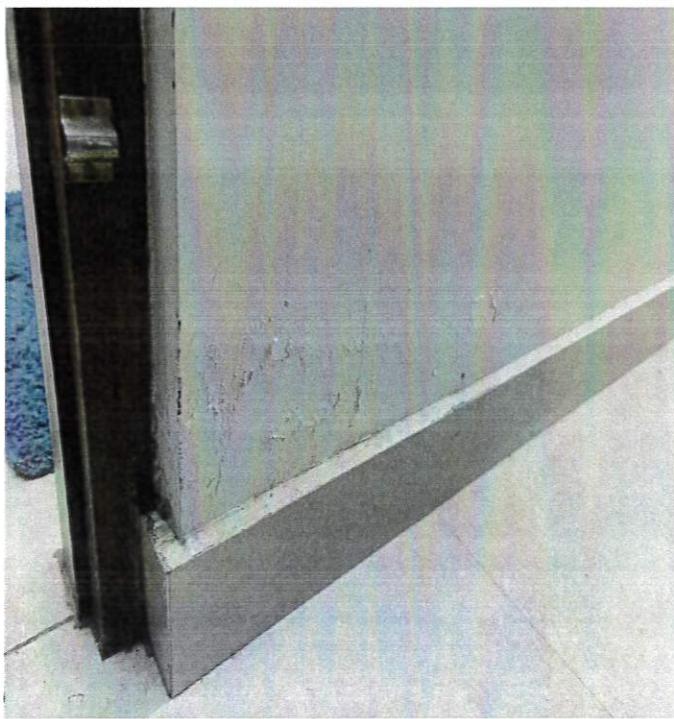
View of dampness/ damp patches/ peeling of paint inside the Flats

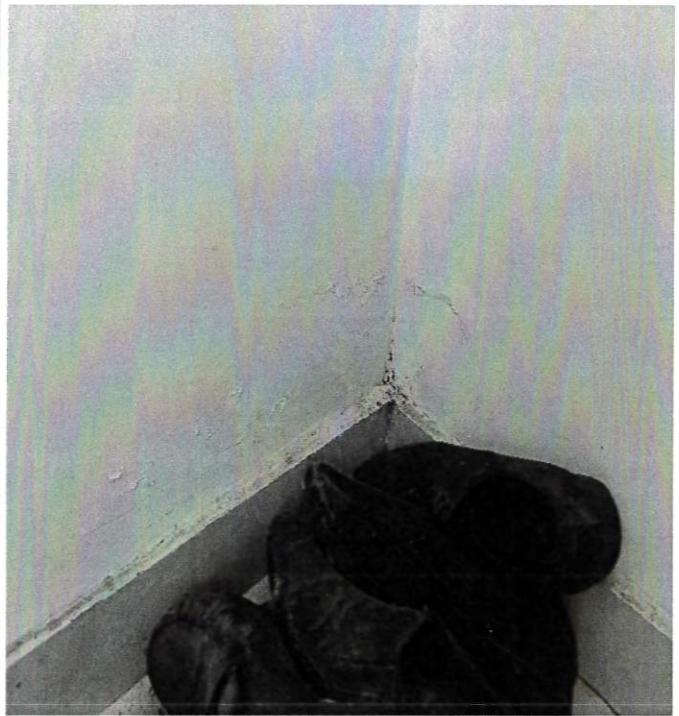
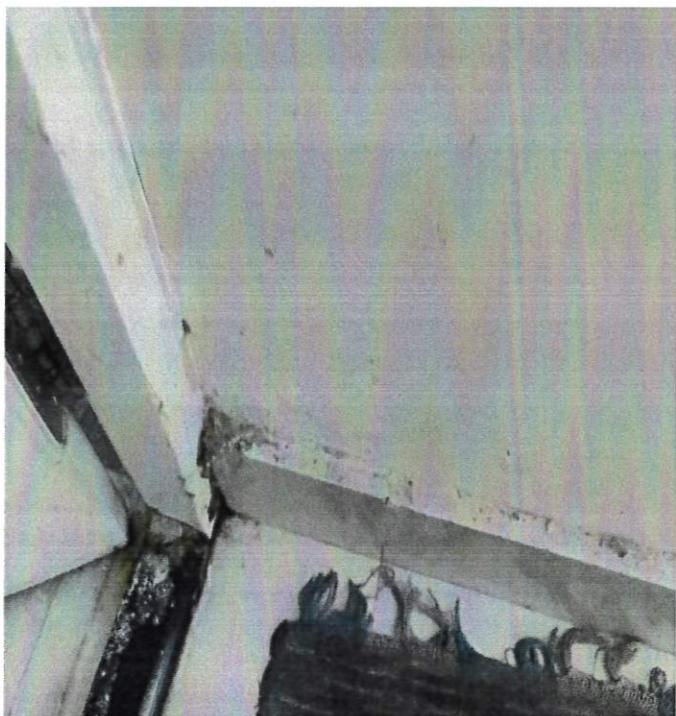
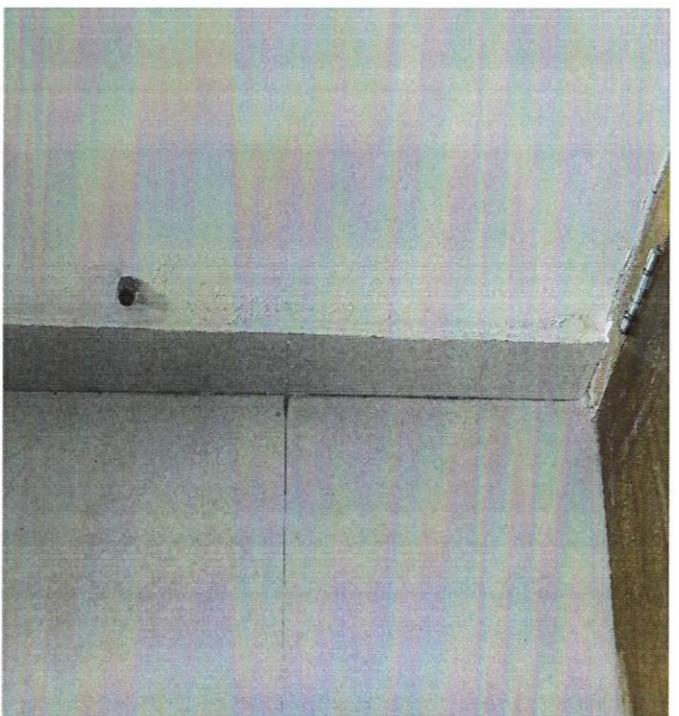
View of dampness/ damp patches/ peeling of paint inside the Flats

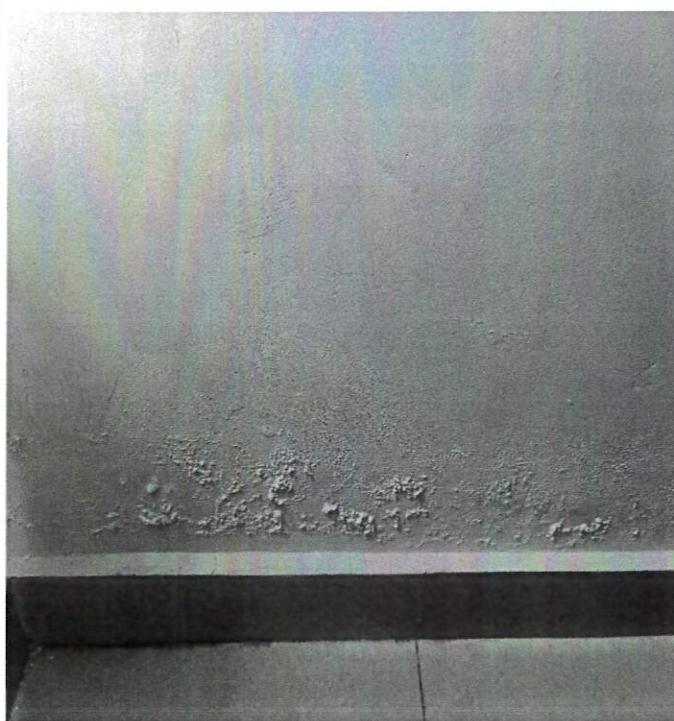
View of dampness/ damp patches/ peeling of paint inside the Flats

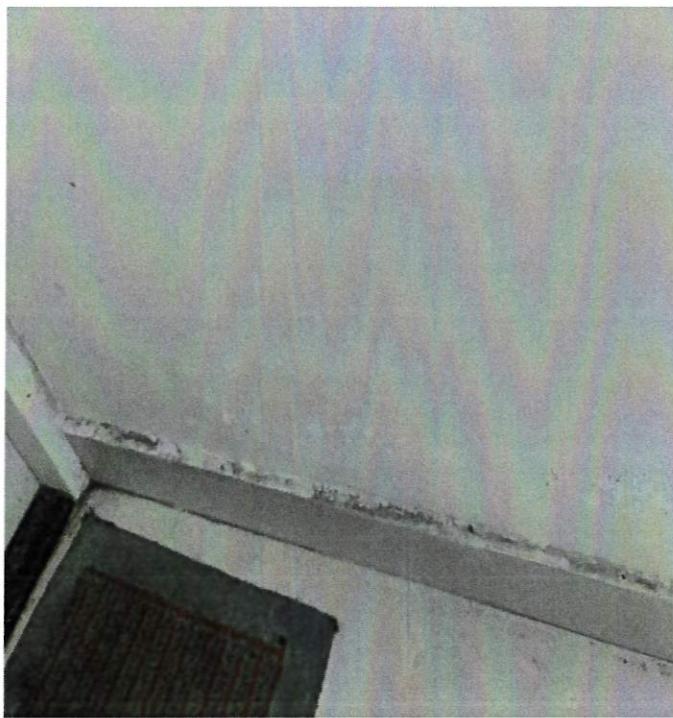
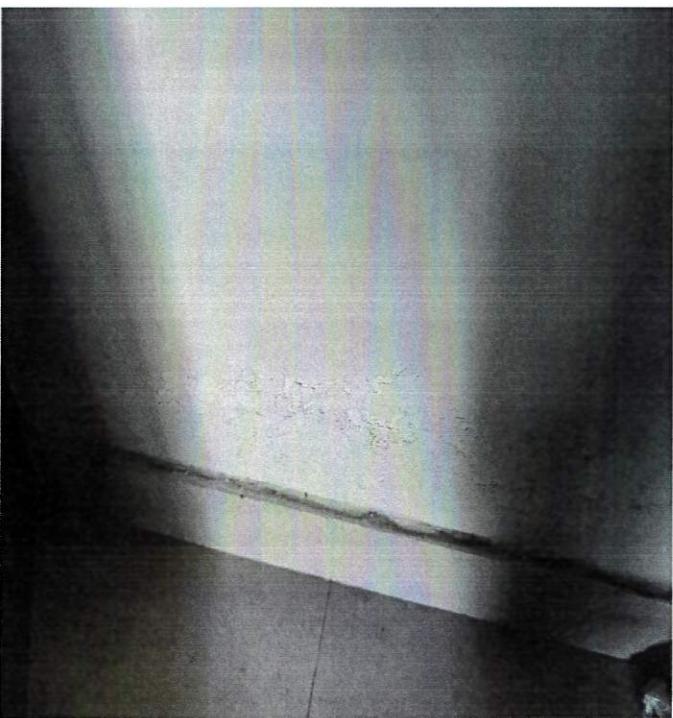
View of dampness/ damp patches/ peeling of paint inside the Flats

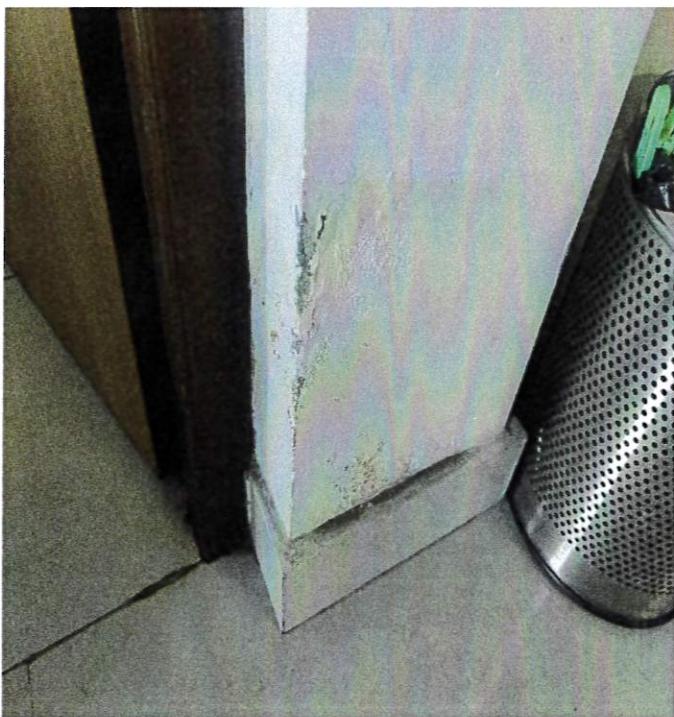
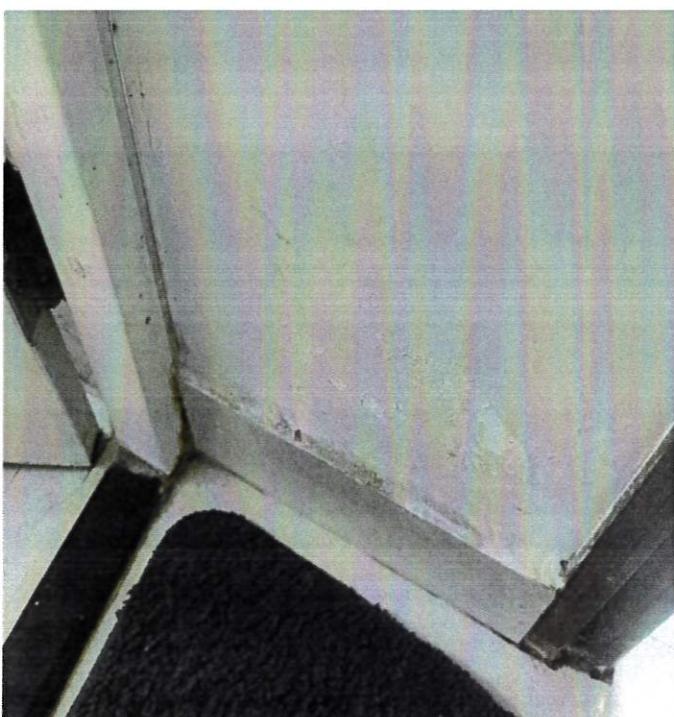
View of dampness/ damp patches/ peeling of paint inside the Flats

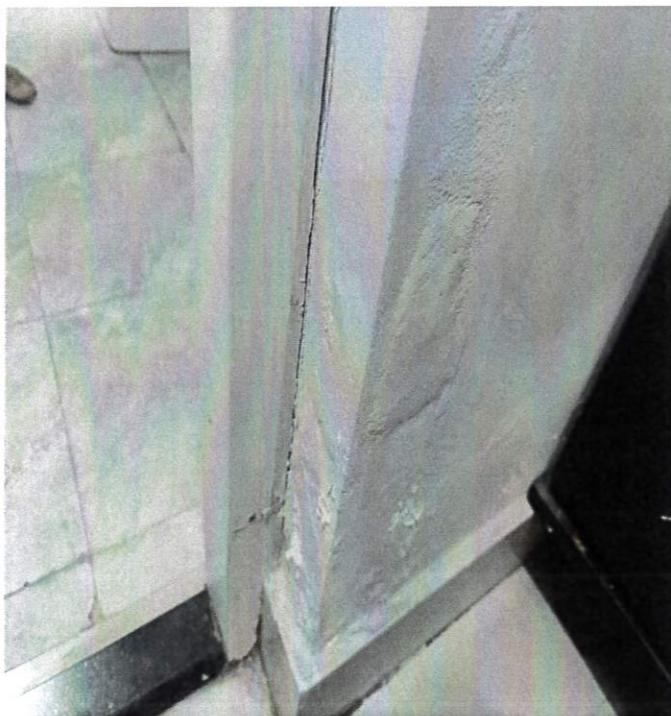
View of dampness/ damp patches/ peeling of paint inside the Flats

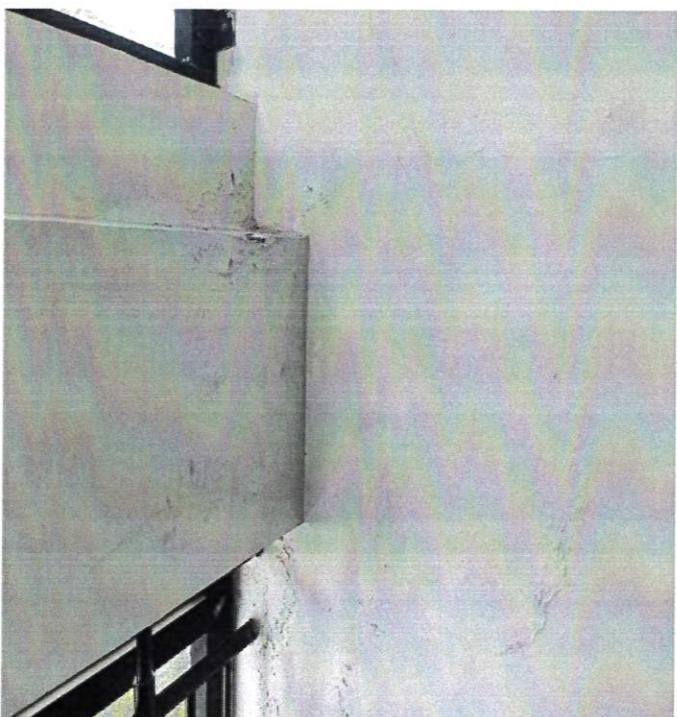
View of dampness/ damp patches/ peeling of paint
